MERCER ISLAND PARKS
OVERWATER STRUCTURES ASSESSMENT

DRAFT REPORT

May 30, 2014

Re: **Mercer Island Parks – Overwater Structures Assessment**

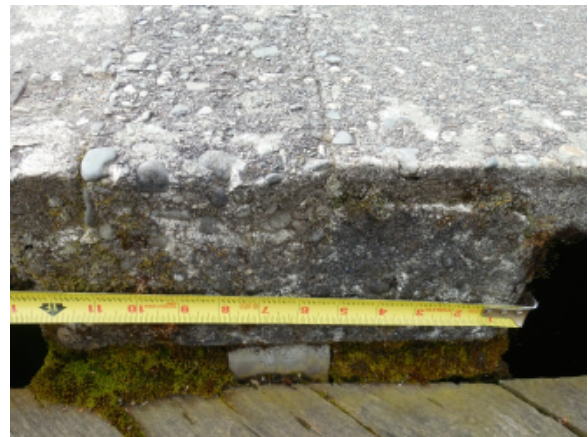
Photo 12A – Deteriorated / loose bull rail

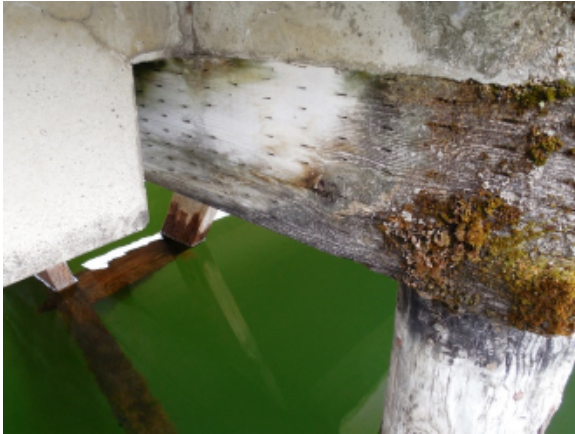
Photo 14A – Deteriorated cap beam

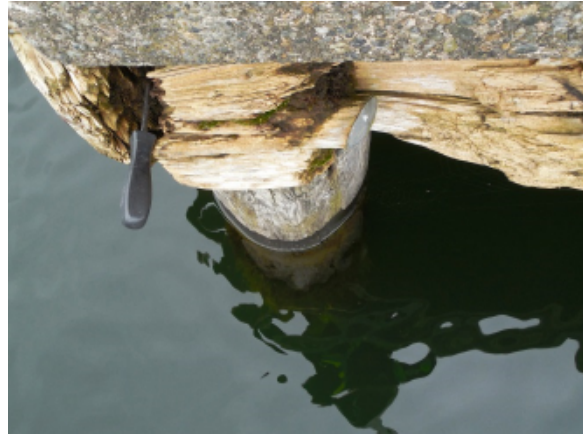
Photo 15A – Deteriorated cap beam end

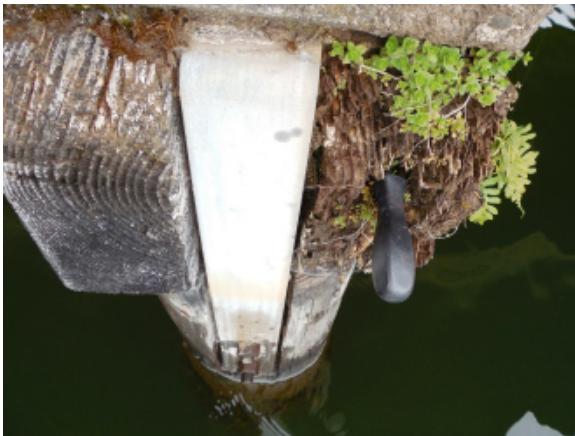
Photo 16A – Spalling at underside of precast "T"

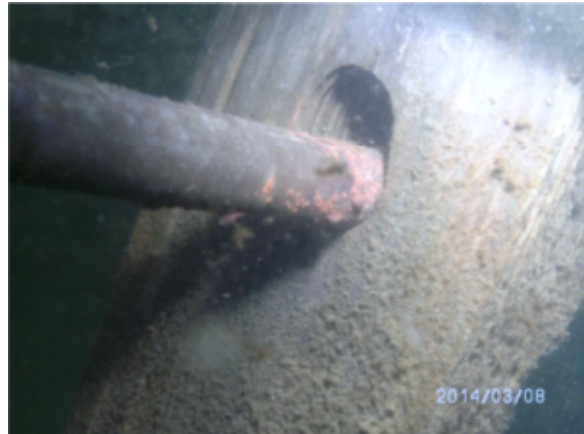
Photo 20A – Loose connector at substructure

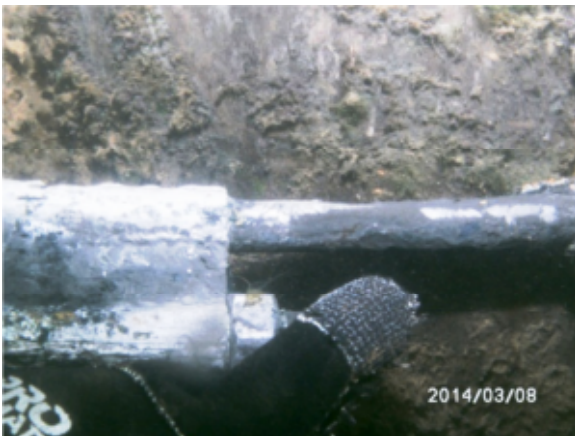
Photo 21A – Stripped / corroded connector

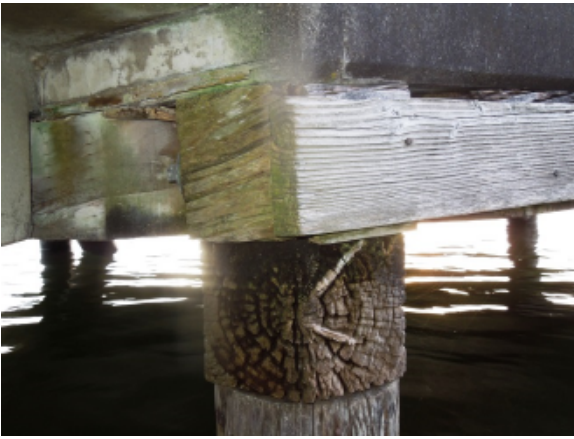
Photo 25A – Deteriorated cap beam (small pier)

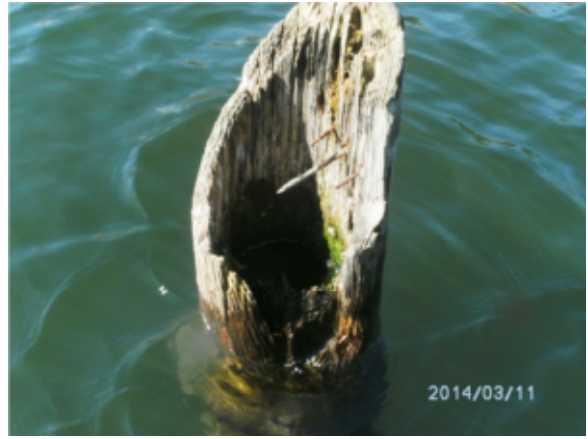
Photo 26A – Deteriorated mooring pile

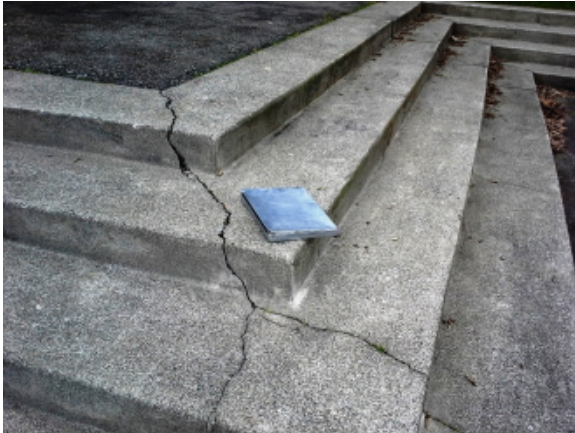
5	Concrete Shoreline Steps [approx 85 ft of shoreline]	Large void present at NE end next to rock bulkhead; 5" to arm length void below footing at toe of steps along full length; cracks located at bends in steps.	Undermining of stairway footing by wave action.	7	10	8	9	10-20	Placement of cobble and gravel aggregate at toe to prevent undermining; annual monitoring.	\$15,000 - \$20,000 monitoring included under Location 4	Complete demolition and replacement of stairs; placement of aggregate at toe to reduce the potential for undermining; annual monitoring.	\$70,000 - \$90,000 monitoring included under Location 4

Photo 7B – Cracked shoreline steps

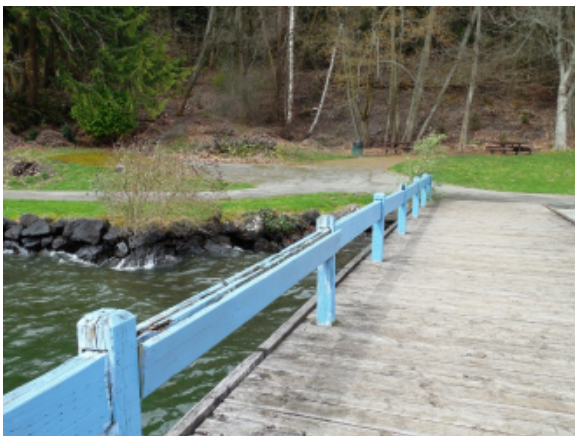
Photo 11B – Deteriorated wood rail

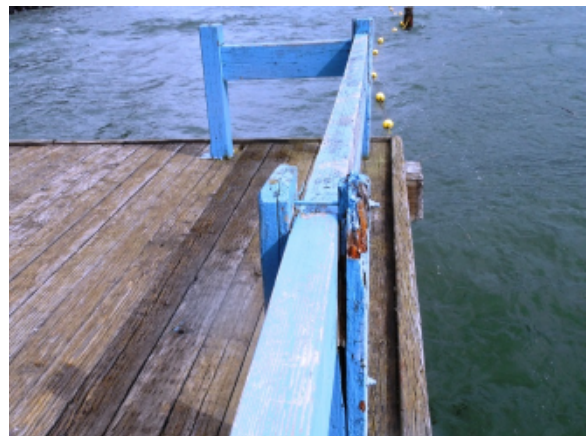
Photo 12B – Deteriorated wood rail

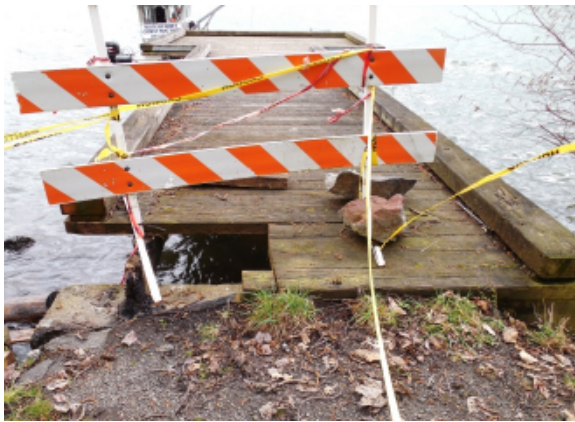
10	Small Pier Superstructure	Construction similar to large pier. Small pier superstructure has sustained fire damage at stinger(s) bearing at abutment.	arson	3	1	1	1	Exceeded	Repair fire damage in-place	\$20,000 - \$25,000	Demolish	\$20,000 - \$25,000
	Small Pier Substructure	Construction and condition similar to large pier - see notes above							see notes above		see notes above

Photo 21B – Fire damage at small pier

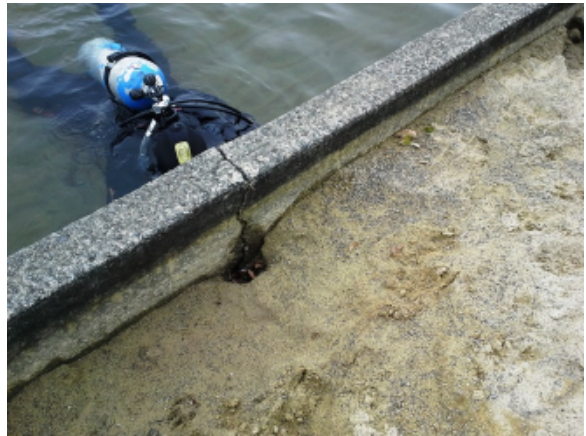
Photo 2C – Cracked bulkhead

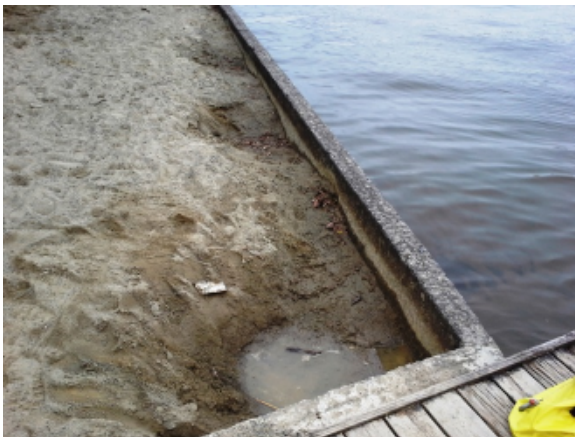
Photo 3C – Eroded sand, Beach 1

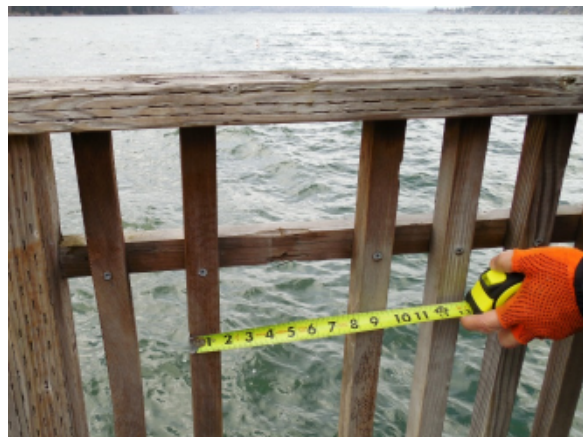
Photo **12C** – Missing rail picket

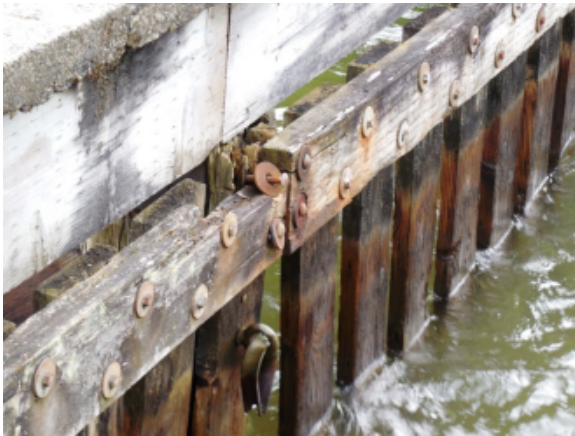
Photo **13C** – Deteriorated skirt wall

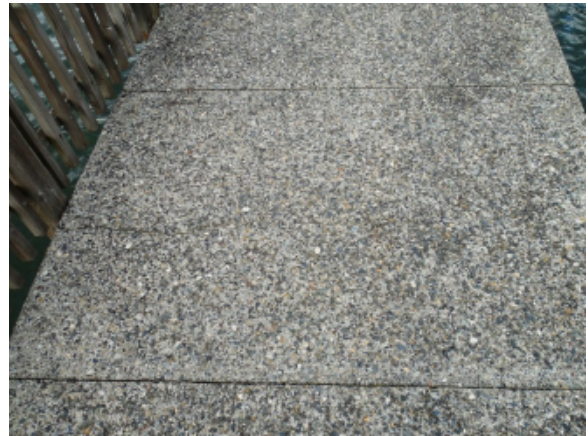
Photo **14C** – Cracked concrete pier slab

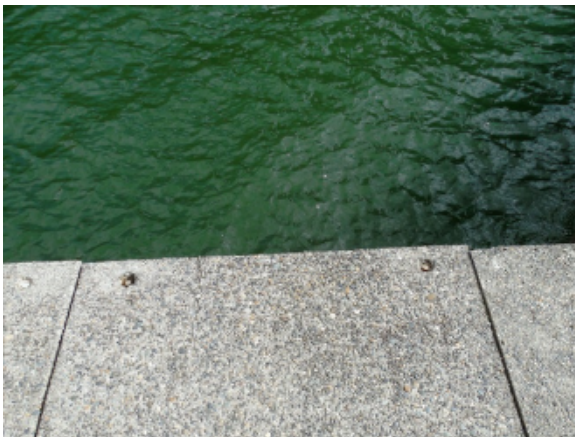
Photo **15C** – Loose slab connections

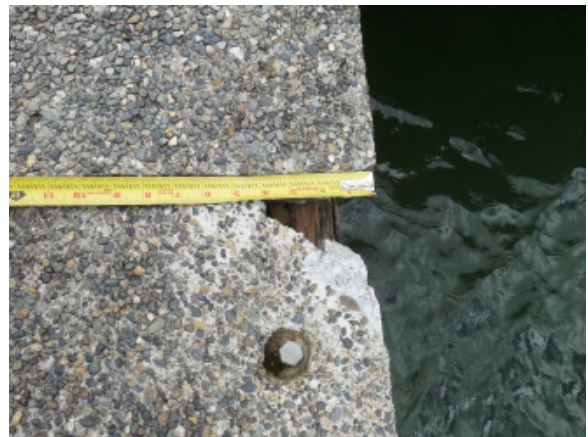
Photo **16C** – Weathered, spalled slab

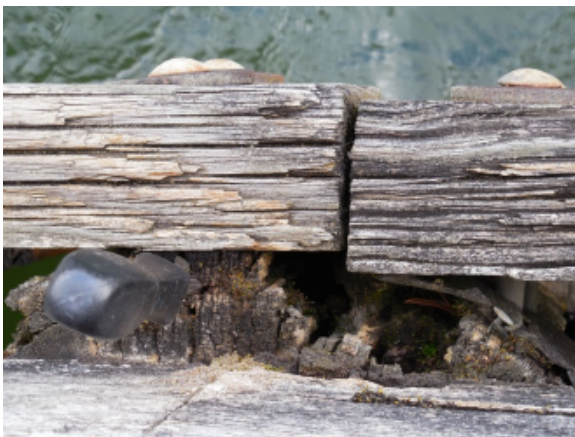
Photo **17C** – Decayed top of pile

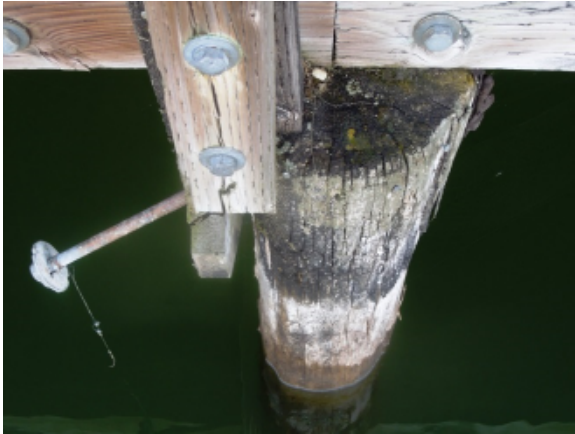
Photo 19C – Loose bracing connector

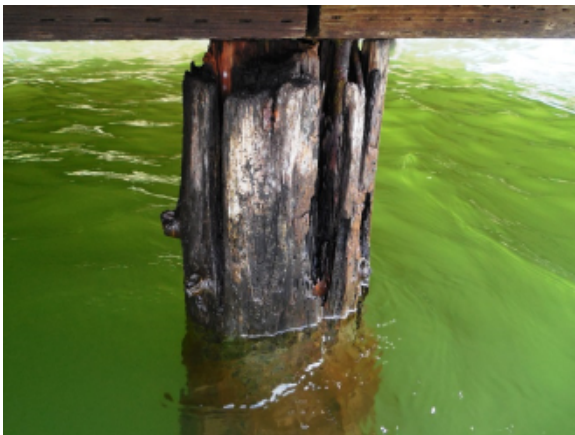
Photo 21C – Severely decayed pile

The decayed piles supporting the two piers at Groveland Park result in diminished load carrying capacity of the structures. These piers should be repaired or replaced in the short-term.

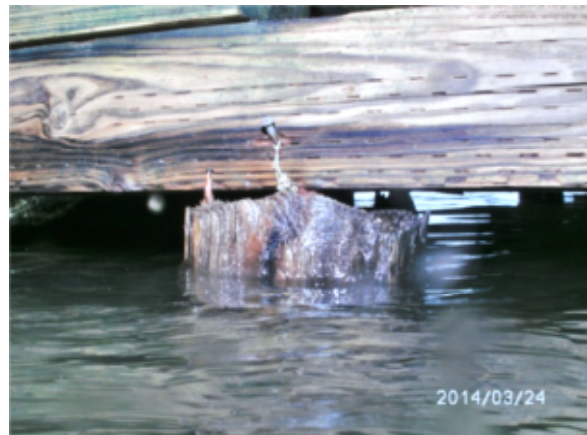
Photo 22C – Severely decayed pile, loss of bearing

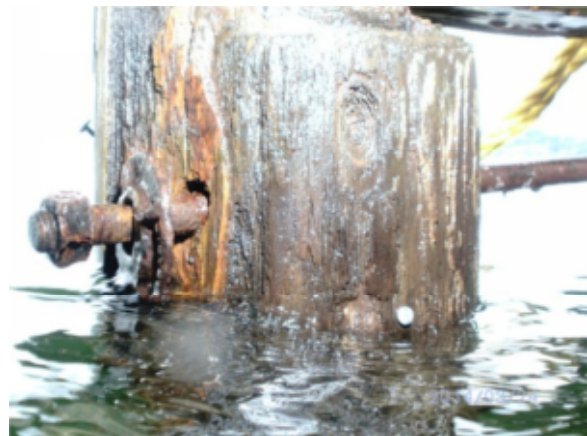
Photo 24C – Decayed pile, loose connection hardware

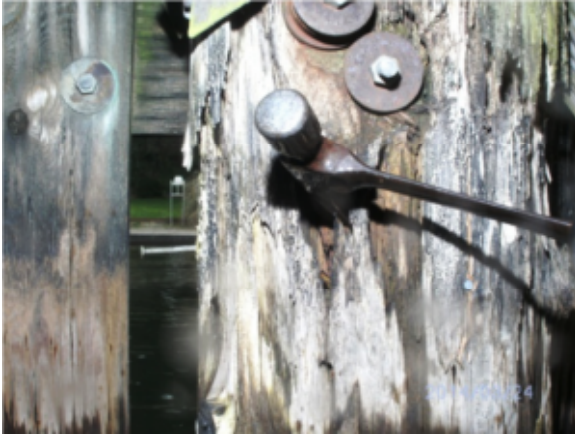
Photo 25C – Decayed pile

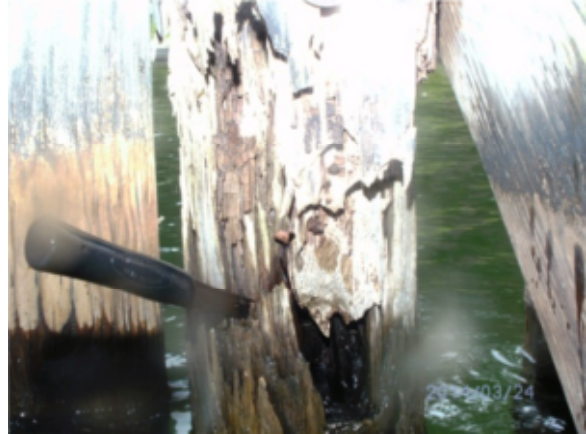
Photo 26C – Decayed pile

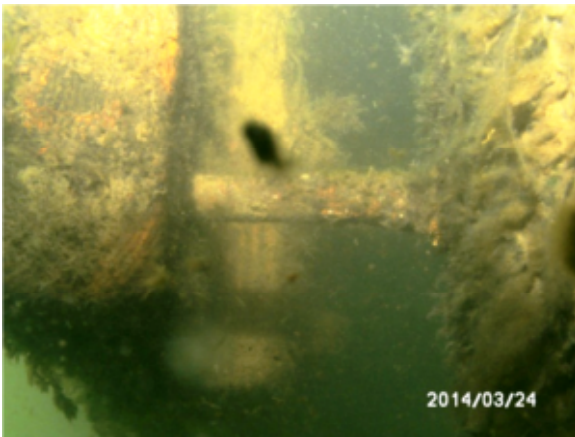
Photo 27C – Corroded fastener

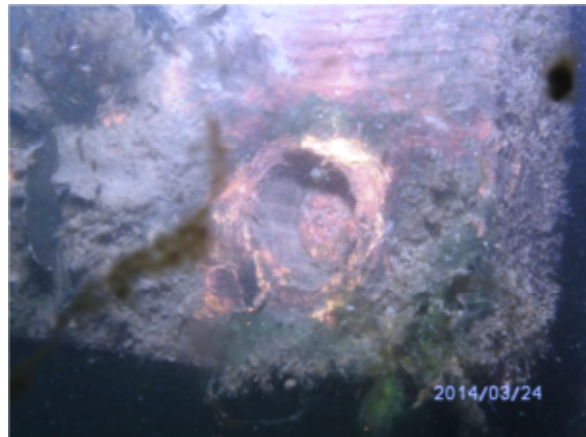
Photo 28C – Corroded fastener

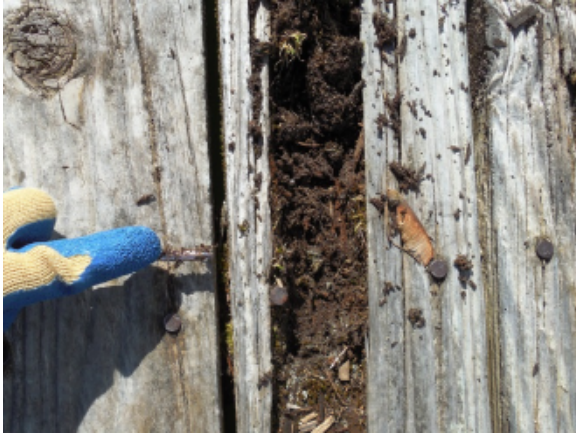
5	Small Pier Superstructure	Wood decking and rails. Decking is weathered / decayed in some areas; limited selective replacement has occurred.	age weathering wood decay	6	6	6	7	5 - 10	Continued selective decking replacement and repair allowance.	\$8,000 - \$10,000	Replace wood decking with proprietary marine grating system.	\$30,000 - \$45,000
	Small Pier Substructure	Construction and condition same as large pier - see notes above (3 of 24 piles have advanced decay; remainder have moderate to advanced)							Repair piles in-place with splicing; repair bracing and stringers as necessary.	15,000 - \$25,000	Allowance for future similar repair work in 10 - 15 years.	\$20,000

Photo 31C – Decayed decking, small pier

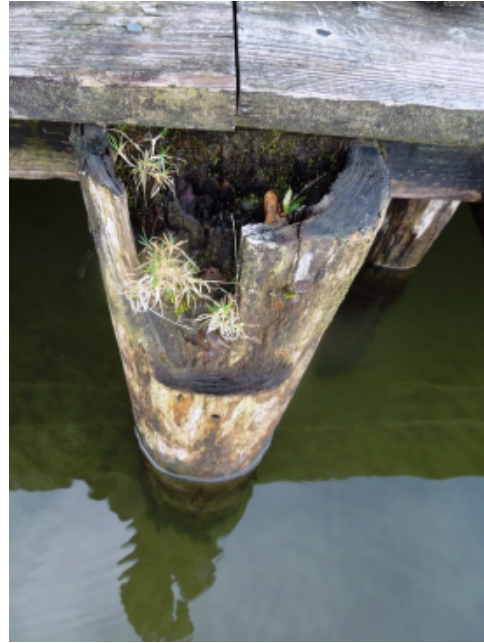
Photo 32C – Decayed pile, small pier
