City of Mercer Island

Americans with Disabilities Act

ADA Transition Plan

2022

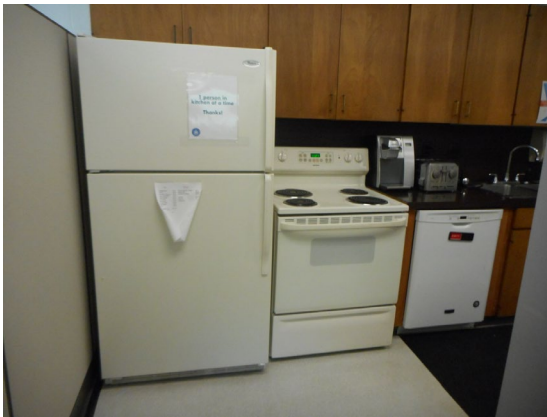
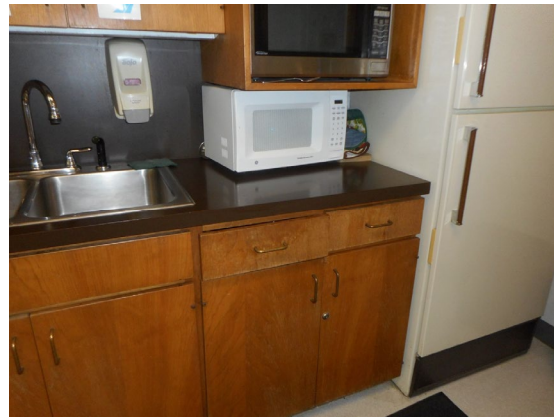
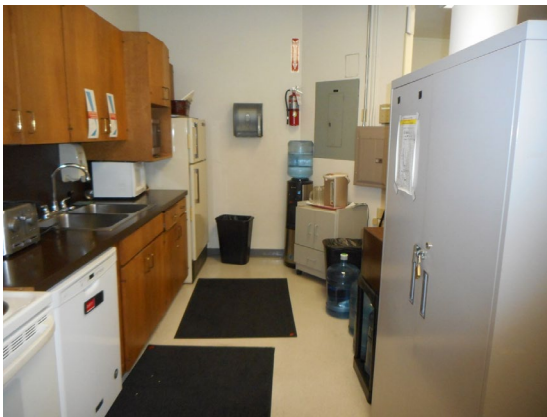
Maintenance Building

- Upper Left: Kitchen range has controls that require a reach over the burners. Kitchens with cooktops require an adjacent work surface with knee & toe space.
- Upper Right: Sink is 36" AFF (34" max. required). Outlets and switches mounted above countertop are not accessible for a side reach due to countertop height & depth.
- Lower Left: Metal cabinets and water bottles block the required turn-around space. Paper towel dispenser and fire extinguisher are mounted too high.

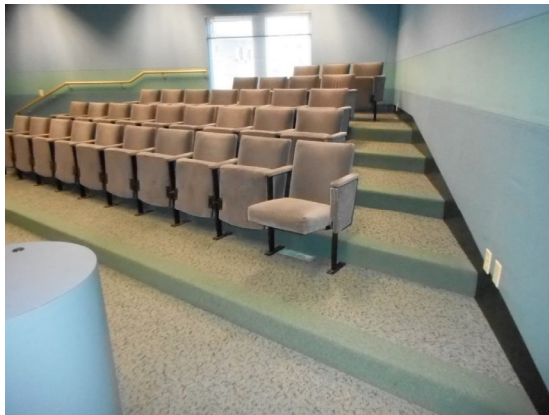
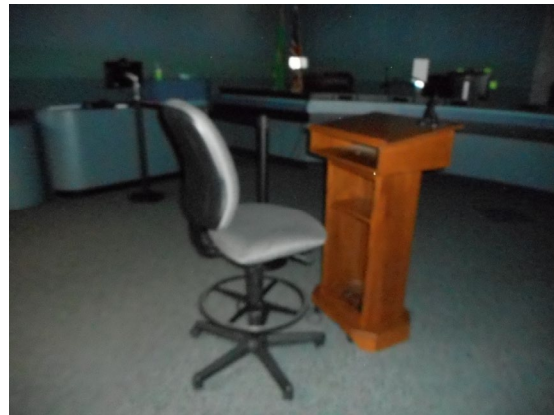
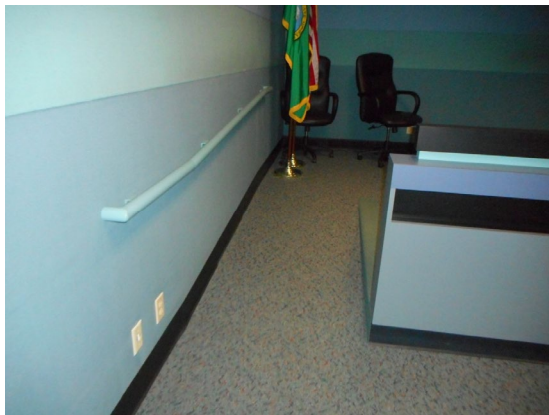
City Hall

- Upper Left: Council Room requires accessible seating adjacent to a companion seat.
- Upper Right: Speaker's podium in Council Room to provide a forward approach to accessible microphone.
- Lower Left: Ramp to judge's platform in Council Room requires additional handrail.

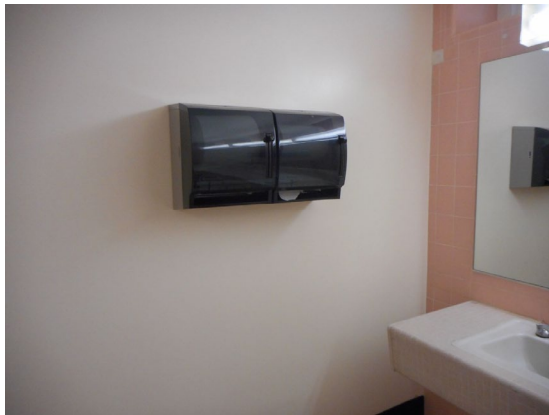
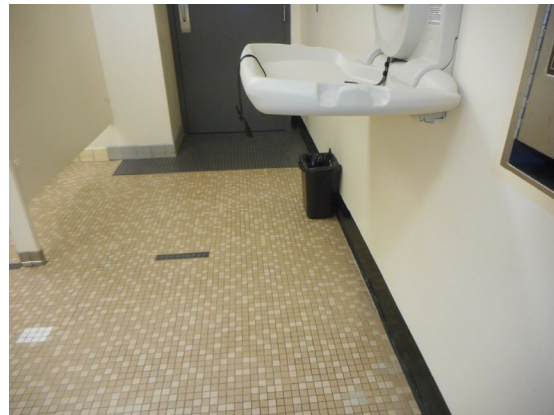
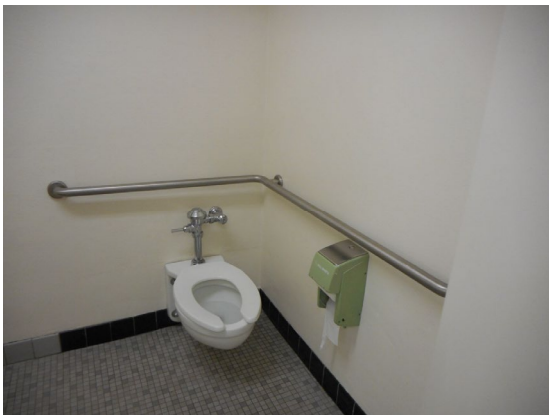
City Hall

- Upper Left: Dispensers present protruding object hazard, requiring relocation or permanent barrier located below.
- Upper Right: Baby changing tables require relocation due to height.
- Lower Left: Wheelchair accessible toilets are required to be 16" min. - 18" max. from side wall. Relocation required at some toilets.

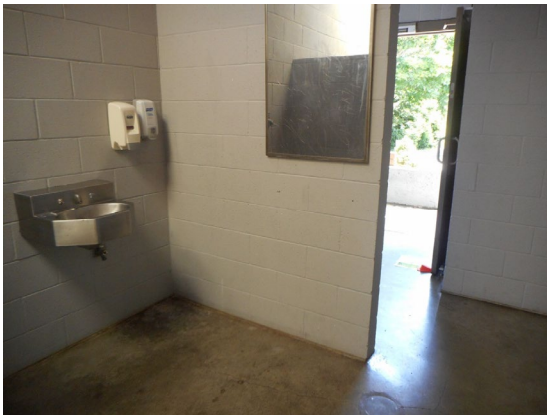
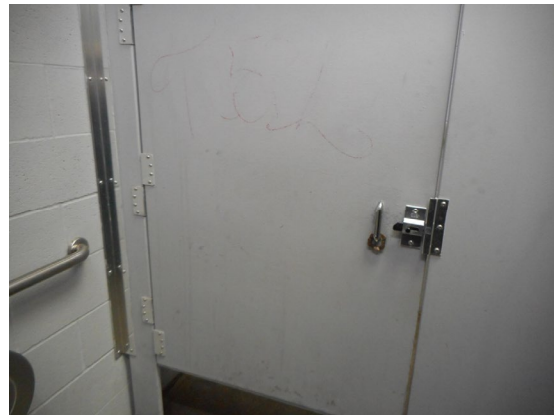
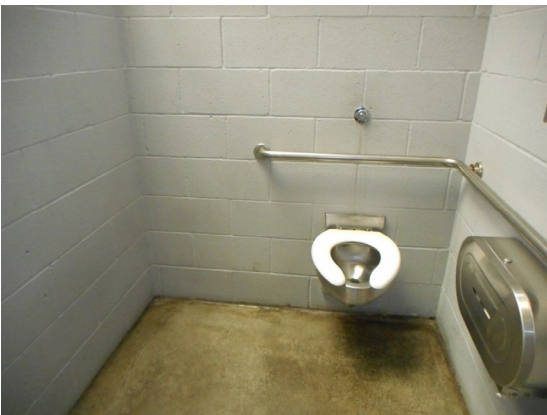
Aubrey Davis Park

- Upper Left: Mirrors in both restrooms by Feroglia Fields should be relocated to above sinks at 40" max. AFF.
- Upper Right: Doors are located on wrong side of accessible stalls at restrooms by Feroglia Fields and should be relocated.
- Lower Left: Flush control in Women's restroom by Feroglia Fields should be repaired or replaced due to operation difficulty.

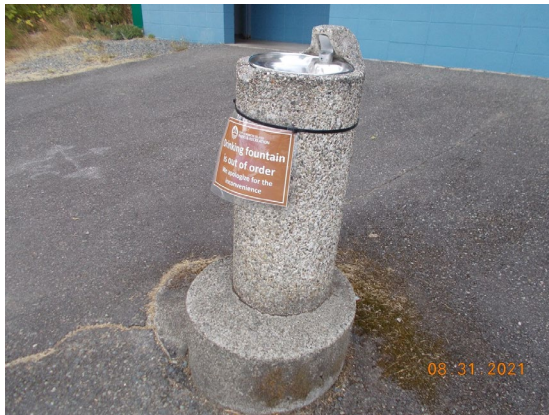
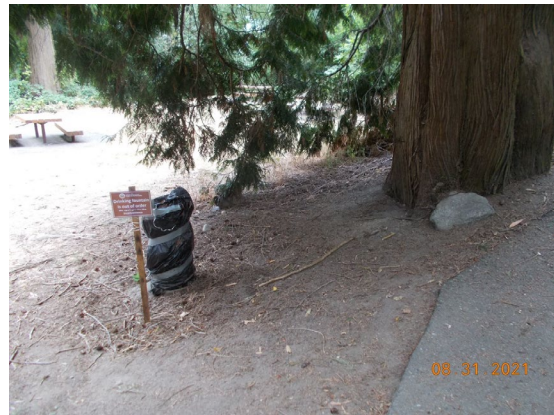
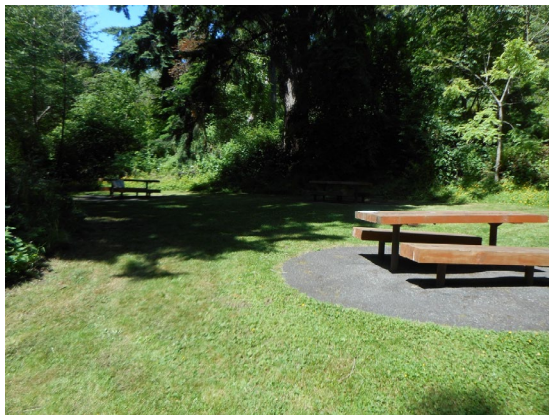
Clarke Beach Park

Upper Left: Hi-low drinking fountain required adjacent to restrooms.

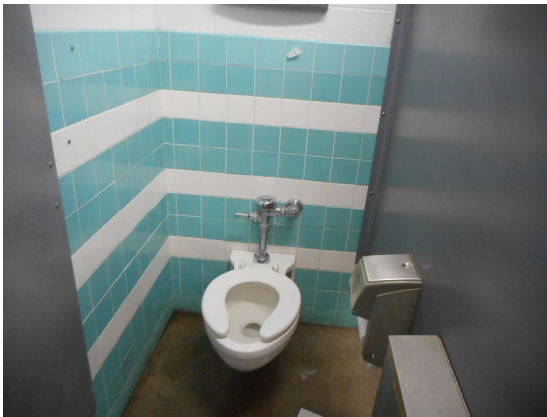
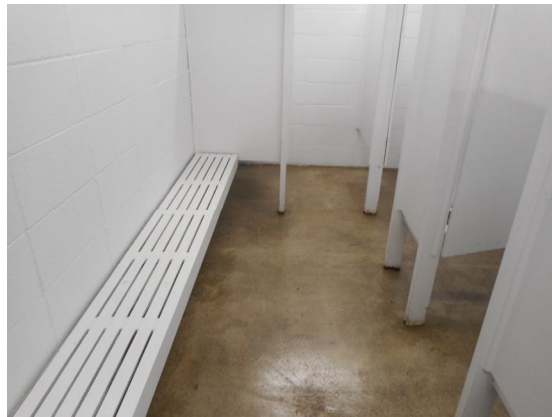
Groveland Beach Park

Upper Left: Restrooms are substantially non-compliant. Accessible stall in the Women's restroom is too small, grab bars are missing, flush control is incorrectly located. The Men's restroom lacks a turn-around.

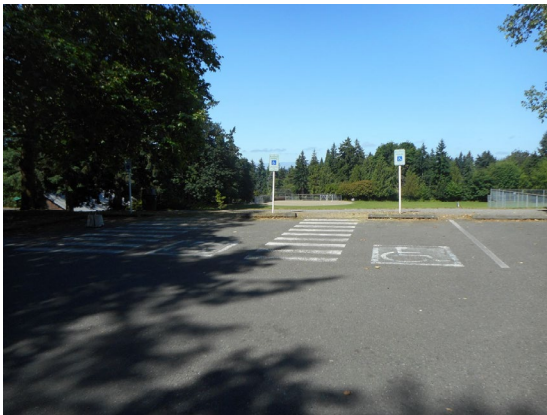
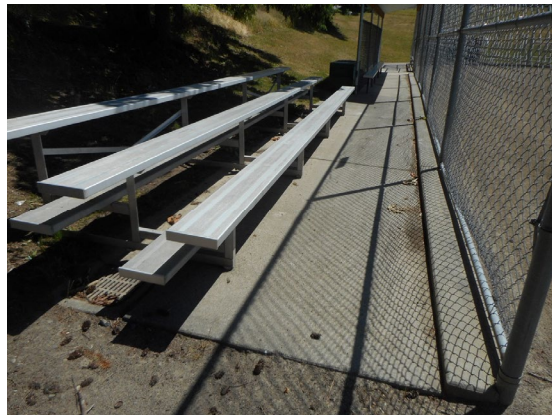
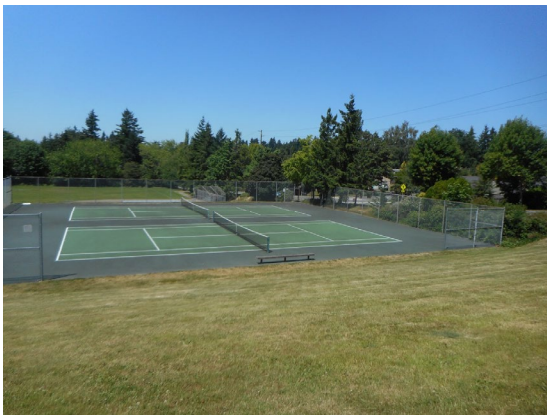
Homestead Park

- Upper Left: Parking signs are mounted too low. Bottom to be 60" min. above paving.
- Upper Right: Bleachers require wheelchair seating (with signage).
- Lower Left: Tennis courts lack an accessible route.

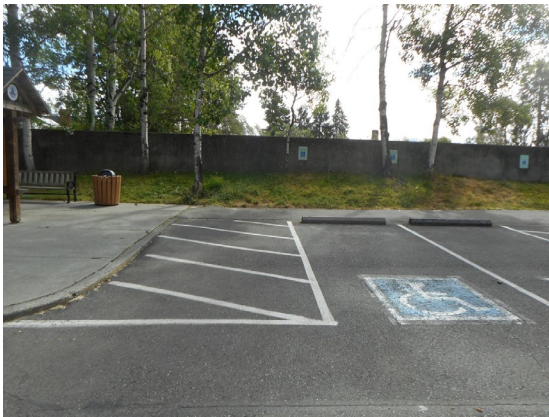
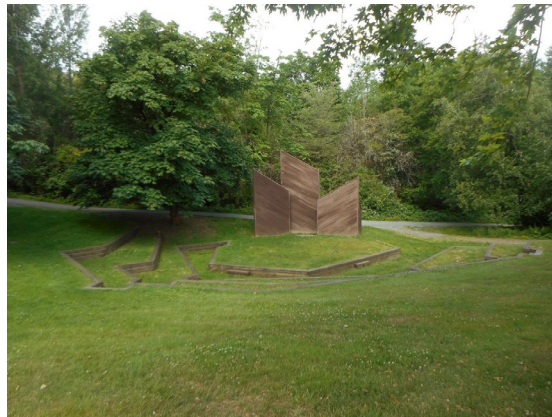
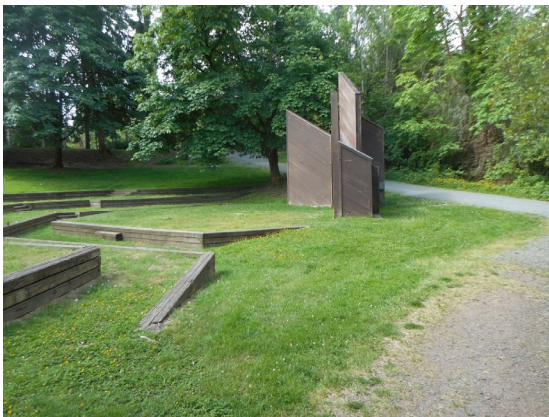
Luther Burbank Park

- Upper Left: Accessible parking signs are mounted too low (and too far from stall). Provide pole mounted signs at head of stalls.
- Upper Right: Amphitheatre lacks an accessible route to seating area and stage.
- Lower Left: There are no accessible seating areas in the Amphitheatre. Wheelchair accessible area next to a companion seat could be accommodated near paths on both sides of stage.

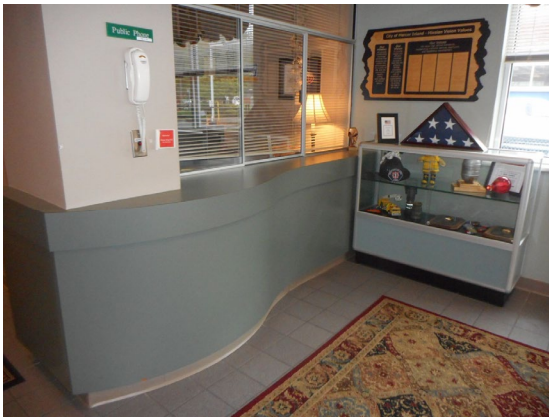
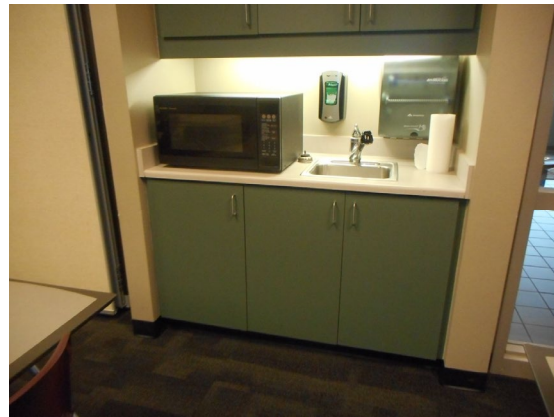
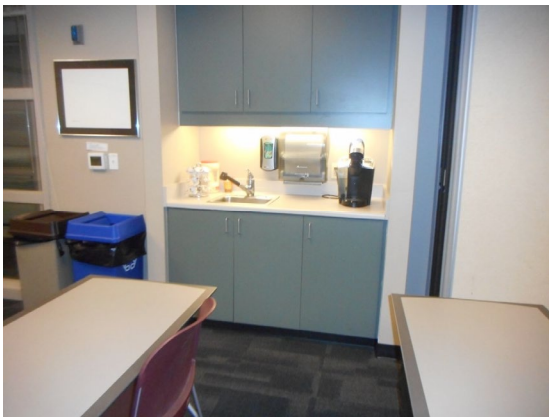
Main Fire Station #91

- Upper Left: Service counter accommodates clear floor space, but curved configuration prevents a parallel approach.
- Upper Right: Meeting room has a movable partition divider, separating it into 2 rooms. Each of these rooms has a wet bar with a sink at 36" AFF. Sinks are required to be 34" max. AFF.
- Lower Left: See above.

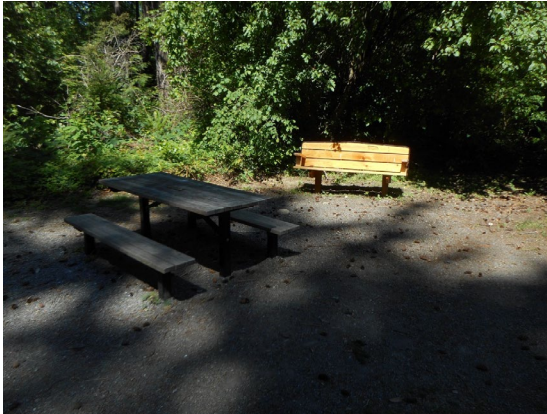
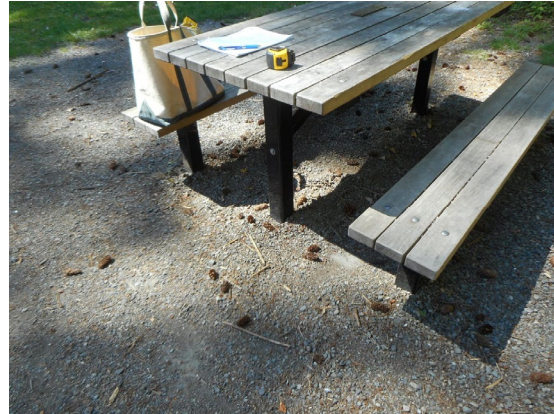
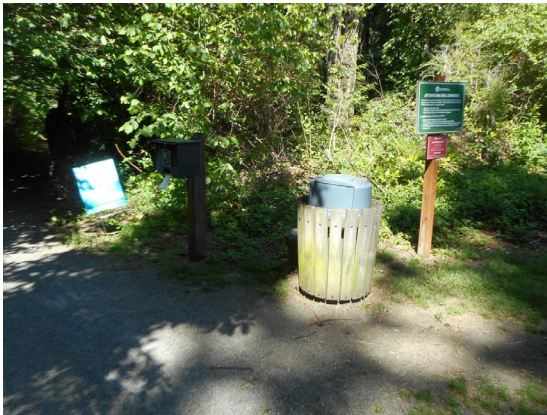
Pioneer Park

- Upper Left: Accessible routes are required to accessible picnic tables and benches.
- Upper Right: Picnic tables do not provide an accessible seat and clear floor space.
- Lower Left: Clear floor space and accessible route is required at min. 5% of dog waste and trash receptacles.

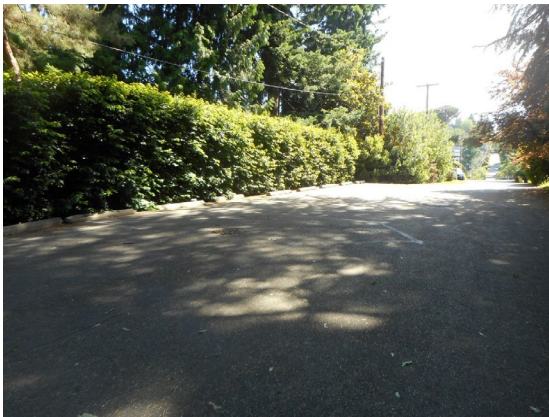
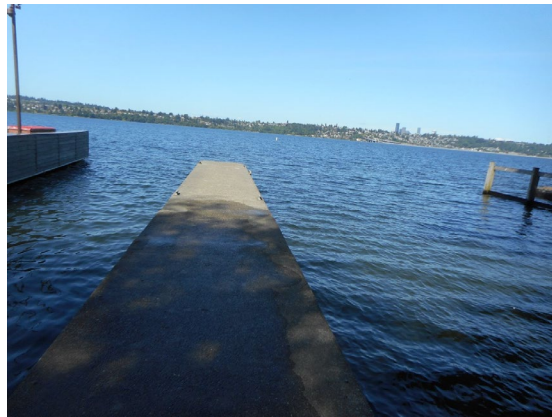
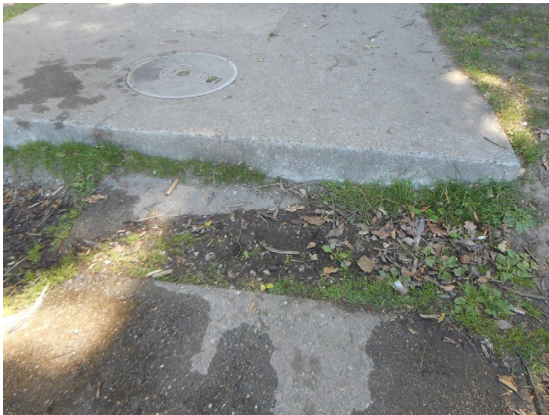
Proctor Landing

Upper Left: 12 parking spaces; no accessible parking is provided.

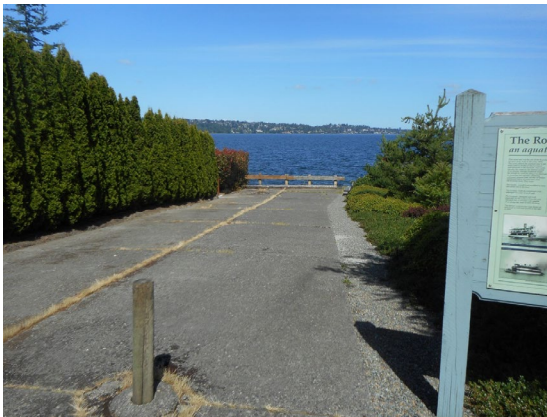
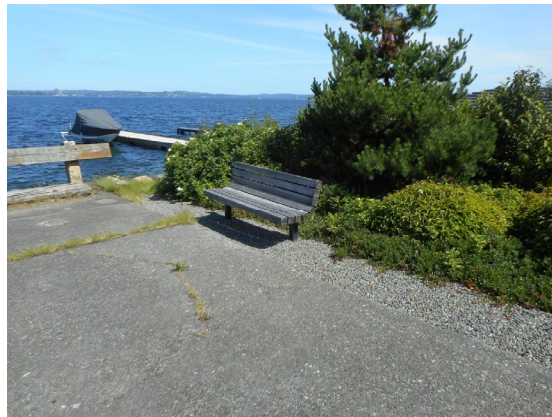
Roanoke Landing

- Upper Left: Roanoke Landing. I
- Upper Right: The bench requires an adjacent clear floor space (concrete pad) at one end. Loose gravel is adjacent to each side of the bench.
