SEWER PUMP STATION CONDITION ASSESSMENT REPORT

Prepared for the City of Mercer Island

January 2024

RH2 Engineering, Inc.

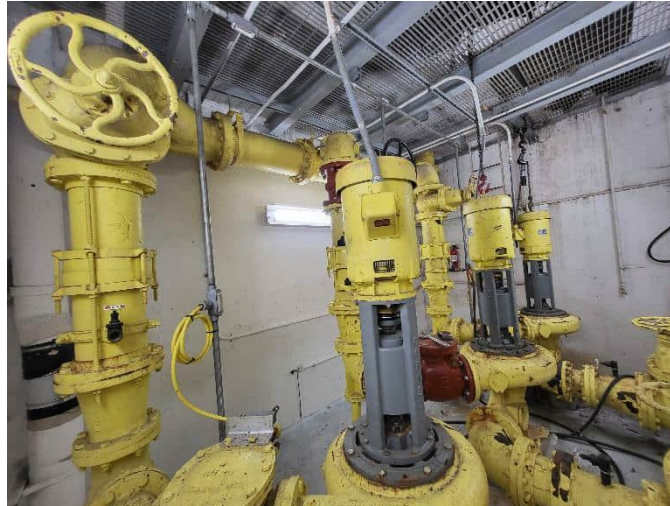
- **The valves are old and in poor condition.** The gate and check valves are all original and are almost 60 years old. The valves do not operate properly and sometimes leak. Additionally, the paint is peeling on the piping in the dry well.

Photo of PS 19 pumps, valves, and fittings on dry well lower level.

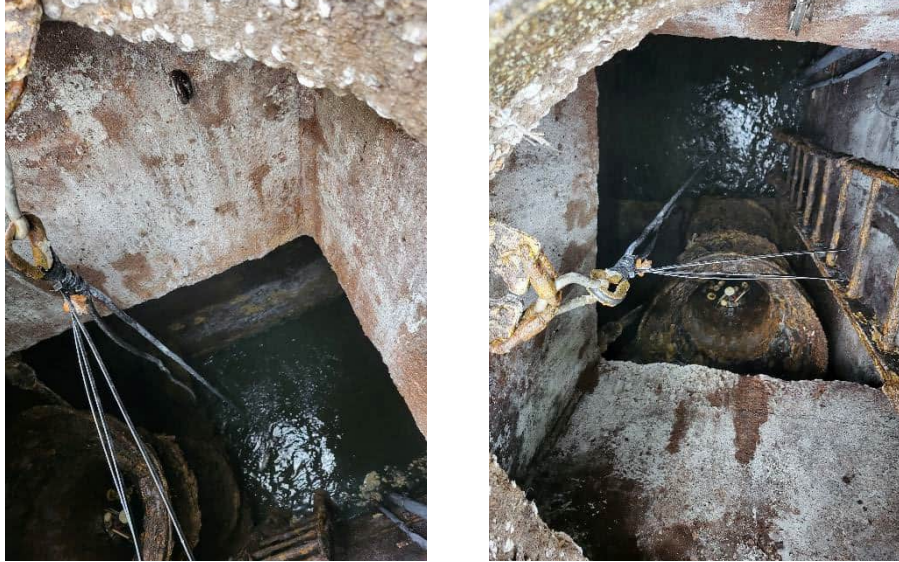
- **The concrete in the wet well is in poor condition.** The concrete in the wet well is showing signs of corrosion.

Photos of PS 19 wet well concrete condition.

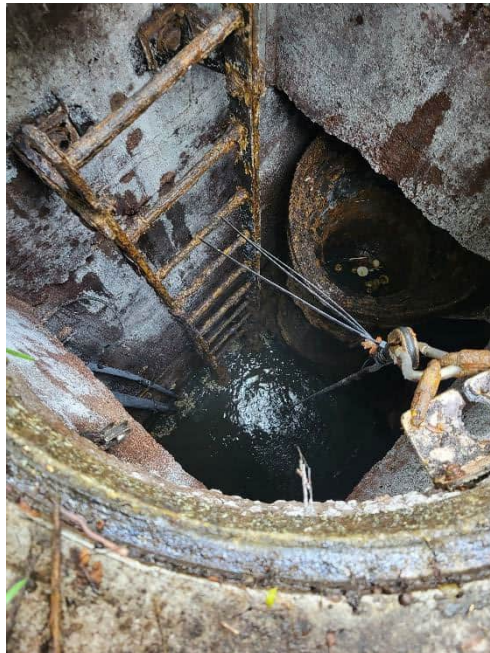
- **The wet well access ladder is in poor condition.** The ladder in the wet well has corroded noticeably.

Photo of PS 19 wet well ladder.

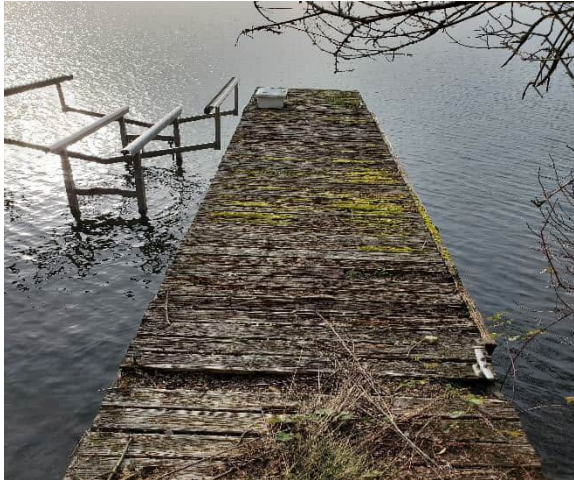
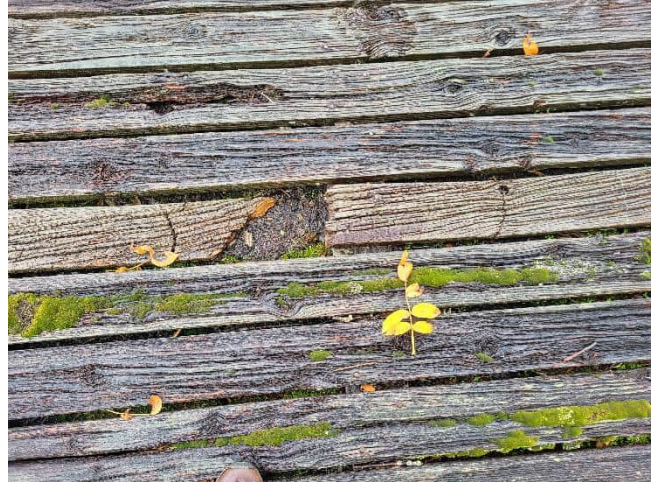
- **Odor complaints.** According to City staff, there have been odor complaints about this PS and PS 21.
- **The wood decking on the dock is showing signs of rotting.** The concrete under the wooden dock is in good condition, but the condition of the piles for the dock is not known.

Photos of wooden decking on top of dock at PS 19.

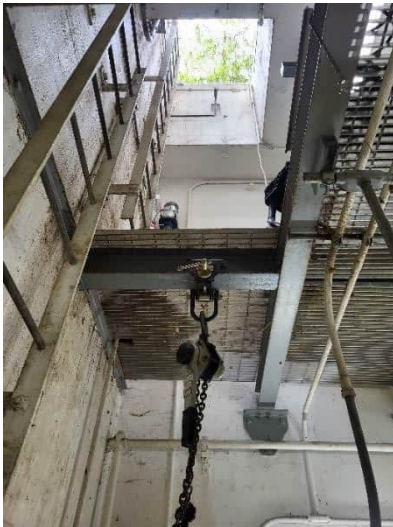
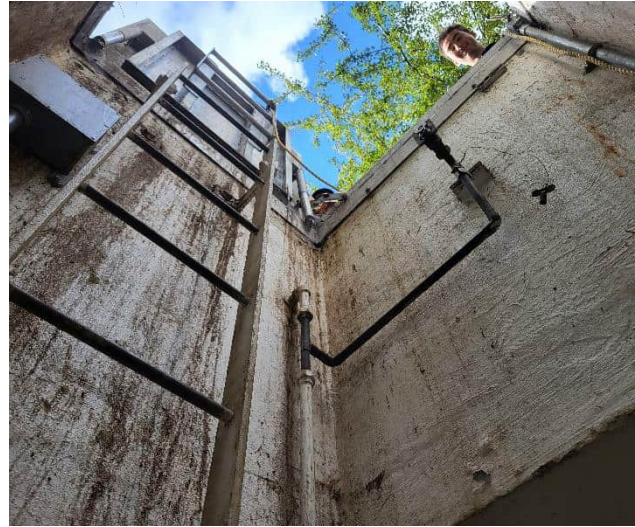
- **The grating platform in the dry well is old.** The existing grating is all original and almost 60 years old. The grating is deformed in places, and the grating hatch (to the dry well lower level) rubs against an electrical conduit when it is opened and closed. City staff have indicated that they would like the grating platform replaced since it is deformed in places and the grating hatch can be difficult to open and close.

Existing PS 19 grating and ladders in dry well (left). Existing condition of PS 19 dry well entrance (right).

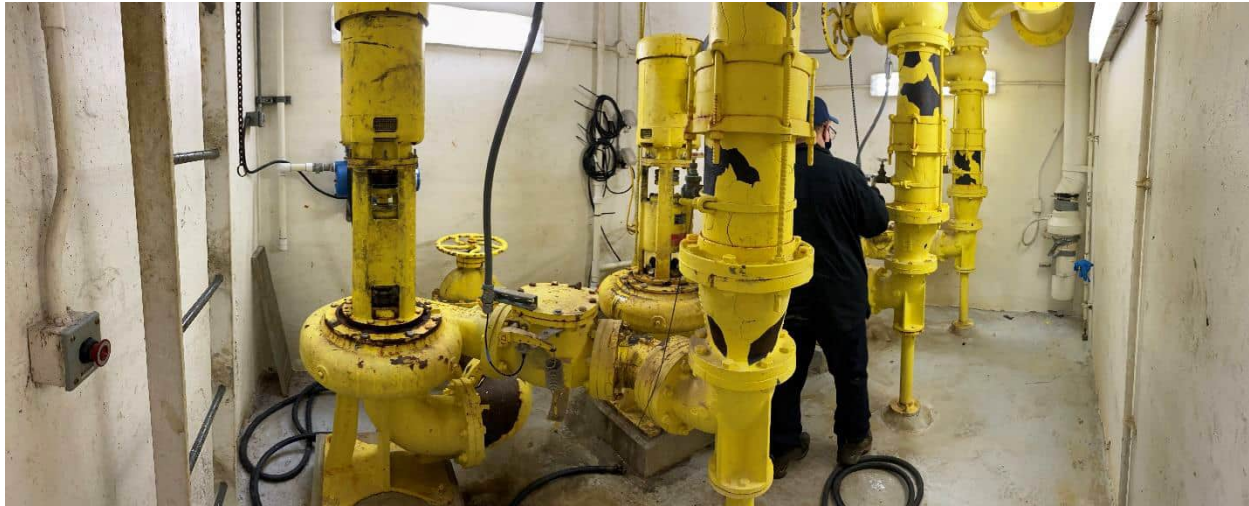
- **The valves are old and in poor condition.** The gate and check valves are all original and almost 60 years old. The gate valves are prone to breaking, and the check valves need to be replaced. Additionally, the paint on the piping is peeling in the dry well.

Photo of PS 20 pumps, valves, and fittings on dry well lower level.

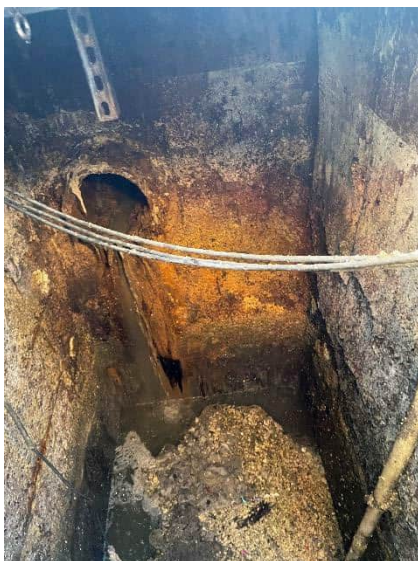
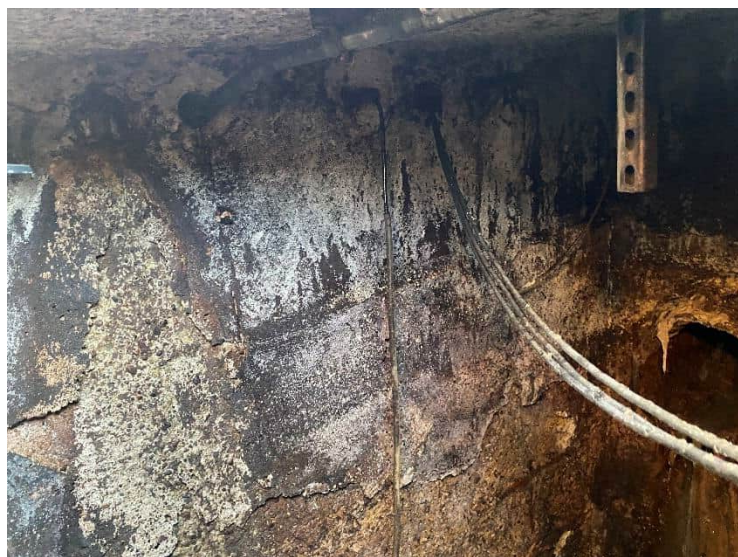
- **There is no flow meter or pressure gauge.** There is not enough straight piping to install a meter and accurately monitor pumped flow rates or discharge pressures for the pumps.
- **The concrete in the wet well is in poor condition.** The concrete in the wet well has corroded noticeably, and the rebar is exposed in several places.

Photos of PS 20 wet well concrete condition and exposed rebar.

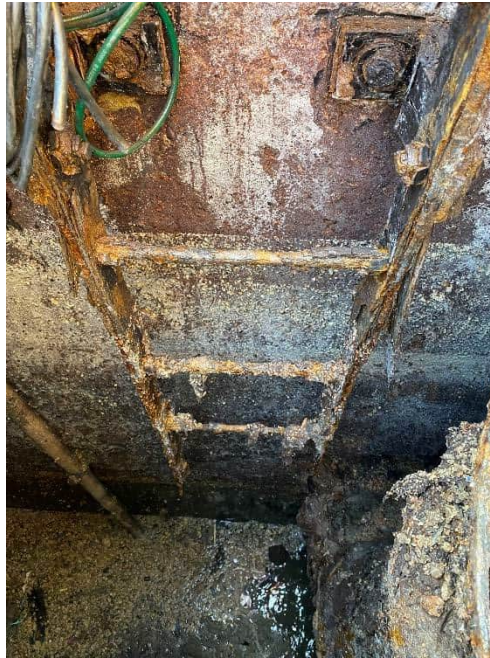
- **The wet well access ladder is in poor condition.** The ladder in the wet well has corroded noticeably and the lower portion of the ladder is missing.

Photo of PS 20 wet well ladder with missing rungs and signs of metal and concrete corrosion.

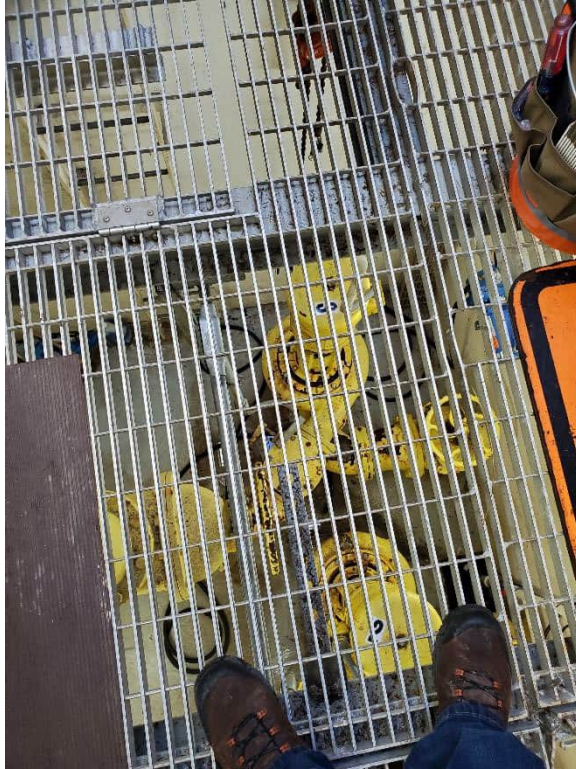
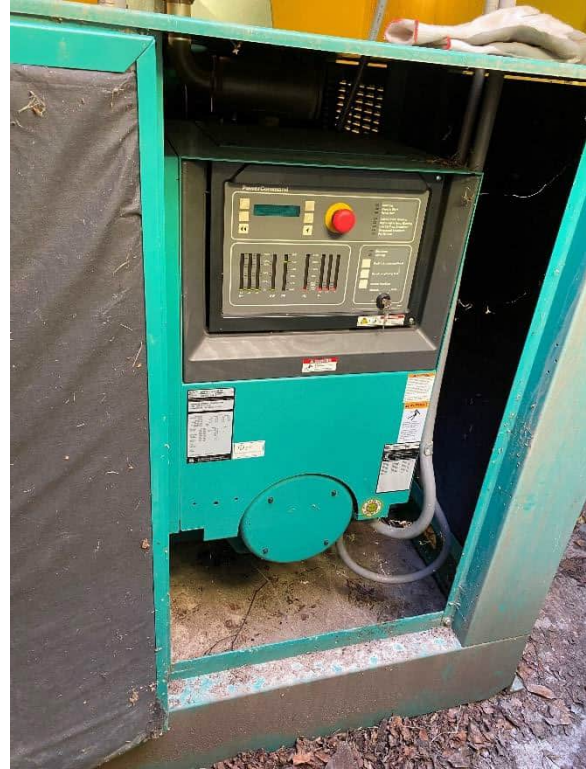
- **The wet well does not have a vent to allow air discharge and supply.**
- **The motor control panels are old and parts are unavailable.** The motor control panels are almost 30 years old, and the manufacturer has said the parts are obsolete and no longer available according to City staff.
- **The distribution panels, circuit breakers, and conductors are almost 30 years old and have reached the end of their lifespan.**
- **There currently is no way to monitor the water level in the HGMH or how much flow recirculates through the HGMH back to this pump station.**
- **The grating platform in the dry well is old.** The existing grating is all original and almost 60 years old. City staff have indicated they would like the grating platform replaced since it is deformed in places and the grating hatch (to the dry well lower level) can be difficult to open and close.

Existing PS 20 dry well grating (left). PS 20 below-grade, on-site diesel generator (right).

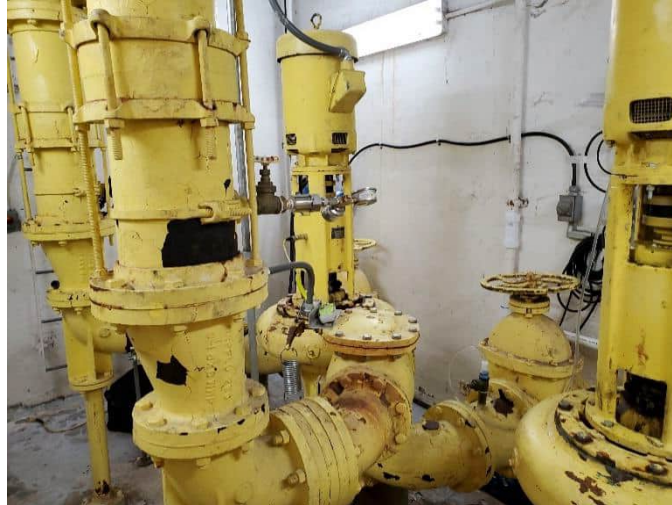
- **The pumps are in poor condition and have excessive vibration.** The determined pumping capacity for each pump from the pump tests are less than the design pump capacity. The pumps are almost 30 years old and rag multiple times per year. According to the PumpTech Service Report(s), vibration readings taken during the site visit on Pumps 1 and 2 exceeded the lateral vibration limit for continuous operation.
- **Valves are old and in poor condition.** The gate and check valves are all original and almost 60 years old. The gate valves are prone to breaking, and one of the check valves needs to be replaced. Additionally, the paint is peeling on the piping in the dry well.

Photo of PS 21 pumps, valves, and fittings on dry well lower level.

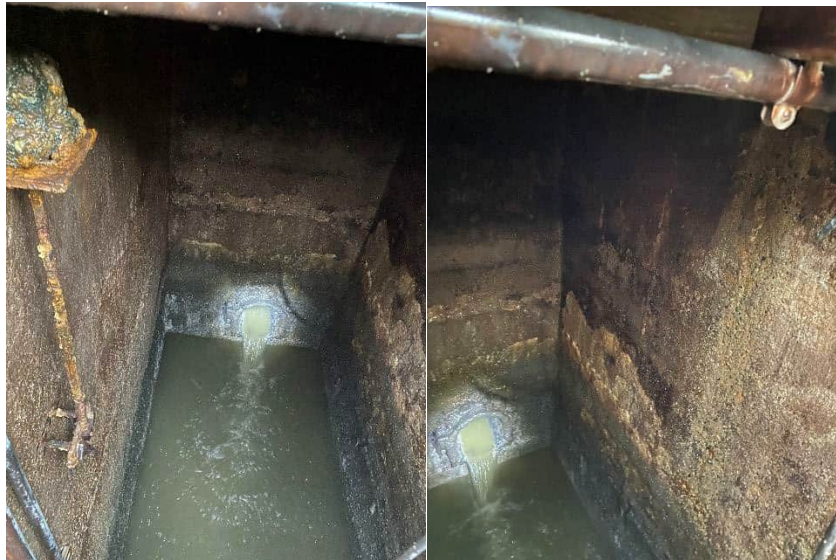
- **There is no flow meter or pressure gauge.** There is no way to monitor pumped flow rates or discharge pressures for the pumps.
- **The concrete in the wet well is in poor condition.** The concrete in the wet well is showing signs of corrosion.

Photos of PS 21 wet well concrete condition.

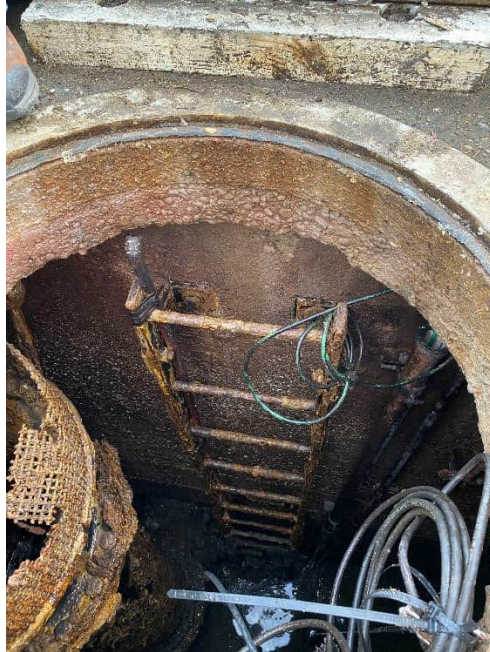
- **The wet well access ladder is in poor condition.** The ladder in the wet well has corroded noticeably.

Photo of PS 21 wet well ladder.

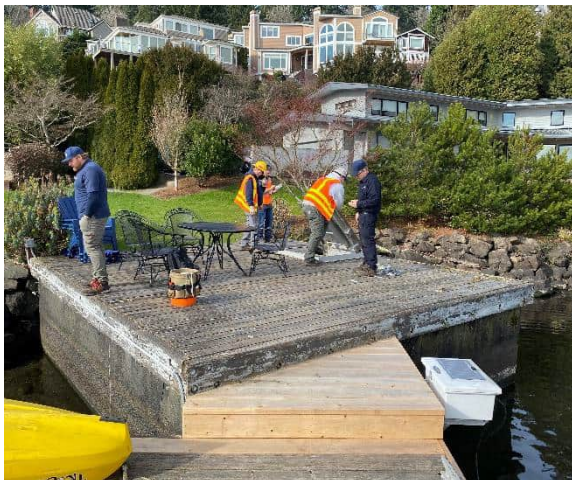
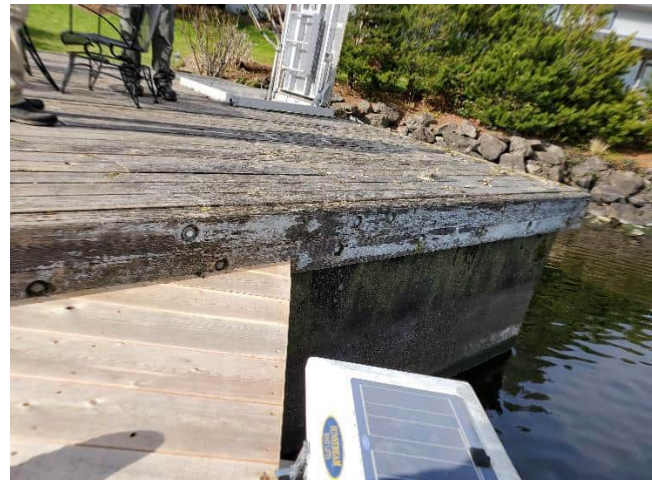
- **The wet well does not have a properly operating vent to allow air discharge and supply.** According to City staff, the sand filter for the ventilation system has failed. Due to the lack of a properly operating vent supply, the wet well maintenance hole lid can be difficult to open at times when the pumps are running according to City staff.
- **Odor complaints.** According to City staff, adjacent residents complain about odor from this PS.
- **The wood decking on the dock is showing signs of rotting.**

Photos of dock on top of PS 21.

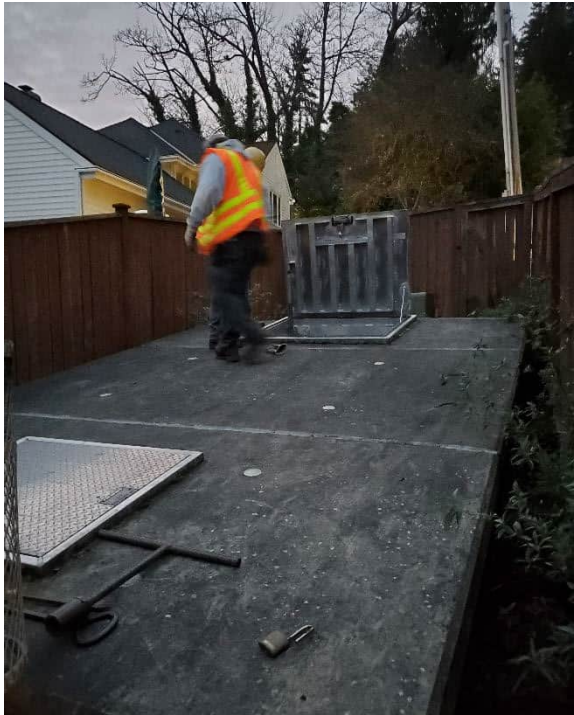
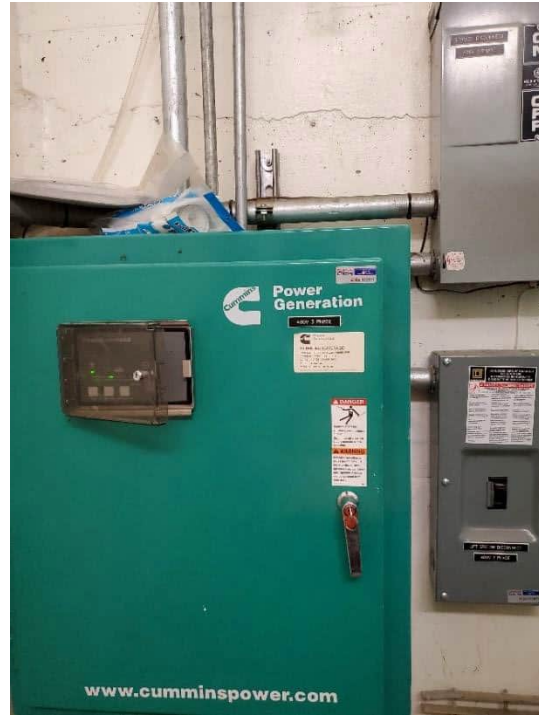
- The distribution panels, circuit breakers, and conductors are almost 30 years old and have reached the end of their lifespan.
- The water level in the HGMH cannot be monitored and cannot measure how much flow recirculates through the HGMH back to this PS.
- This PS has a 3-phase converter in a panel near the generator. Only two phases of overhead power from Puget Sound Every (PSE) serve this PS.

PS 21 upland generator access (left). PS 21 existing Cummins generator ATS (right).

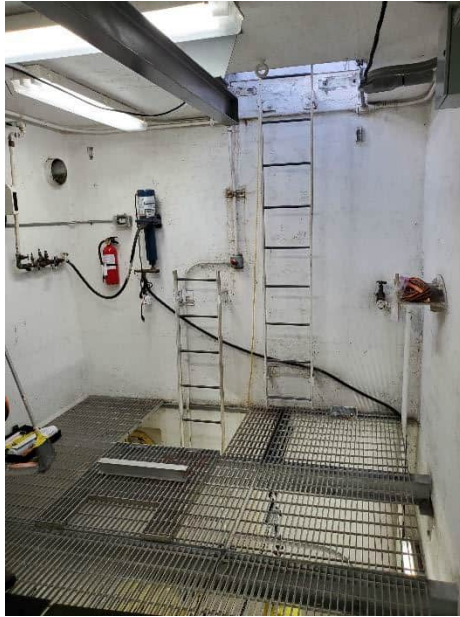
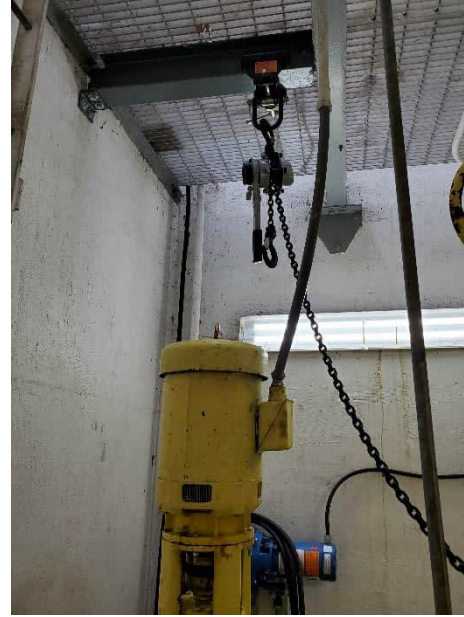
- **The grating platform in the dry well is old.** The existing grating is all original and almost 60 years old. City staff have indicated they would like the grating platform replaced since it is deformed in places and the grating hatch (to the dry well lower level) can be difficult to open and close.

Existing PS 21 dry well grating and ladders (left). Existing PS 21 lighting in dry well (right).

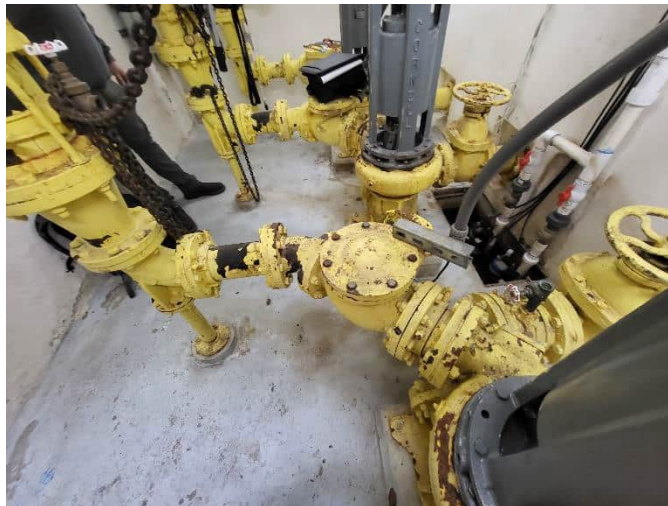
- **The pumps are in poor condition.** The determined pumping capacity for each pump from pump tests are less than the design pump capacity. The pumps are almost 30 years old and clog multiple times per year. According to the PumpTech Service Report, vibration readings taken during the site visit on Pump 1 are elevated, and one reading is above Hydraulic Institute's limit.
- **The valves are old and in poor condition.** The gate and check valves are all original and almost 60 years old. The valves do not operate properly and sometimes leak. Additionally, the paint is peeling on the piping in the dry well.

Photo of PS 22 pumps, valves, and fittings on dry well lower level.

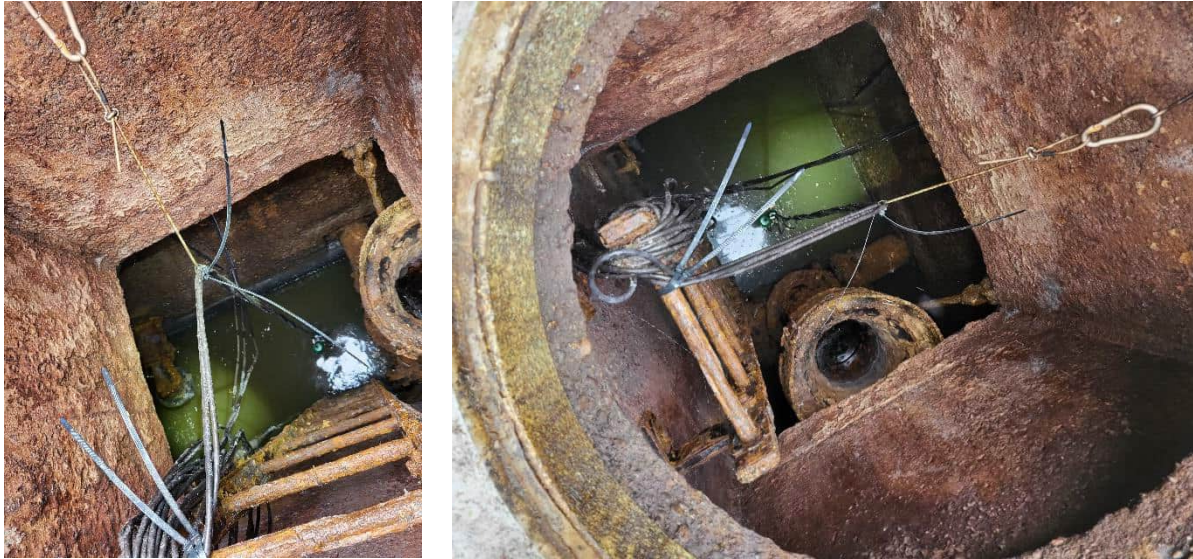
- **The flushing system is old and not in operation.** The plug and gate valves are original and almost 60 years old. The air actuator for the flush valves has failed, and the City made the plug valve inoperable over 15 years ago. The actuator and the plug valve need to be replaced.
- **The concrete in the wet well is in poor condition.** The concrete in the wet well is showing signs of corrosion.

Photos of PS 22 wet well concrete condition.

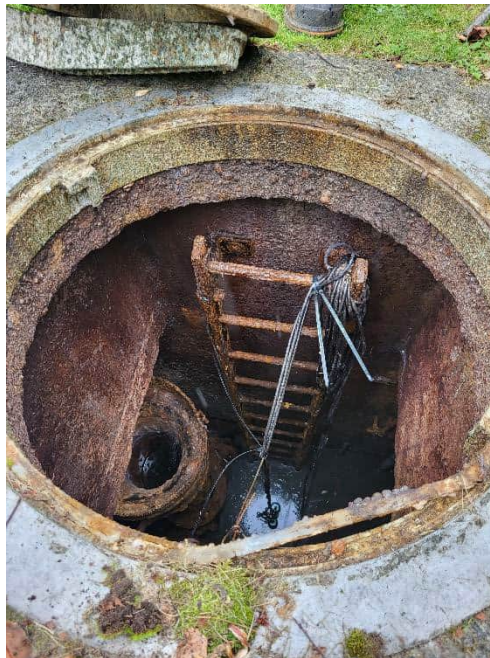
- **The wet well access ladder is in poor condition.** The ladder in the wet well has corroded noticeably.

Photo of PS 22 wet well ladder.

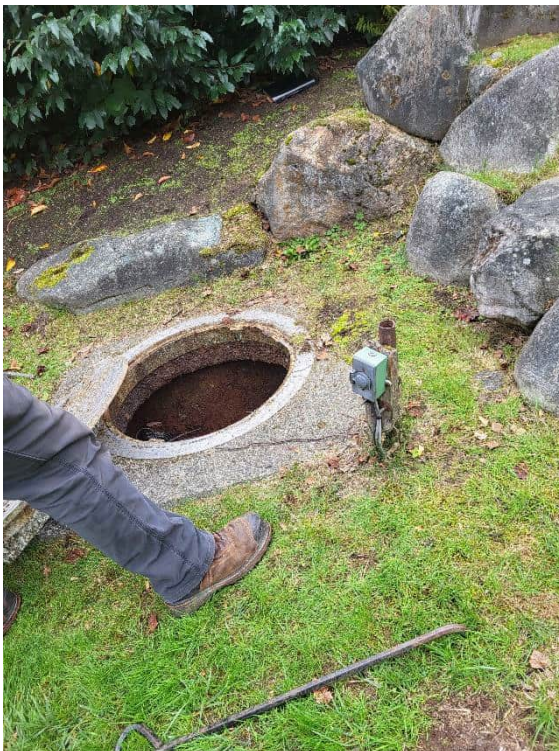
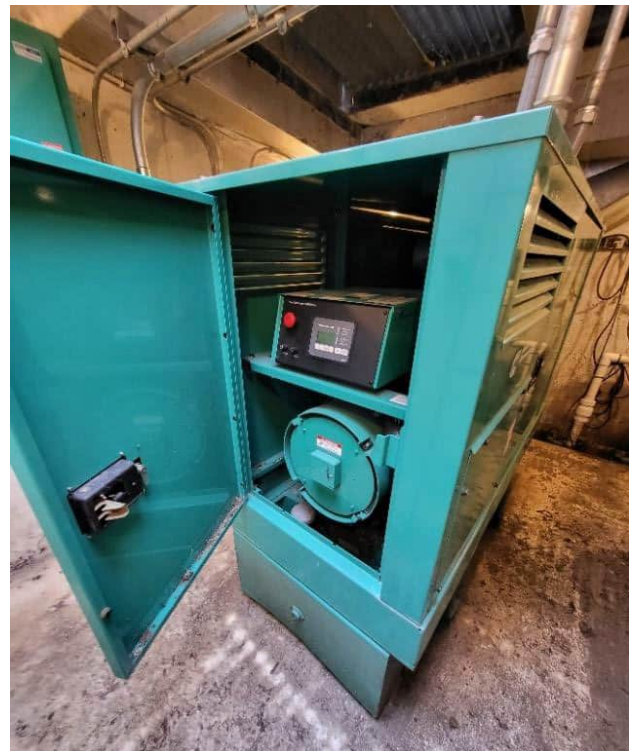
- **There is currently no way to monitor the water level in the HGMH or how much flow recirculates through the HGMH back to this pump station**
- **The grating platform in the dry well is old.** The existing grating is all original and almost 60 years old. City staff have indicated they would like the grating platform replaced since it is deformed in places and the grating hatch (to the dry well lower level) can be difficult to open and close.

PS 22 exterior electrical switch (left). PS 22 existing below-grade generator (right).

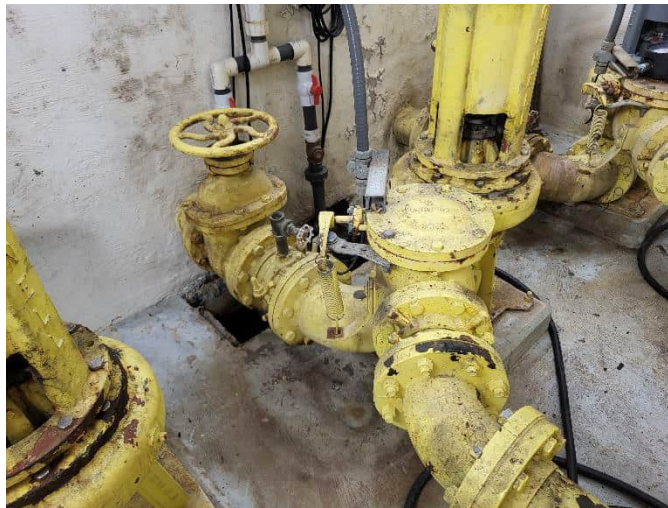
- **The pumps are in poor condition.** The determined pumping capacity for each pump from pump tests are less than the design pump capacity. The pumps are almost 30 years old and clog multiple times per year. According to the PumpTech Service Report, one of the vibration readings taken on Pump 2 during the site visit was high enough to trigger a warning level and should be monitored.
- **The valves are old and in poor condition.** The gate and check valves are all original and almost 60 years old. The valves do not operate properly and sometimes leak. Additionally, the paint is peeling on the piping in the dry well.

Photo of PS 23 pumps, valves, and fittings on dry well lower level.

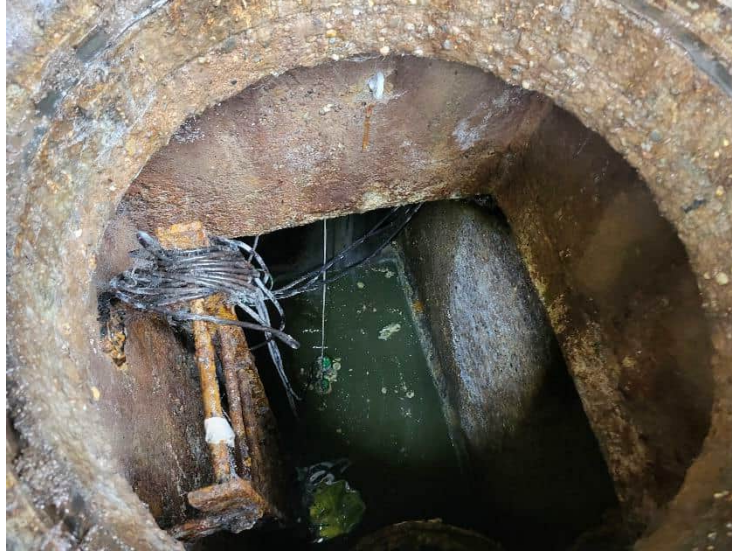
- **There is no flow meter or pressure gauge.** There is not enough straight piping to install a meter and accurately monitor pumped flow rates or discharge pressures for the pumps.
- **The concrete in the wet well is in poor condition.** The concrete in the wet well is showing signs of corrosion.

Photo of PS 23 wet well concrete condition.

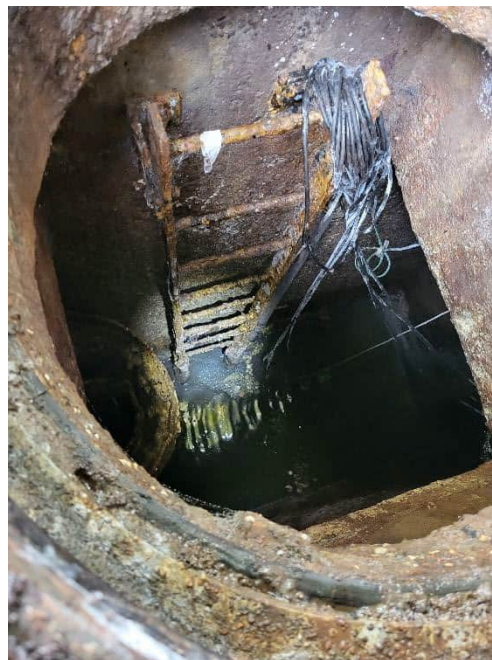
- **The wet well access ladder is in poor condition.** The ladder in the wet well has corroded noticeably.

Photo of PS 23 wet well ladder.

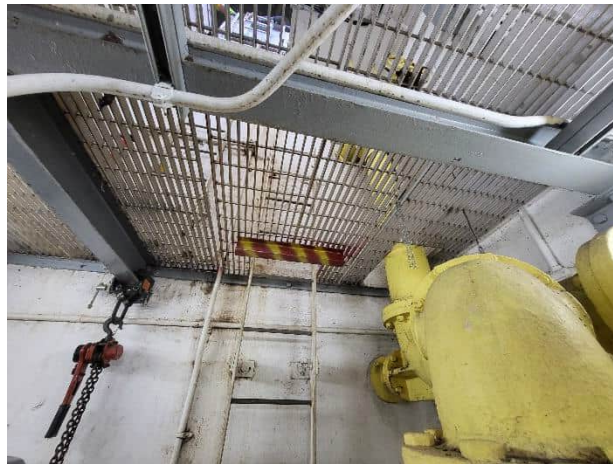
- **There is currently no way to monitor the water level in the HGMH or how much flow recirculates through the HGMH back to this pump station.**
- **The grating platform in the dry well is old.** The existing grating is all original and almost 60 years old. The grating is deformed in places, and the grating hatch (to the dry well lower level) rubs against an electrical conduit when this hatch is opened and closed. City staff have indicated they would like the grating platform replaced since it is deformed in places and the grating hatch can be difficult to open and close.

Existing PS 23 dry well grating.
