PS 10 VEGETATION MANAGEMENT - SITE PLAN

PS 19 VEGETATION MANAGEMENT - SITE PLAN

SUBJECT: Capital Improvement Project
PS 10, PS 19 Tree Evaluation
9042 N. Mercer Way, 7697 W. Mercer Way

PURPOSE: A) Management recommendations for trees and vegetation obstructing pump station access, and
B) Risk assessment of trees within striking range of pump station

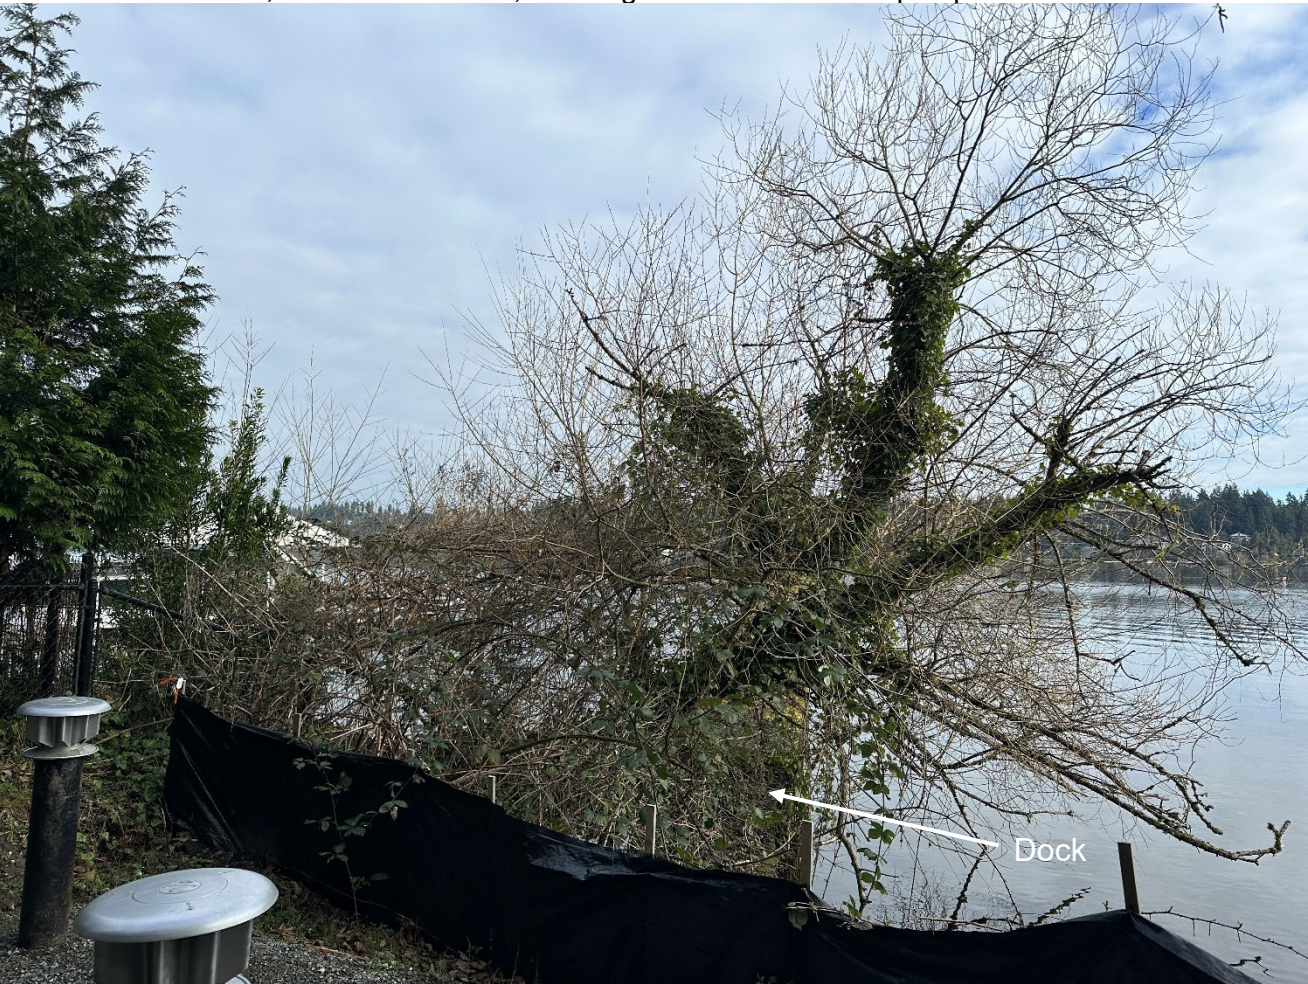
Tree #172: A partially failed Scouler's willow (*Salix scouleriana*) was leaning across the dock for the station. I estimated the tree had a 14-inch diameter. Every primary stem had previously failed and the crown consisted entirely of new sprouts (Photo 1). The trunk may have been in contact with the dock and therefore partially supported by the structure. Although it had very poor form and structure,

the tree had good health and it was viable. Clearing the tree from the dock will necessitate cutting the main trunk below most of the crown.

Photo 1. Tree #172, a Scouler's willow, blocking dock access to the pump station.

PS 10: Tree #172, the Scouler's willow over the dock and **tree #173**, the bigleaf maple fallen in the water next to the dock should be removed to provide access. Both trees have limited ecological function at this point relative to a tree with better form. The leaning red alder, **tree #174**, had a low risk rating and it should be retained. The branches overhanging the dock should be pruned back to the trunk. The ivy on the tree should be controlled. **Tree #176**, the declining western red cedar, should be converted to a wildlife snag to mitigate risk. A 10-foot tall snag will provide some wildlife habitat for birds and insects.

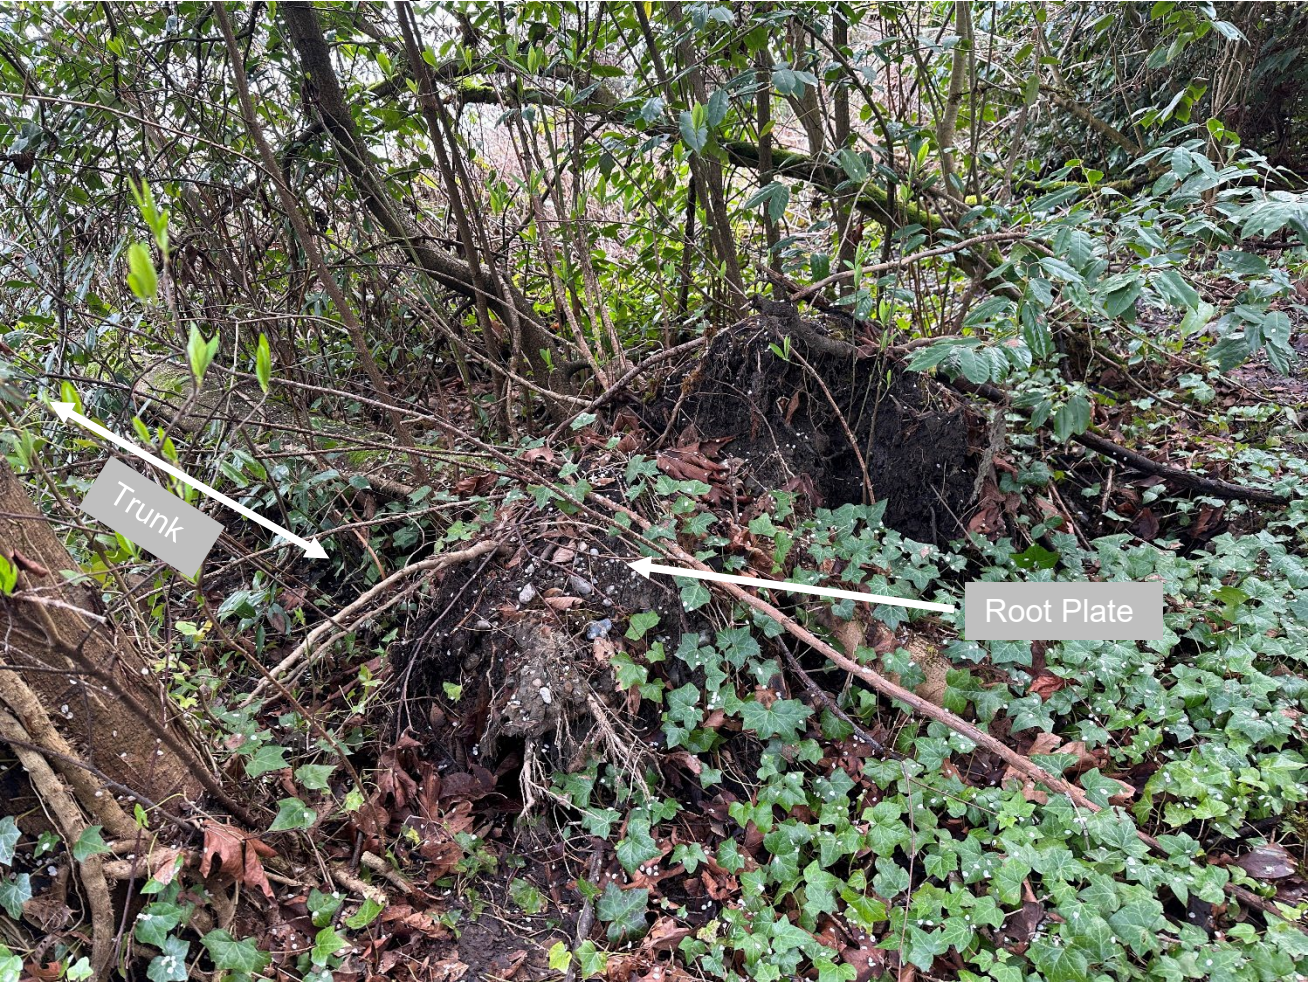
Tree #173: A bigleaf maple (*Acer macrophyllum*) with an approximately 11-inch DBH had failed into the water southeast of the dock. Its root plate was uplifted (Photo 2), yet there were still live branches on the top side of the trunk. Even so, I do not expect the tree to be viable in the long-term. It was obstructing water access to the dock.

Photo 2. Tree #173, a failed bigleaf maple was on the ground with its root plate uplifted.

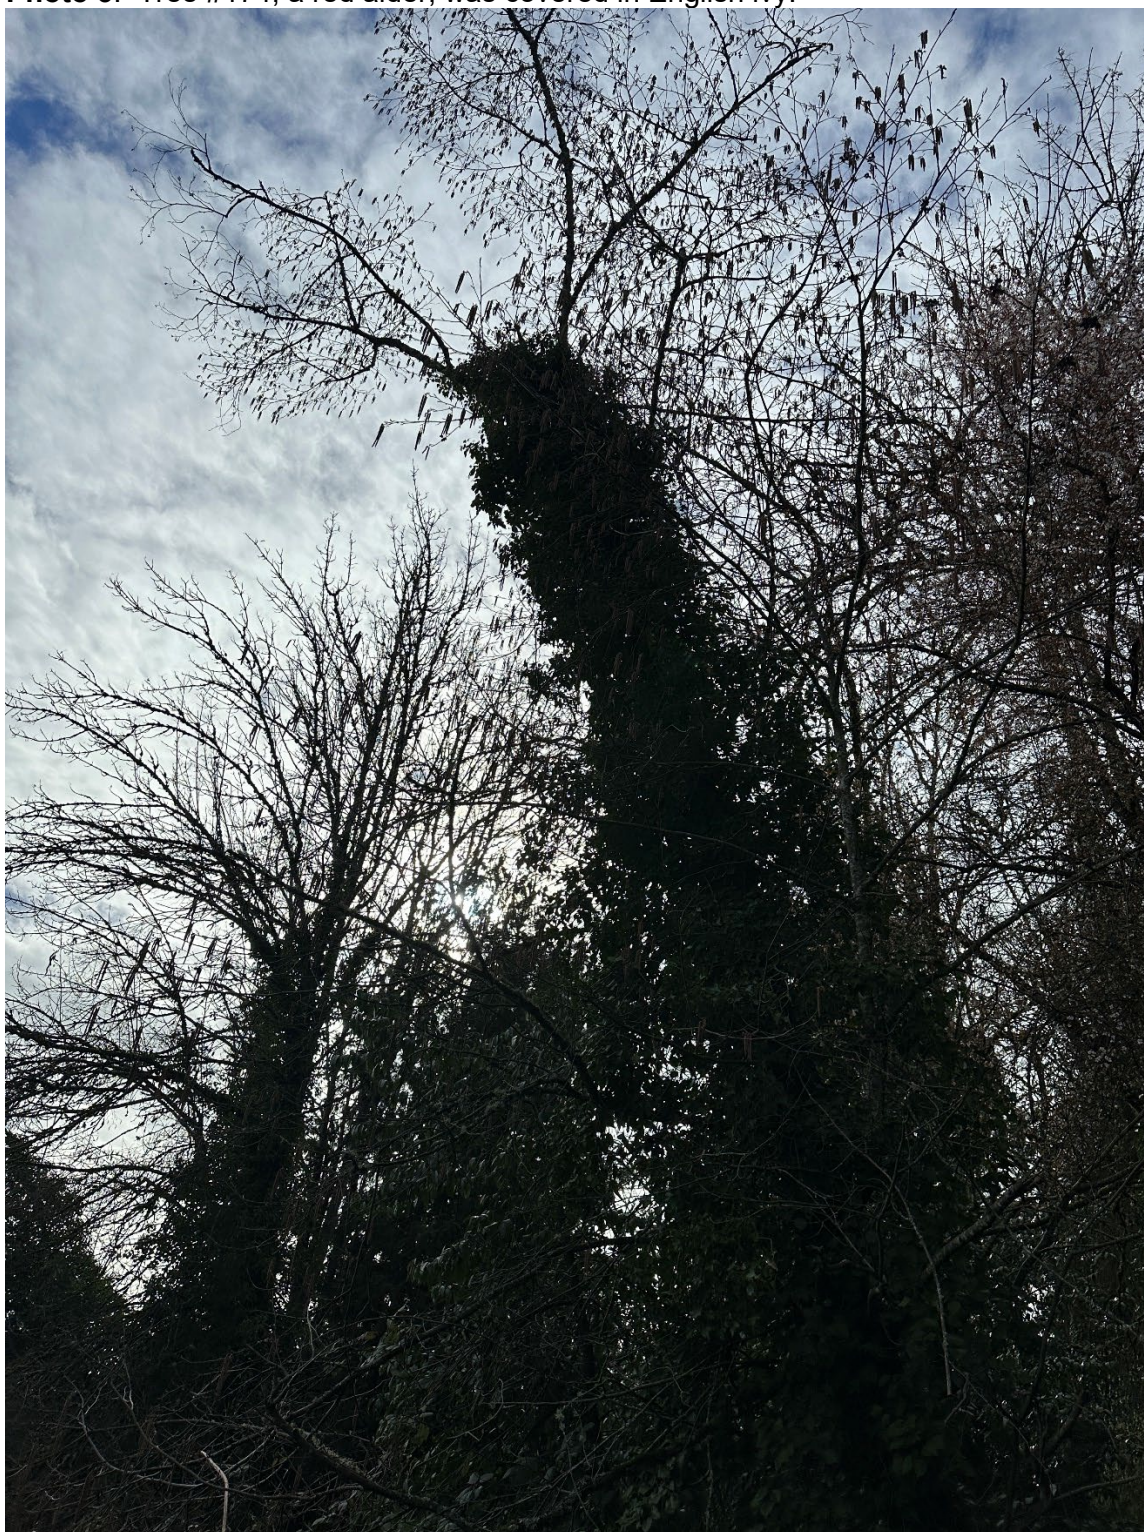
Tree #174: A red alder (*Alnus rubra*) with a 12-inch DBH was leaning towards the water from upland of the ordinary high water mark (OHWM). It has fair structure and health. English ivy (*Hedera helix*) was covering most of the tree (Photo 3). A couple longer branches were overhanging the dock and path to the station. If the ivy is removed, I expect the tree will be viable and a low risk to the dock and facility.

Photo 3. Tree #174, a red alder, was covered in English ivy.

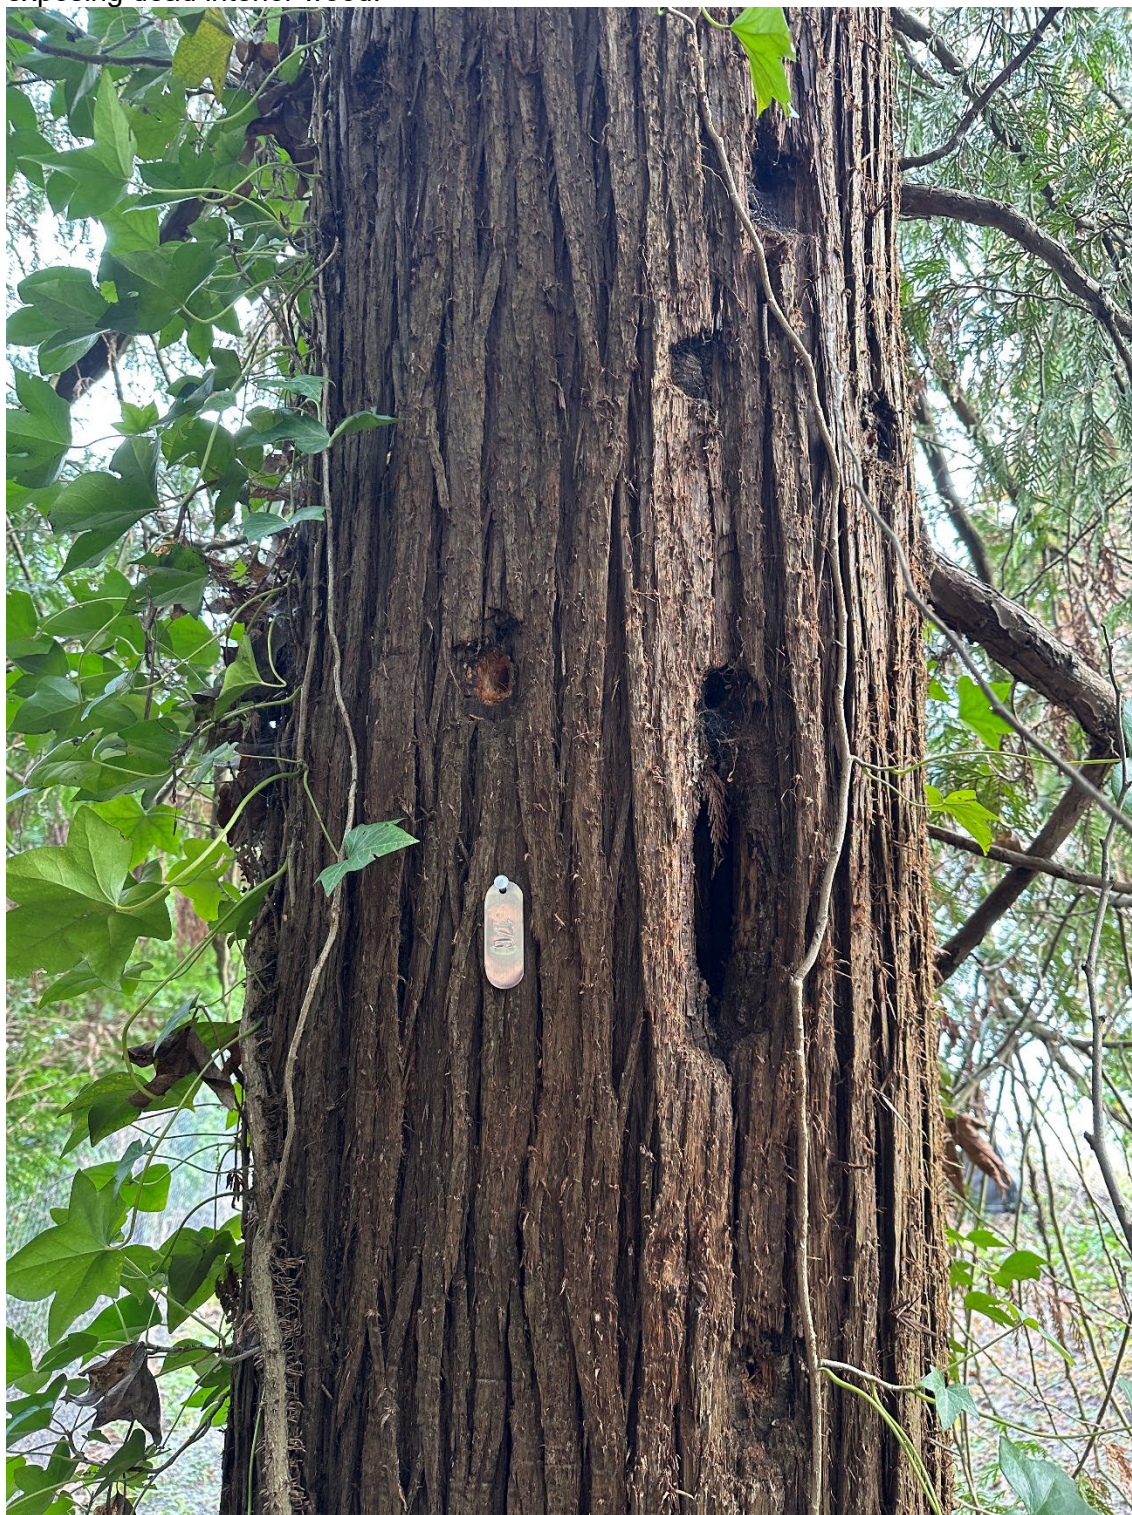
Tree #176: A western red cedar (*Thuja plicata*) with a 22-inch DBH and an estimated height of 50 feet. The tree was 29 feet southwest of the pump station stacks and next to the stairs leading to the street. When struck with a mallet, the trunk sounded hollow. The top 15 feet of the tree was dead and dead heartwood was visible on the south side of the trunk (Photo 4). The tree was in decline and not viable. Failure was probable with a high likelihood of striking the station or dock and causing significant damage. The tree had a high risk rating.

Photo 4. Tree #176, a western red cedar, had a hollow sounding trunk and woodpecker holes exposing dead interior wood.

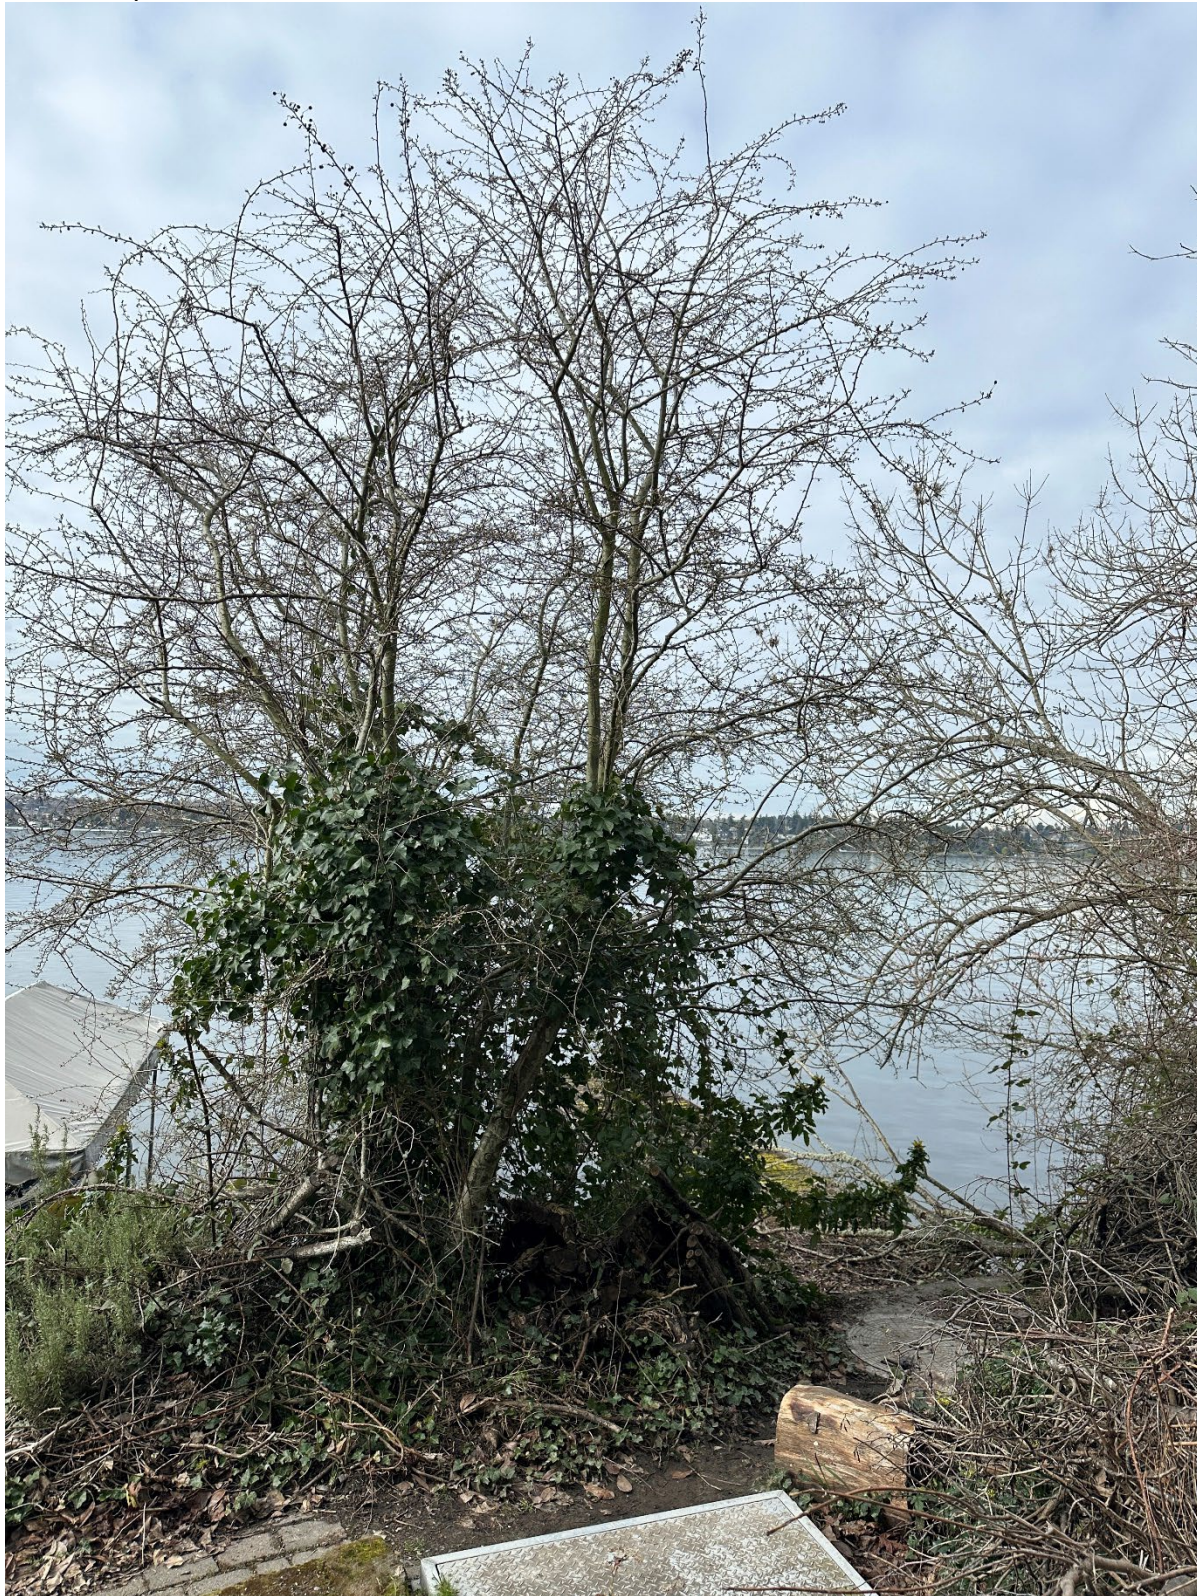
Tree #177: A hawthorn (*Crataegus* species) just south of the dock had seven stems ranging in diameter from 2 to 5.2 inches. It was about 15 feet tall and growing on the shoreline (Photo 5). The tree had fair structure and form, with good vigor. About half of its crown was overhanging the dock and shoreline access to the dock.

Photo 5. Tree #177, a hawthorn, in front of the dock for PS 19. Invasive blackberry and ivy are on the lower part of the tree.

PS 19: Tree #177, the hawthorn next to the dock, can be retained but about half its crown should be removed to allow dock access. Given the size of the tree and number of stems, I expect it will maintain its health with that amount of crown loss. **Tree #178**, the ash over the water, can be retained. Pruning the one scaffolding branch over the dock should be sufficient management to allow site access. **Tree #180**, the Norway maple, can be retained. The hanging failed branch, dead top, and any other dead branches over 2 inches in diameter should be cleaned from the crown to mitigate risk. The tree should be re-assessed for risk after the brush pile at the base of the tree is gone. **Tree #181** can be retained. The ivy on the tree should be removed to reduce the likelihood of failure and increase its health.

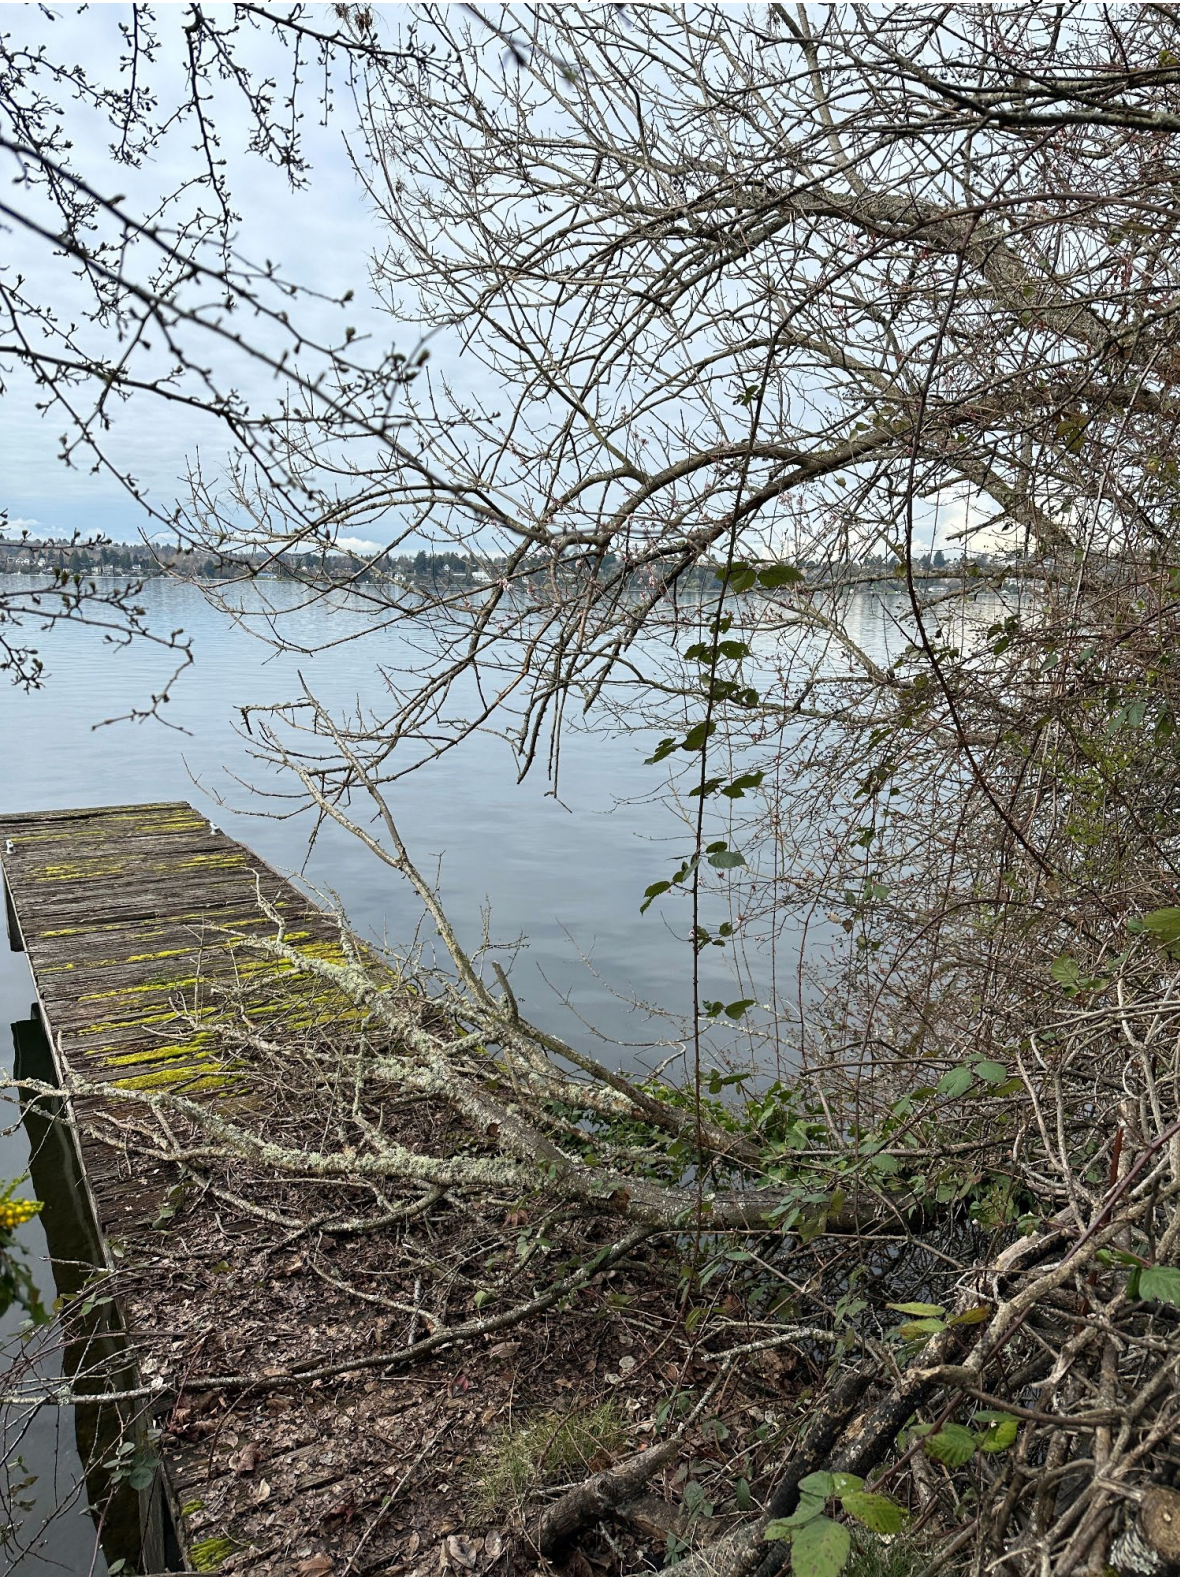
Tree #178 (not tagged): An ash (*Fraxinus* species) with an estimated DBH of 10 inches was leaning over the water on the north side of the dock (Photo 6). The tree had good health. One scaffolding branch overhung the dock. Removing the branch for access would reduce the crown by less than 20 percent.

Photo 6. Tree #178, an ash next to the dock, had one scaffold branch overhanging the dock.

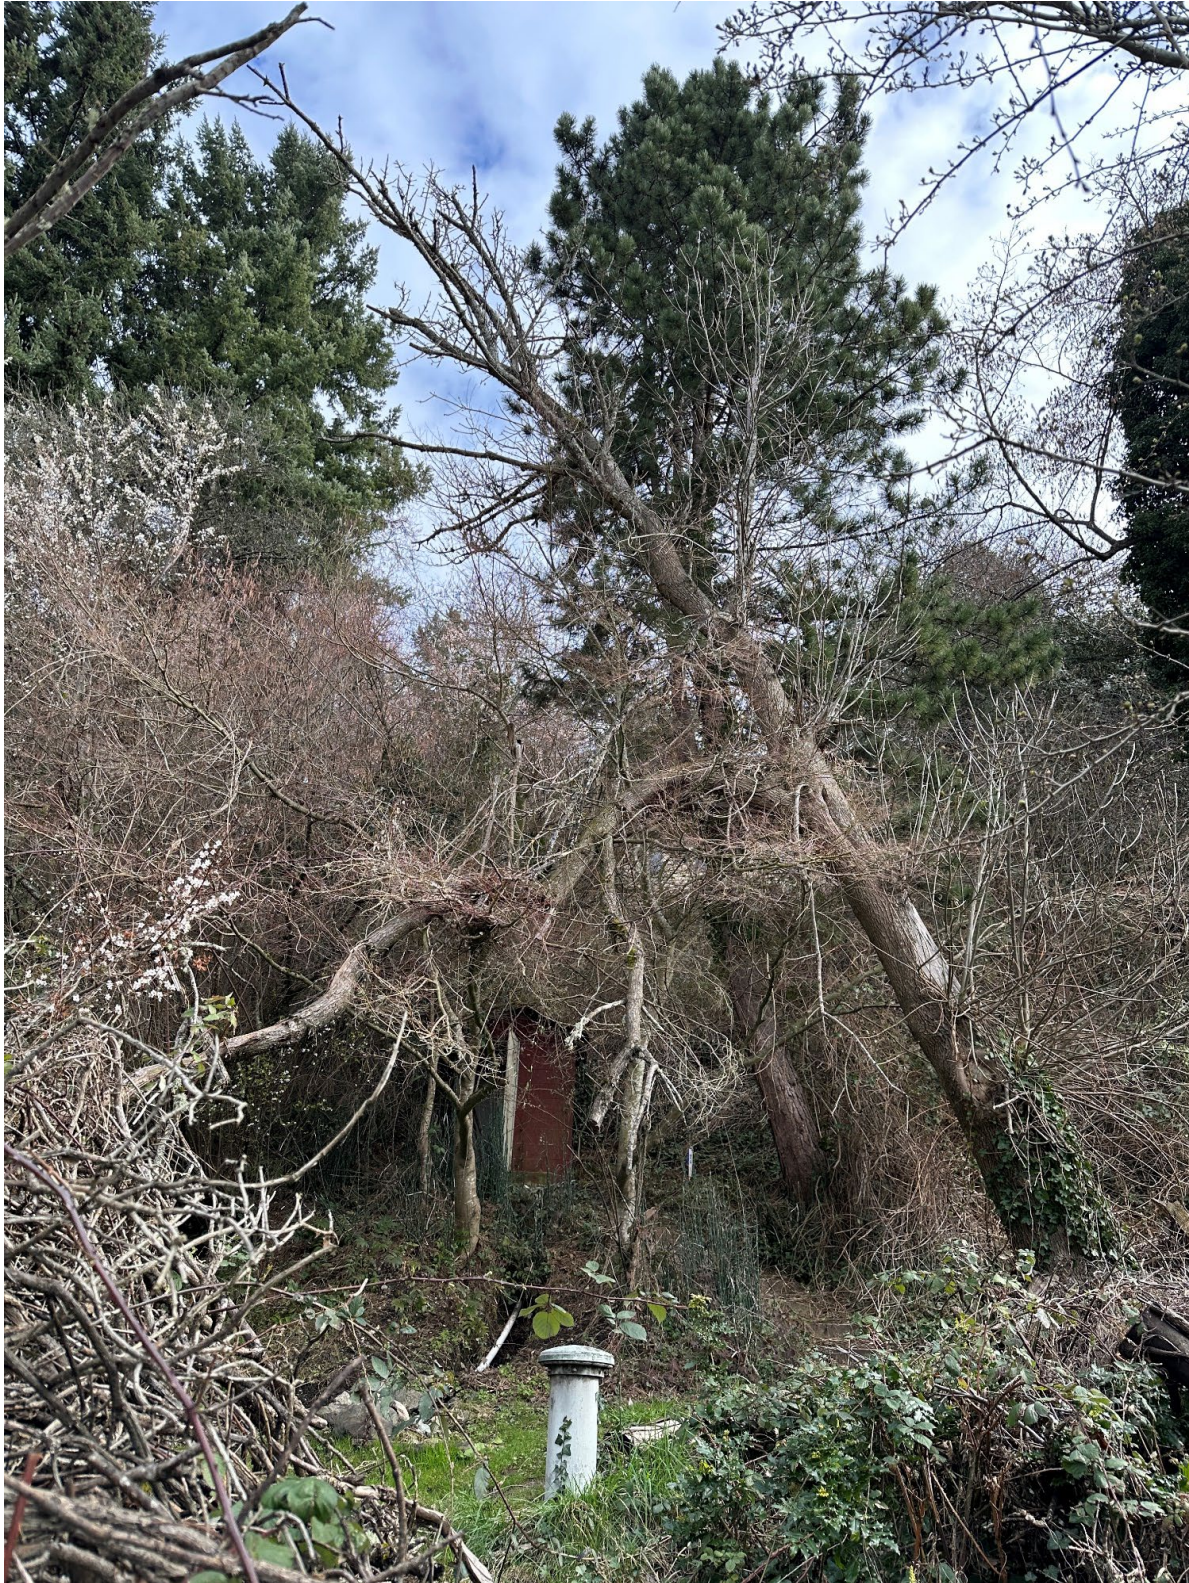
Tree #179: A Norway maple (*Acer platanoides*) with a 24.5-inch DBH and approximately 35 feet tall was growing just east of the pump station (Photo 7). A branch about 8 inches in diameter had failed and was in contact with the ground while suspended from the tree. The upper third of the crown was dead and leaning towards the pump station stack. The trunk sounded solid and live branches were sprouting or on stems on the lower part of the tree. A brush pile was obscuring the base of the tree. Failure of the dead top and hanging branch was probable with a high likelihood of striking the pump station and causing significant damage. The top and branch had a high risk rating. The rest of the tree had a low risk rating, pending further investigation of the base of the tree beneath the brush pile.

Photo 7. Tree #179, a Norway maple, had a dead top and large hanging branch that should be removed to mitigate risk. The pump station stack is in the foreground of the photo.

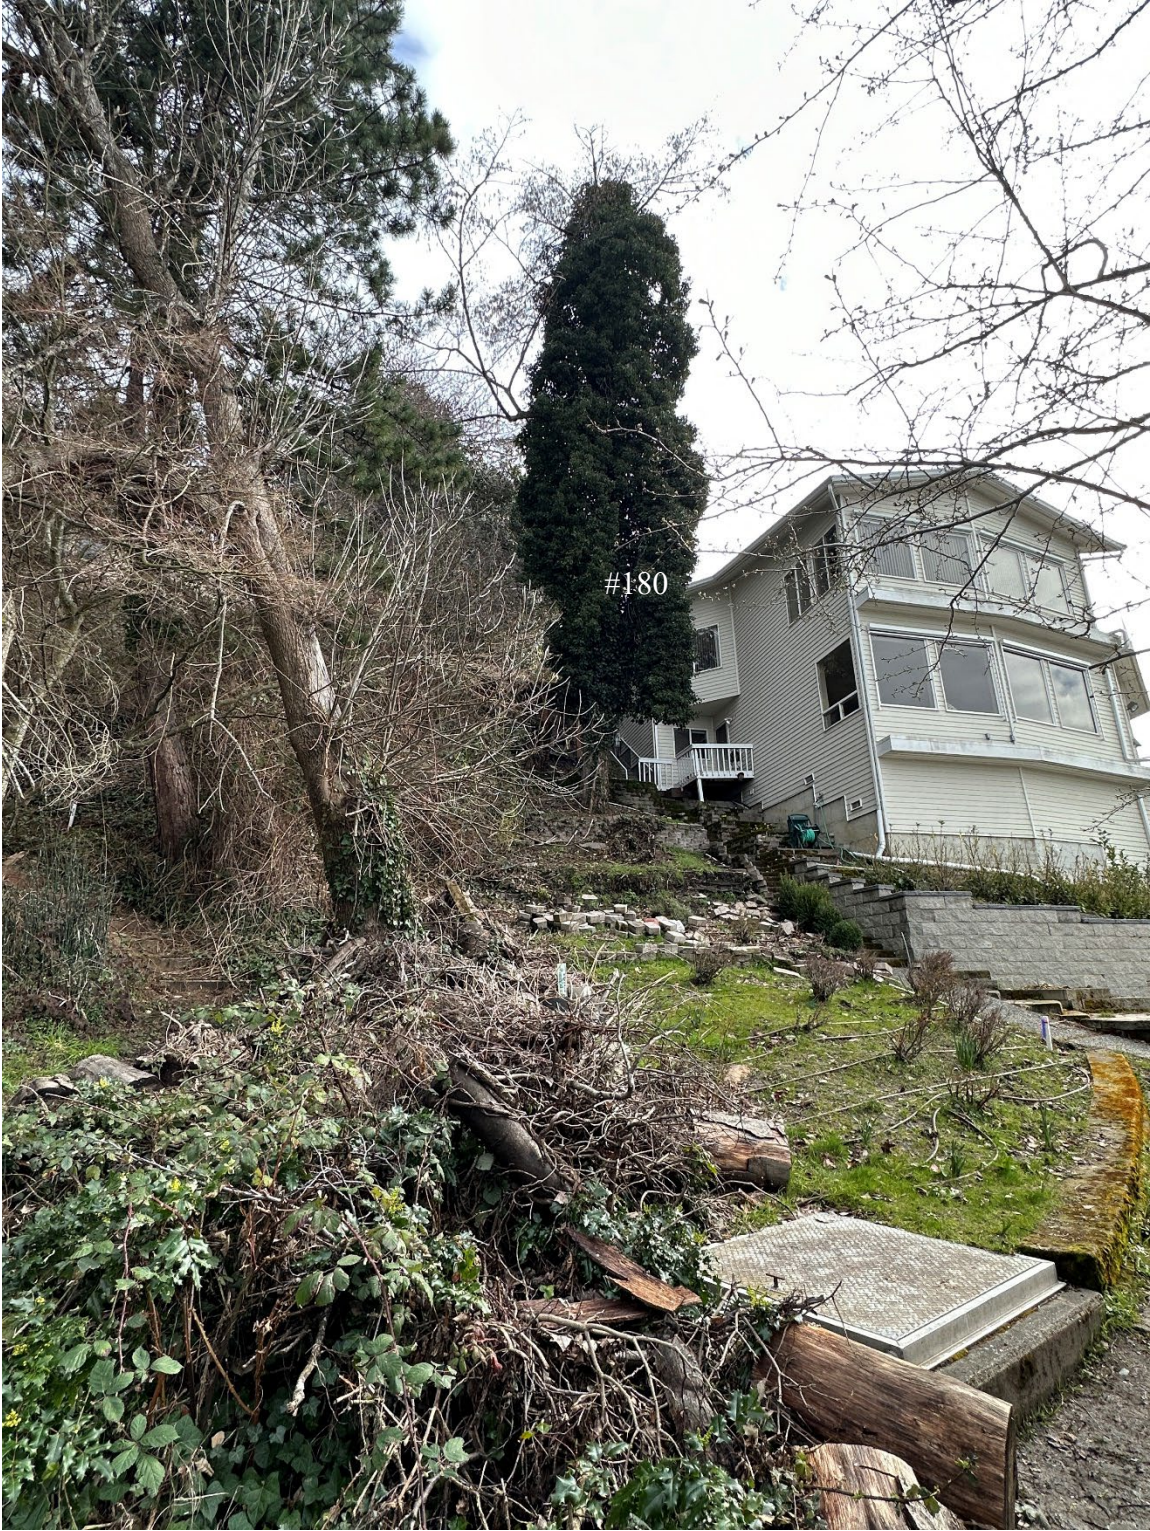
Tree #180 (not tagged): A red alder upslope of the pump station on private property. English ivy covered the trunk (Photo 8) and I estimated the DBH to be 20 inches. The trunk sounded solid and other than a slight lean towards the pump station, I did not see any structural defects. The tree had very few live branches and it may not be viable, depending on what it looks like after the ivy is removed. It had a low risk rating.

Photo 8. Tree #180, a red alder on the neighboring property to the east, was covered in ivy.
