Luther Burbank Park

Appendix

DRAFT Technical Memorandum

Re: Draft Shoreline Habitat Inventory Memorandum

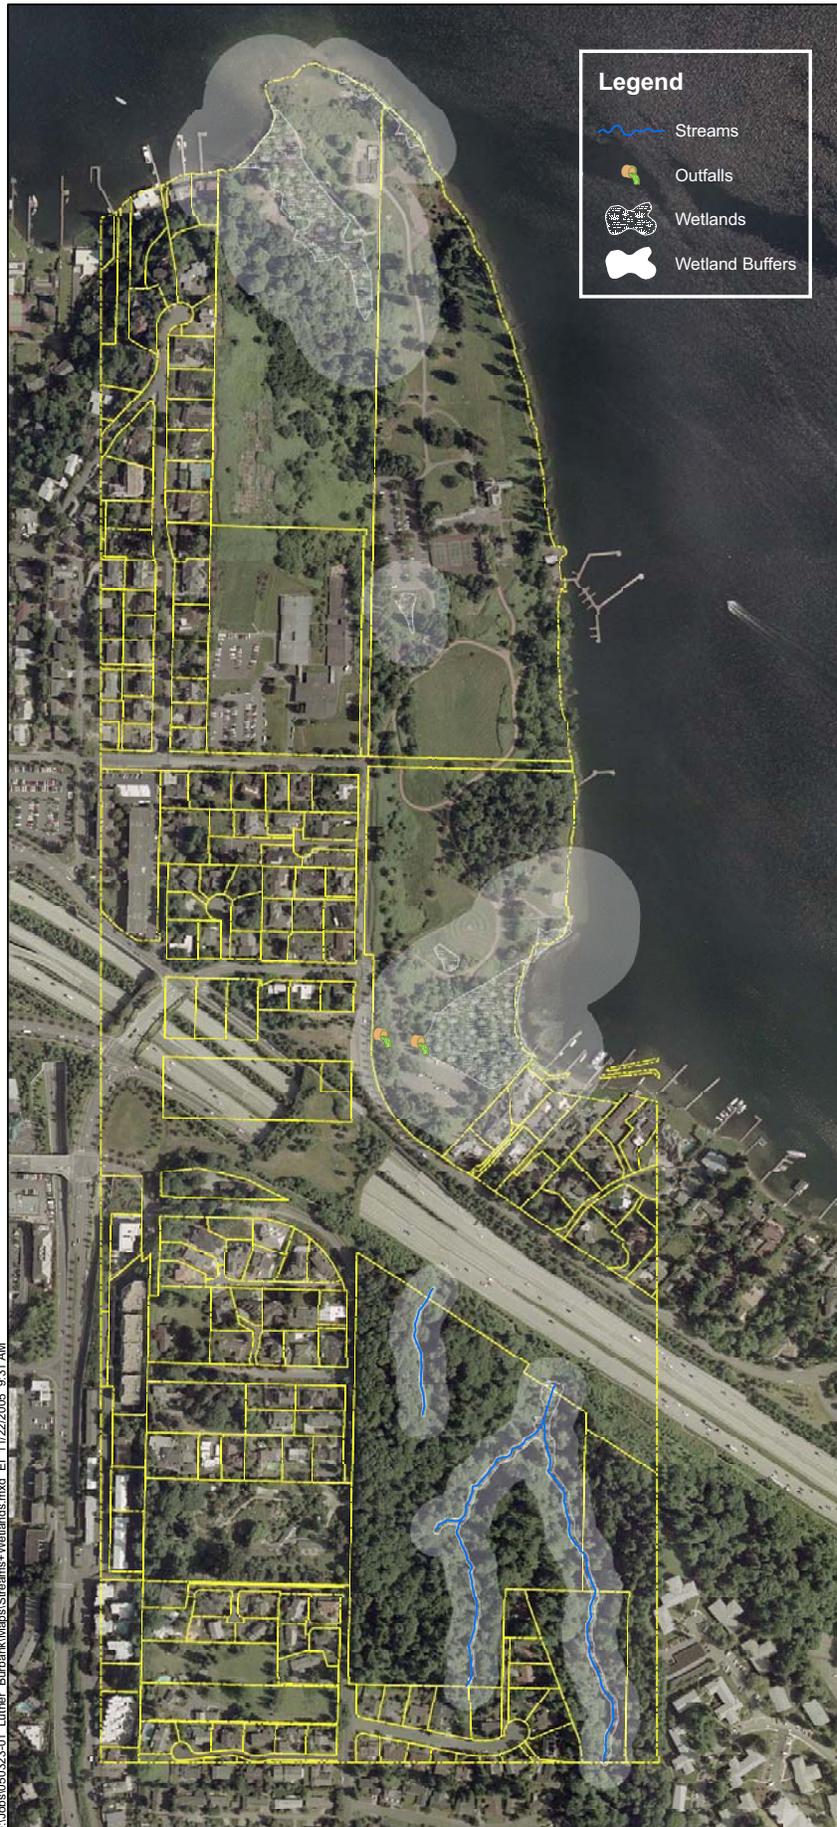
Notes:
 Potential wetland habitat conditions were evaluated based on a reconnaissance-level site visit performed on September 30, 2005. Wetland delineations or surveys were not performed as part of this analysis. To confirm the presence, absence, boundaries, functions, and values of wetland systems, wetland delineations should be conducted according to the methods defined in the 1987 U.S. Army Corps of Engineers Wetland Delineation Manual and the 1997 Washington State Department of Ecology Wetland Identification and Delineation Manual.

Wetland conditions were identified based on observed plant communities and hydrologic conditions. Wetland delineations or surveys were not performed as part of this analysis. The general locations and approximate boundaries of all potential wetland habitat observed during the site visit were located using a differential global positioning system (DGPS), for subsequent transfer to an AutoCAD topographic survey map (Attachment A). Potential wetland classifications and buffer widths were identified based on observations during the wetland reconnaissance. The City's ECA Ordinance does not identify wetland rating and buffer width criteria. According to the City's Planning Department (Salzman 2005), wetland ratings are determined using the Washington State Department of Ecology (Ecology) *Washington State Wetland Rating System – Western Washington* (2004) and buffer widths are determined using Ecology's *Guidance for Protecting and Managing Wetlands* (2005). This guidance provides three options for determining wetland buffer widths: buffer widths based on land use and wetland function scores, buffer widths based on land use, and buffer widths without incorporating land use or functions information. For this analysis, buffer widths were based on land use criteria. Approximate potential wetland boundaries, wetland ratings, and wetland buffers are presented on the map in Attachment A.

In addition to the wetland habitat analysis, drainages in the forested parcel south of I-90 were evaluated to identify stream classifications according to the Washington State stream typing system, as defined in Chapter 222-16-030 of the Washington Administrative Code (WAC 2005). Stream habitat characteristics assessed during the reconnaissance included potential fish usage, hydrologic functions, channel bed and bank conditions, substrate composition, and riparian vegetation. Approximate stream channel boundaries and classifications are presented on the map in Attachment A.

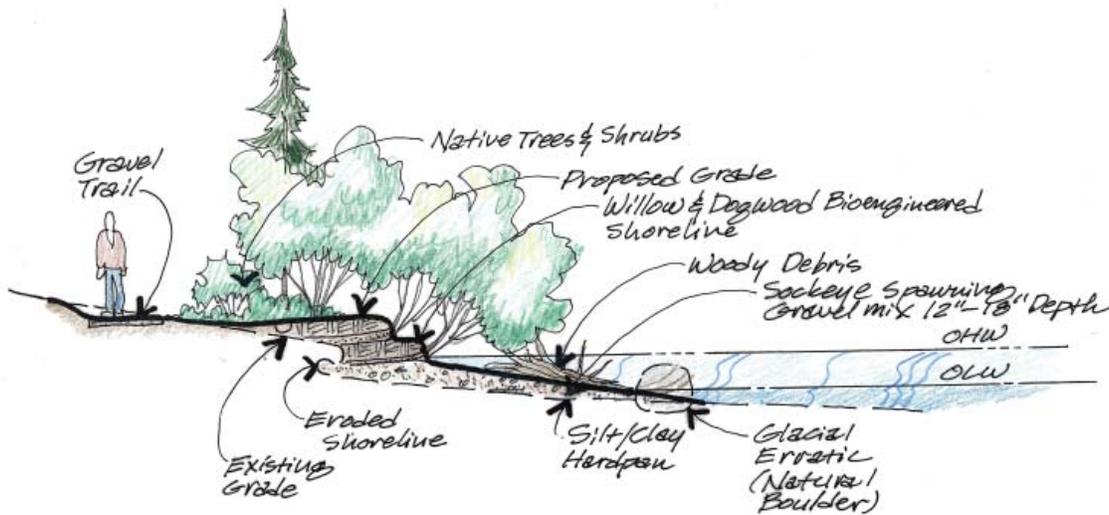
Figure 1

The goal of this prototype (see Figure 1) is to improve the shoreline for a wide range of native fish and wildlife species including salmon. Two key aspects of habitat structure are targeted by this restoration prototype: overhanging riparian vegetation, and substrate (lake bottom surface material). Each of these two structural elements support key habitat functions such as aquatic and terrestrial prey organisms (food for fish and wildlife) and refuge from predators (hiding places) both of which are important to rearing and survival of most native fish and wildlife species. Riparian vegetation would consist of native willow and red osier dogwood shrub/small tree species overhanging the water and planted in soils wrapped in a biodegradable fabric (coir matting) placed over and in front of existing low eroding banks. The willows and dogwood are effective at stabilizing the shoreline and preventing erosion once established and are the basis for this "biotechnical" erosion control approach. Behind these plantings, other native upland trees and shrubs are proposed to provide more layers of vegetation at higher levels. A gravel surfaced trail paralleling the shoreline is proposed landward of these plantings. In general, no excavation would be needed to perform the restoration, but placement of imported soil and gravel materials is needed. Substrate restoration consists of placing a sockeye salmon spawning gravel mix just below the willow plantings between the Ordinary High and Ordinary Low Water lines (OHW and OLW). There is a two foot difference in the lake's summer and winter water levels. These gravels are less than 1-1/2 inch in diameter and would cover the exposed "hard pan" presently devoid of gravels. Finally some woody debris is proposed in the restored areas between the OHW and OLW lines.

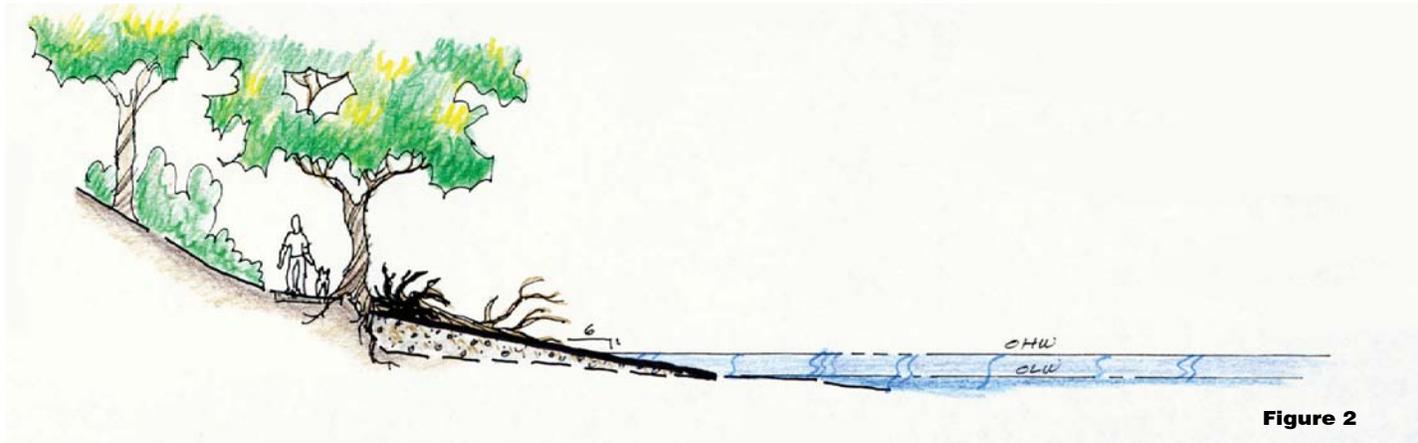
Figure 2

Periodically interspersed with the habitat restoration prototype, would be very small, “micro” beaches (see Figure 2). The goal of these beaches is to improve habitat substrate, as described above, but also to provide places for visitors to access the water on foot. Shallow draft small watercraft, such as kayaks and canoes could also use these micro beaches as landing sites. The beaches would include the same materials as the habitat prototype but consist of more beach and less restored vegetation. Some excavation and placement of gravel materials will be needed. The length of shoreline for each micro beach is intended to be no more than 30 feet. The width would be between 20 to 30 feet, with the widest point where the shoreline trail touches the beach. The gaps in riparian planting that the micro beaches form would be small enough that mature trees would spread over them. A combination of some buried rock covered with the spawning gravel described above, and large woody debris would form the edges of the beaches to help hold them in place. A similar effect is evident where some of the large poplar trees have fallen into the lake below the Park’s office. This woody debris has allowed more sand and gravel to accumulate on the updrift (north) side of it.

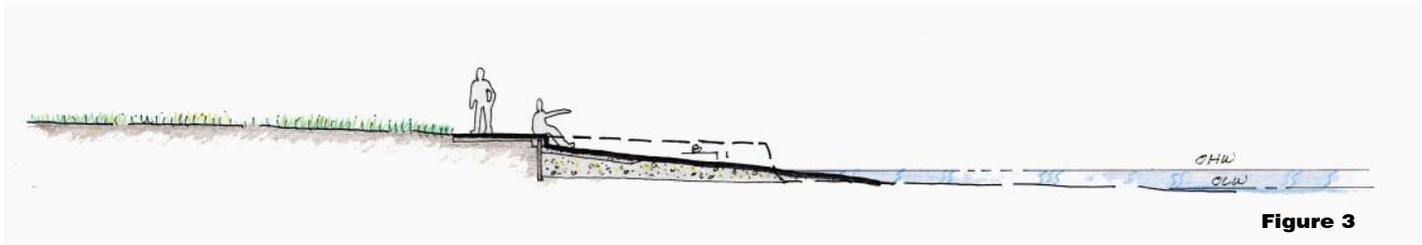
Figure 3

The goal of the human access beach prototype is to emphasize access to the water for relatively larger numbers of park visitors. However, these beaches will provide a significant improvement in habitat by improving substrate conditions beyond the hardpan, steep eroding banks, or vertical bulkheads that exist in these locations. In most cases, sockeye spawning substrate can be used as the surface material for these beaches. These beaches are limited to the following five areas identified in the Master Plan including: Calkins Point; off leash dog area; homeowner demonstration area ("morning lawn"); dock/boiler building small boat launching beach; and the swim beach (see Figures 3, 4, and 5). Some excavation would be needed at some locations and placement of beach gravel would be needed at all of them. The beaches range in shoreline length from a maximum of 240 to 300 feet (swim beach and Calkins Point) to a minimum of 60 to 100 feet (off leash dog beaches, and homeowner demonstration beach). Riparian planting is not proposed at these beaches in order to maximize recreational shoreline access and water views. A combination of some buried rock covered with the gravel and large woody debris would form the edges of the beaches to help hold them in place. Some areas have existing upland edge materials such as the swim beach and the bulkhead at the boiler building. Most of the other beaches will require new edging materials to define the uplands from the beach. These edge materials are proposed to consist of durable and shoreline compatible products such as stone, and/or partially buried vinyl sheetpile with a continuous concrete cap twelve to eighteen inches wide (see Figures 3 and 4).
