CITY OF MERCER ISLAND

GENERAL SEWER PLAN

November 2018

FINAL

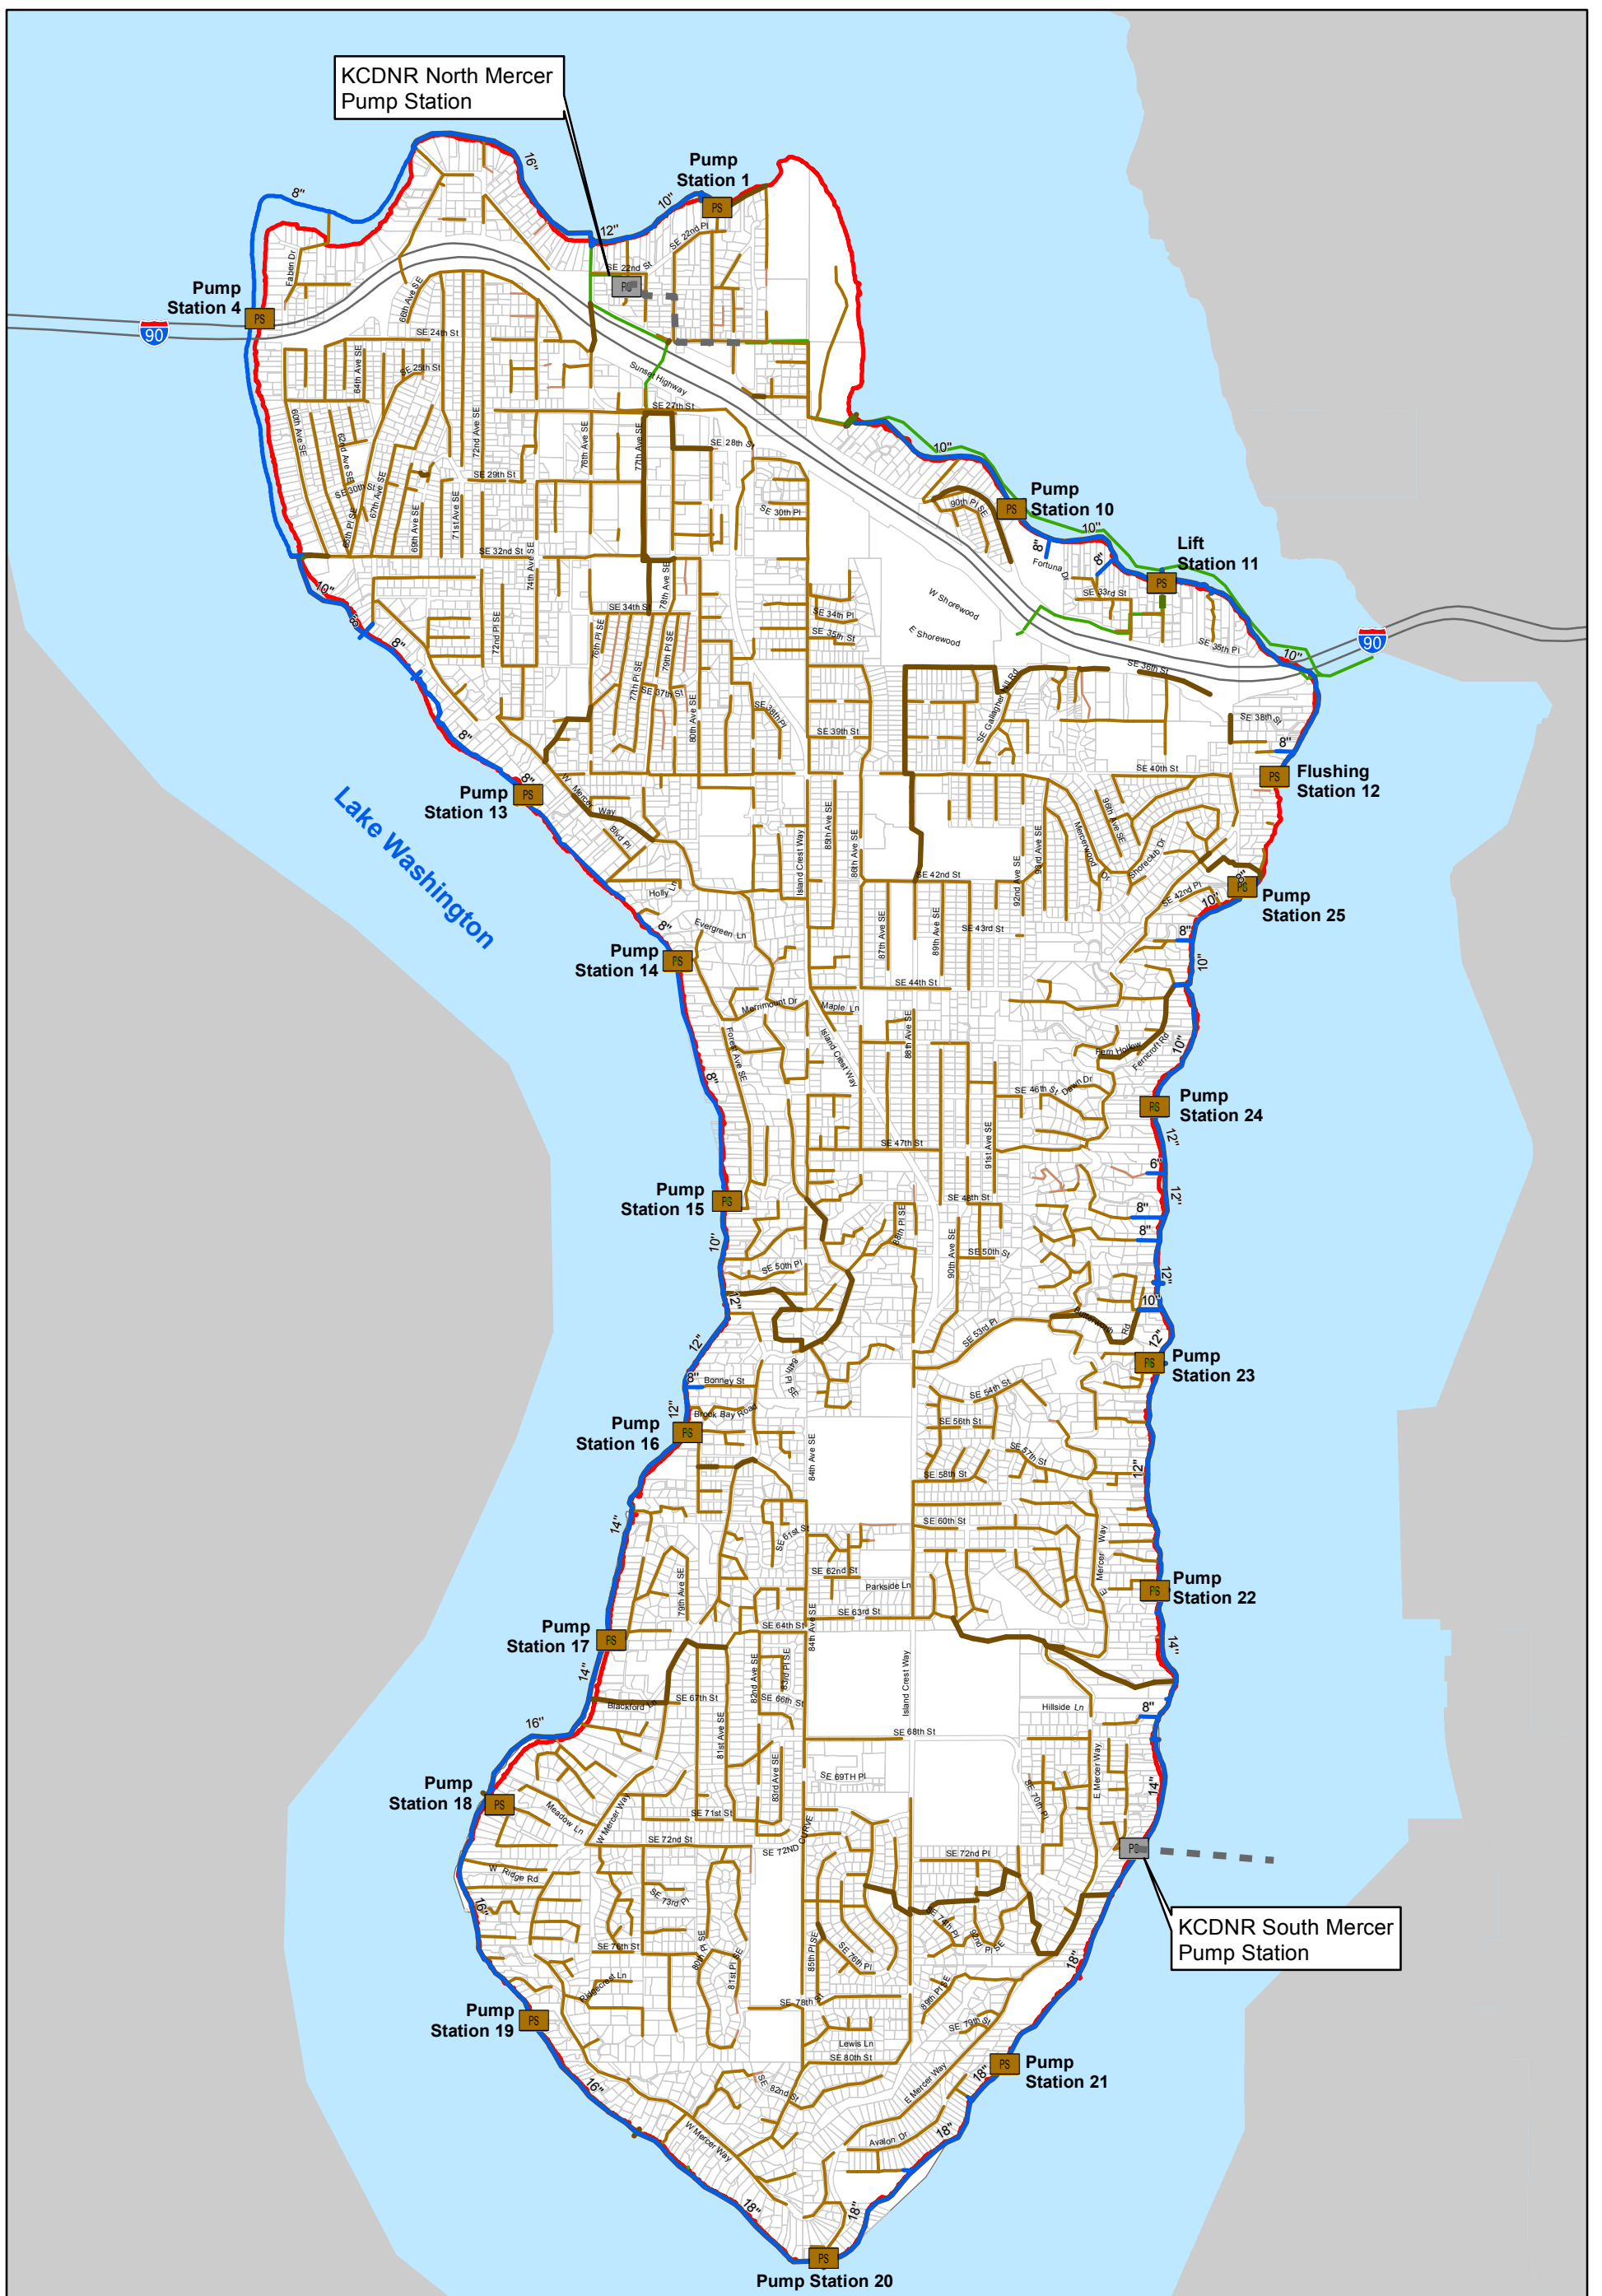
Figure ES.1
Sewer System
 General Sewer Plan
 City of Mercer Island

Legend			
King County Pump Station	Lakeline Main	King County Gravity Main	
Mercer Island Pump Station	Gravity Main by Diameter	Service Area Boundary	
Force Main	10" or Larger		
King County	8"		
Mercer Island	6" or Smaller

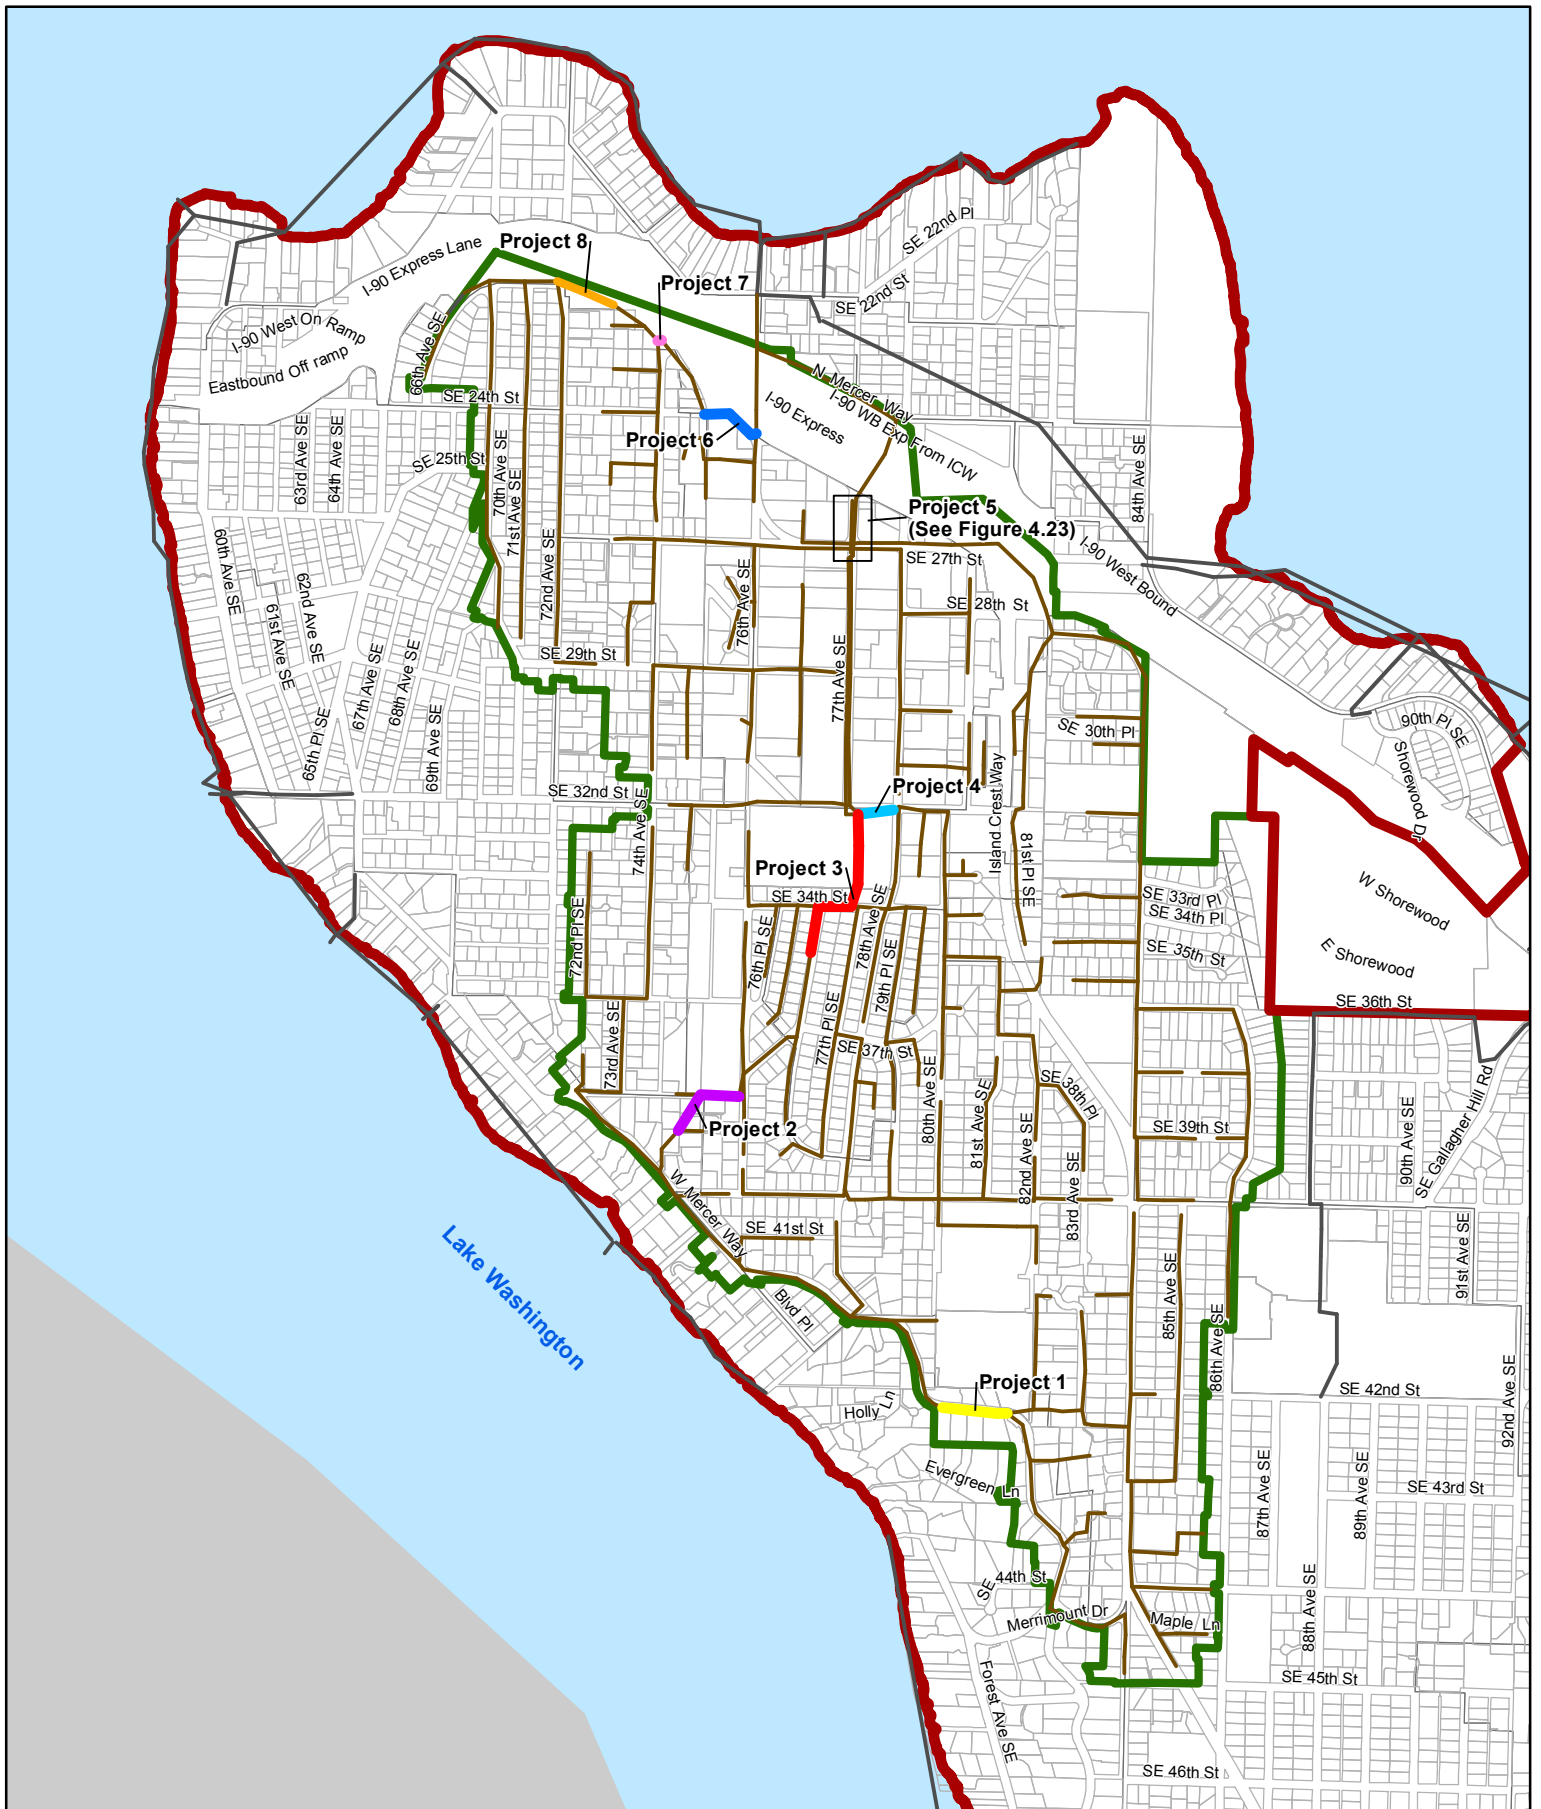
Improvements were recommended to alleviate the capacity issues under the planning conditions. Improvements to provide sufficient capacity throughout the system mainly include upgrades to pipe diameters. Figure ES.2 illustrates the proposed sewer improvements required to meet the d/D criteria. A total of approximately 3,300 linear feet of pipes ranging from 12-inch to 16-inch are recommended to alleviate capacity deficiencies identified.

| Legend | Project 1 | Project 6 | Service Area Boundary |

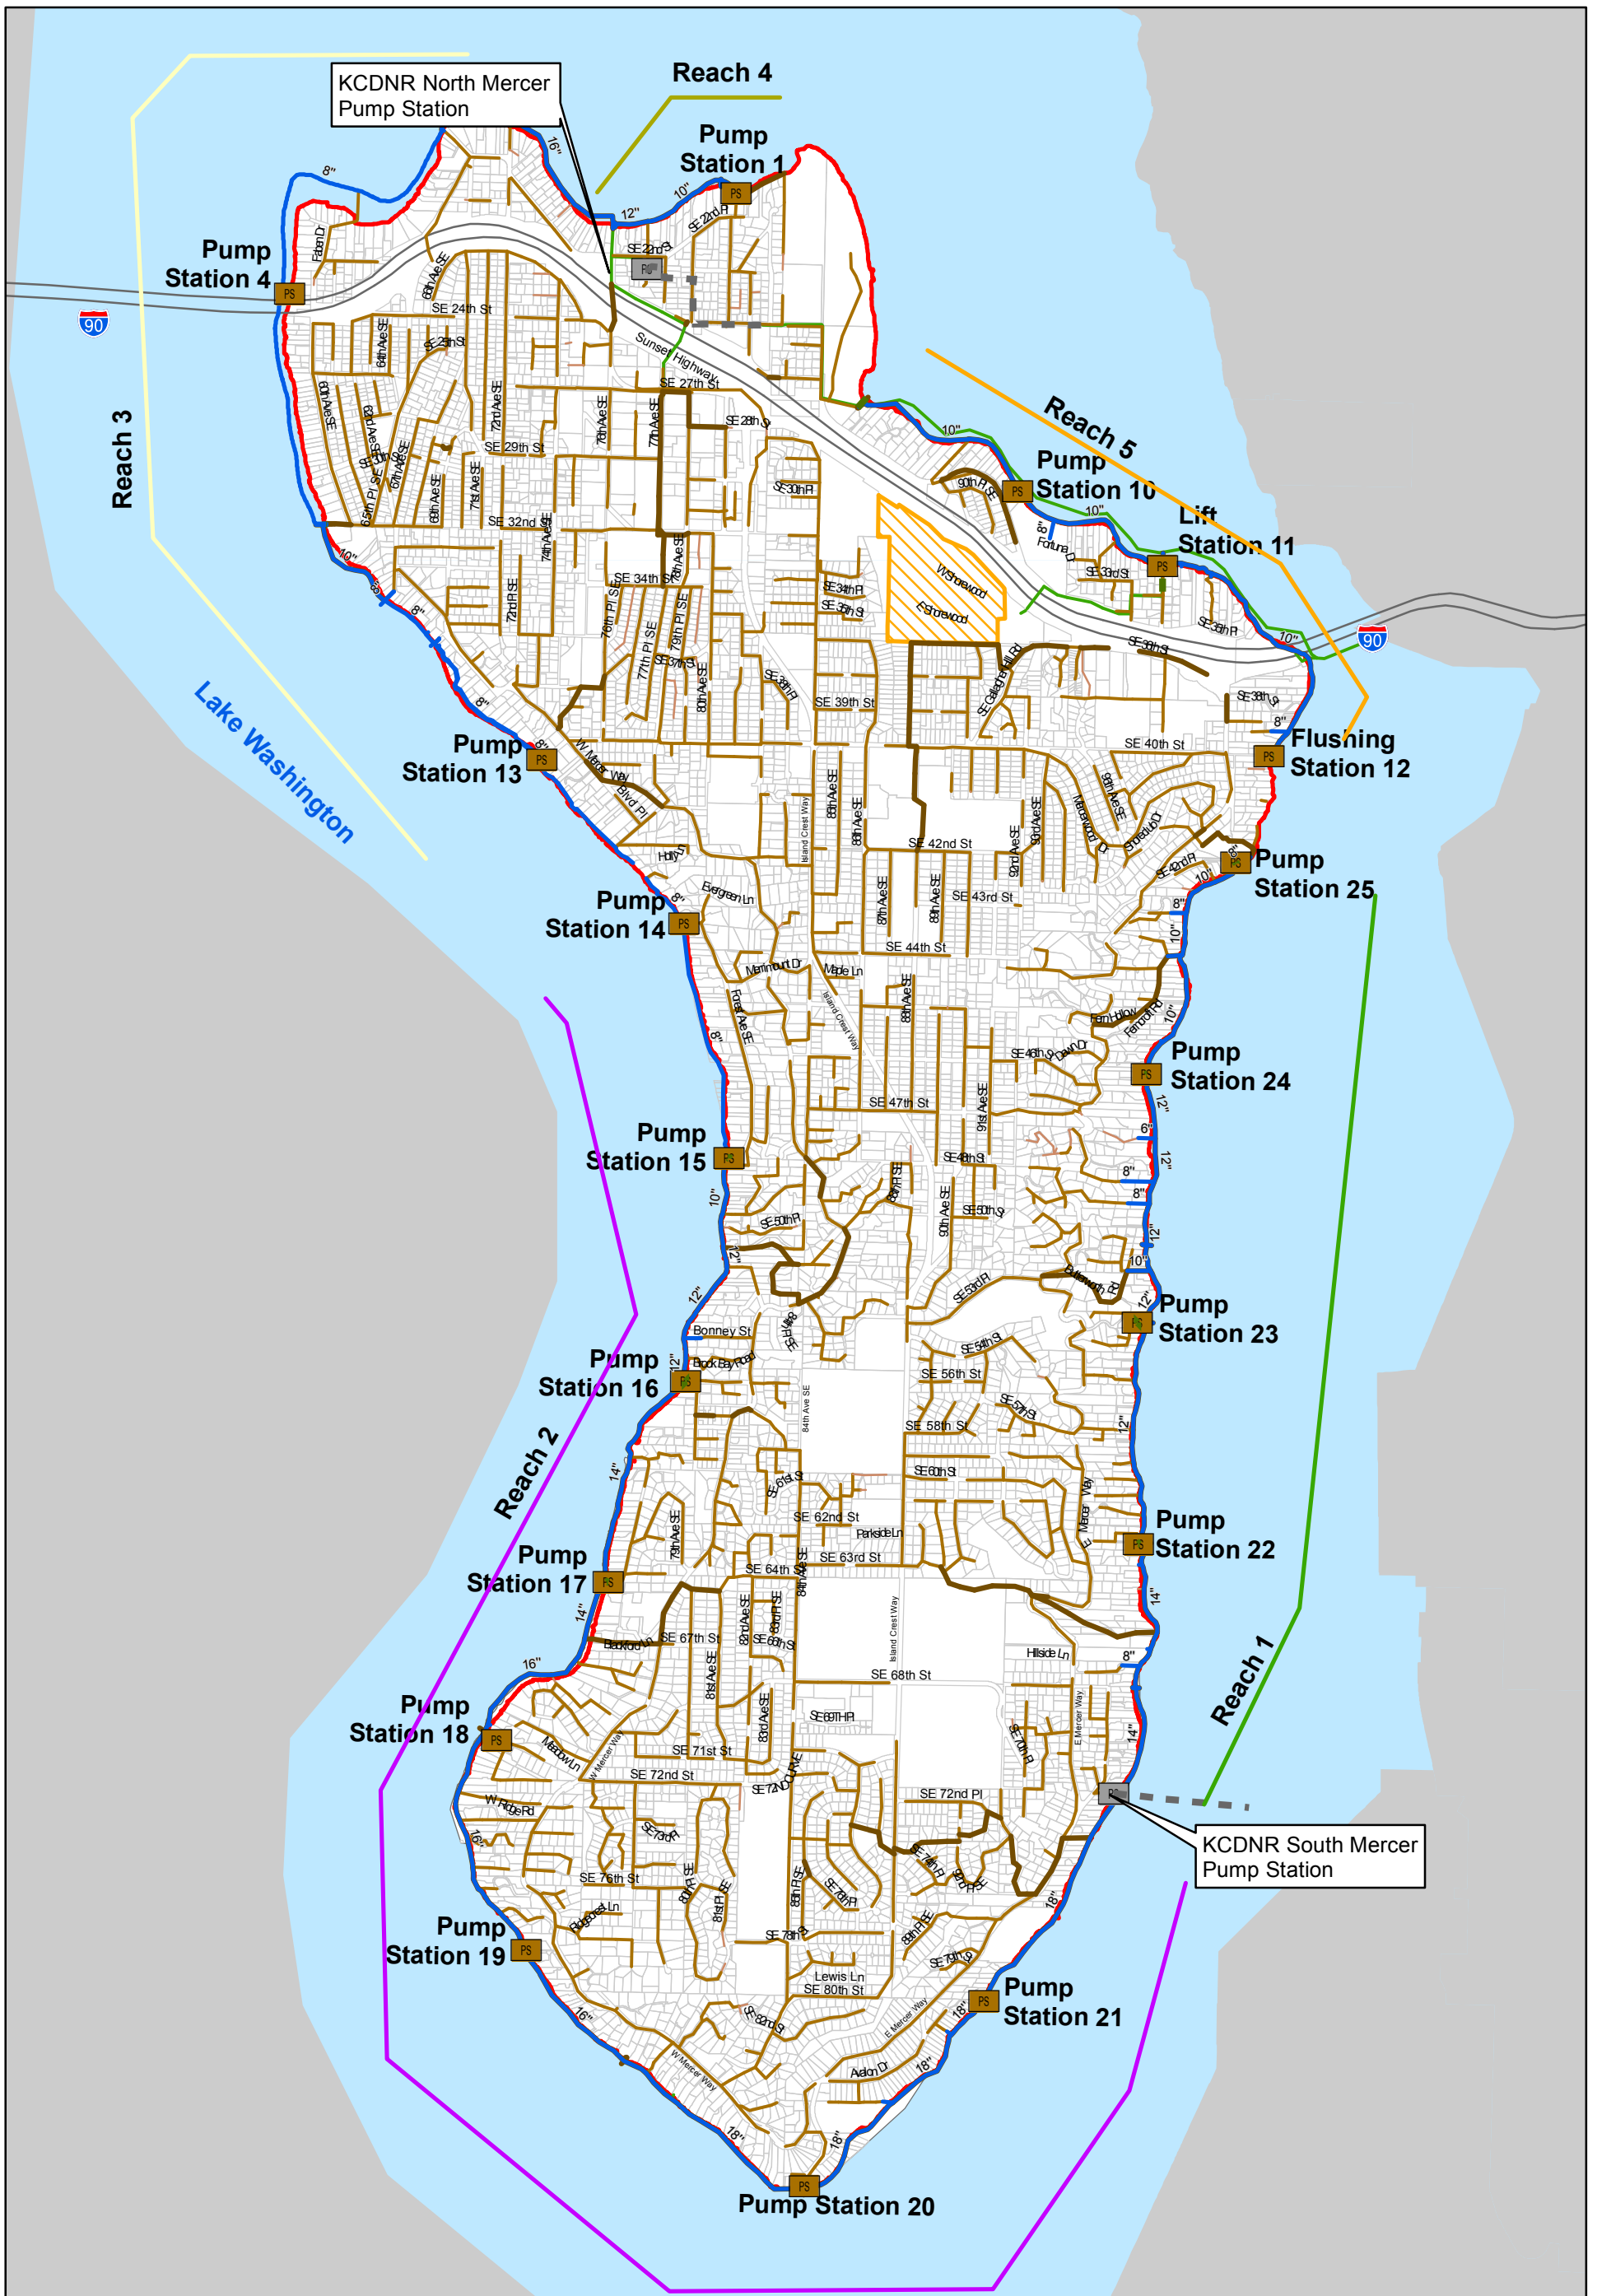
The sanitary collection system consists of approximately 2,400 manholes and 105 miles of pipe. The majority of the system was originally constructed by the Mercer Island Sewer District through three Utility Local Improvement Districts (ULIDs) in the late 1950s and early 1960s. The City assumed control of the systems in 1975 when the Mercer Island Sewer District was dissolved. A smaller portion of the system, within the East Mercer Sewer District is believed to have been constructed in the 1950s. The City assumed control of this system in 1988. There are two private collection systems on the Island: Shorewood Apartments and Covenant Shores Retirement Community. Flows from Shorewood Apartments discharges directly into KCDNR Manhole #45-121 and therefore, it is not a City customer. Flows from Covenant Shores discharges directly into the City's Lakeline collection system; therefore, it is a City customer. Figure 3.1 depicts the City's collection system. Appendix G includes a large scale map that depicts the flow direction of the collection system.

- King County Pump Station
- Mercer Island Pump Station

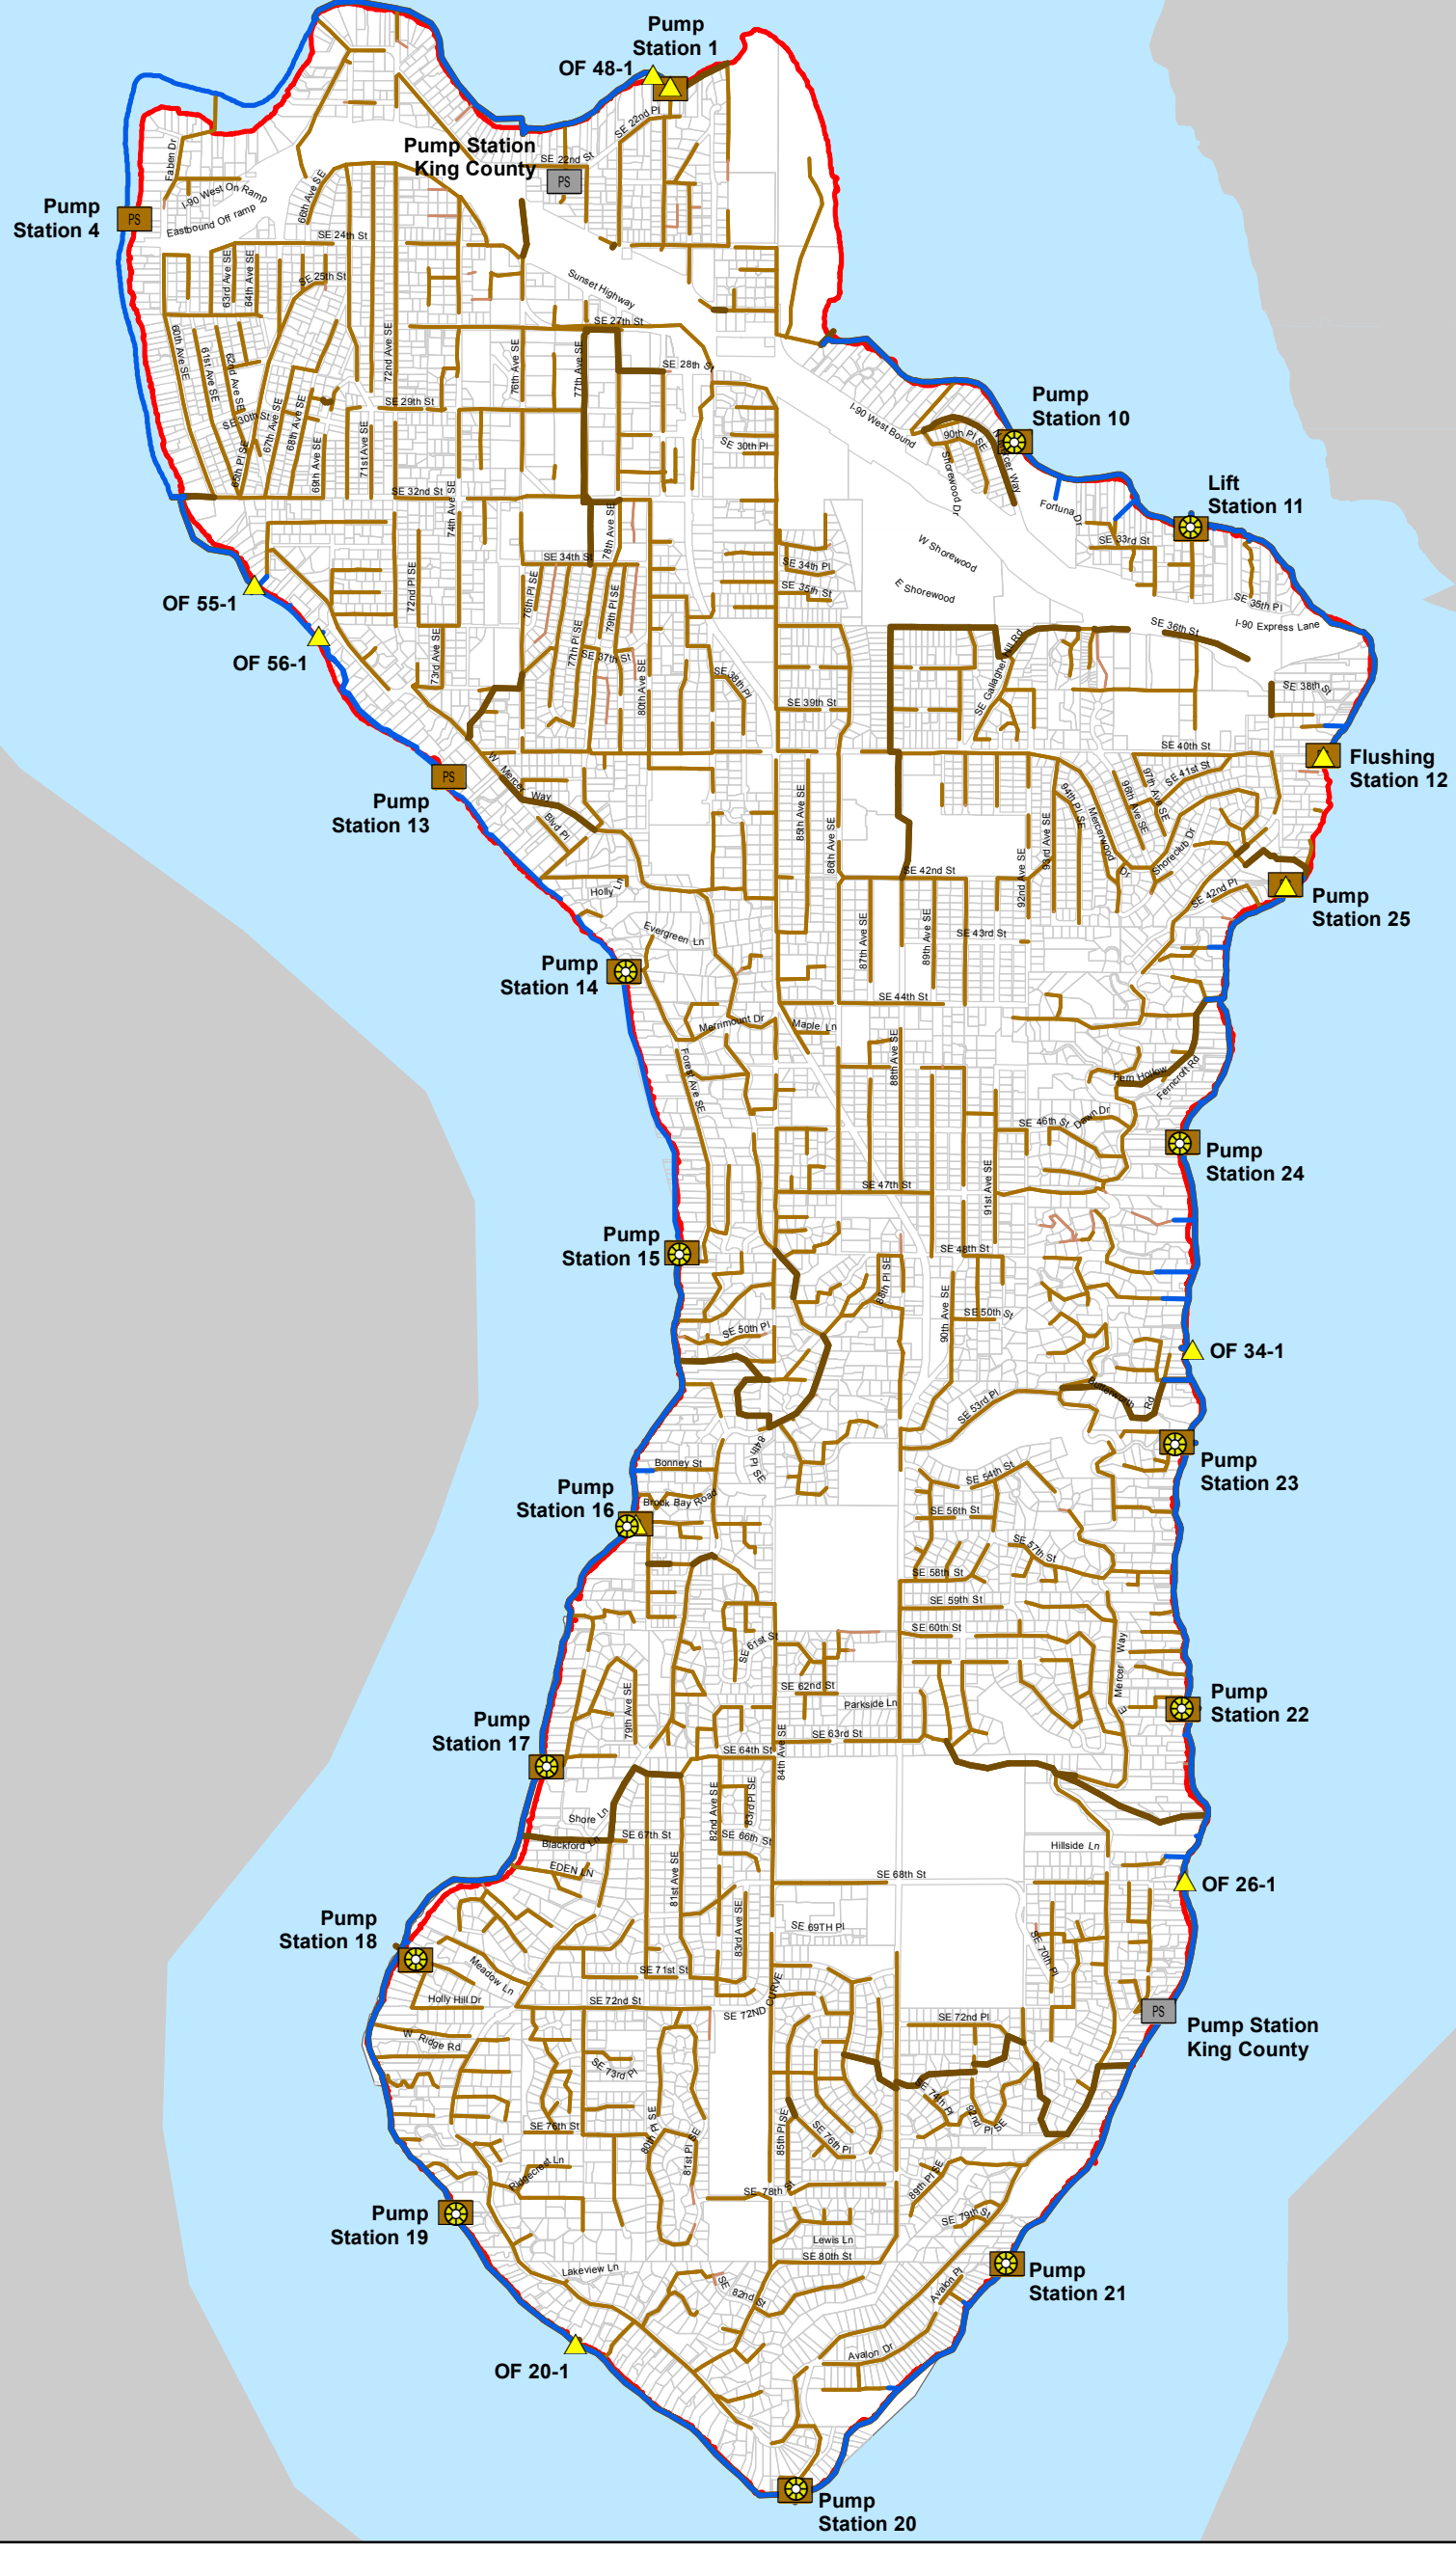
Weir elevations were reportedly set at an elevation slightly lower than the lowest service connection downstream of the overflow. Thus the structures protect individual homes from flooding by limiting the possible hydraulic gradelines downstream of a control weir.

Table 3.4 documents the overflow elevations of these structures from available as-builts. The City does not have as-builts for PS 1 and plans to replace the station in 2022. The City monitors high wet well alarms at all stations, which allows them to identify periods of high flows.

King County Pump Station	Lakeline Gravity Main	Service Area Boundary
Mercer Island Pump Station	Gravity Main by Diameter	
Gravity Overflow	10" or Larger	
Hydraulic Grade Manhole	8"	
	6" or Smaller

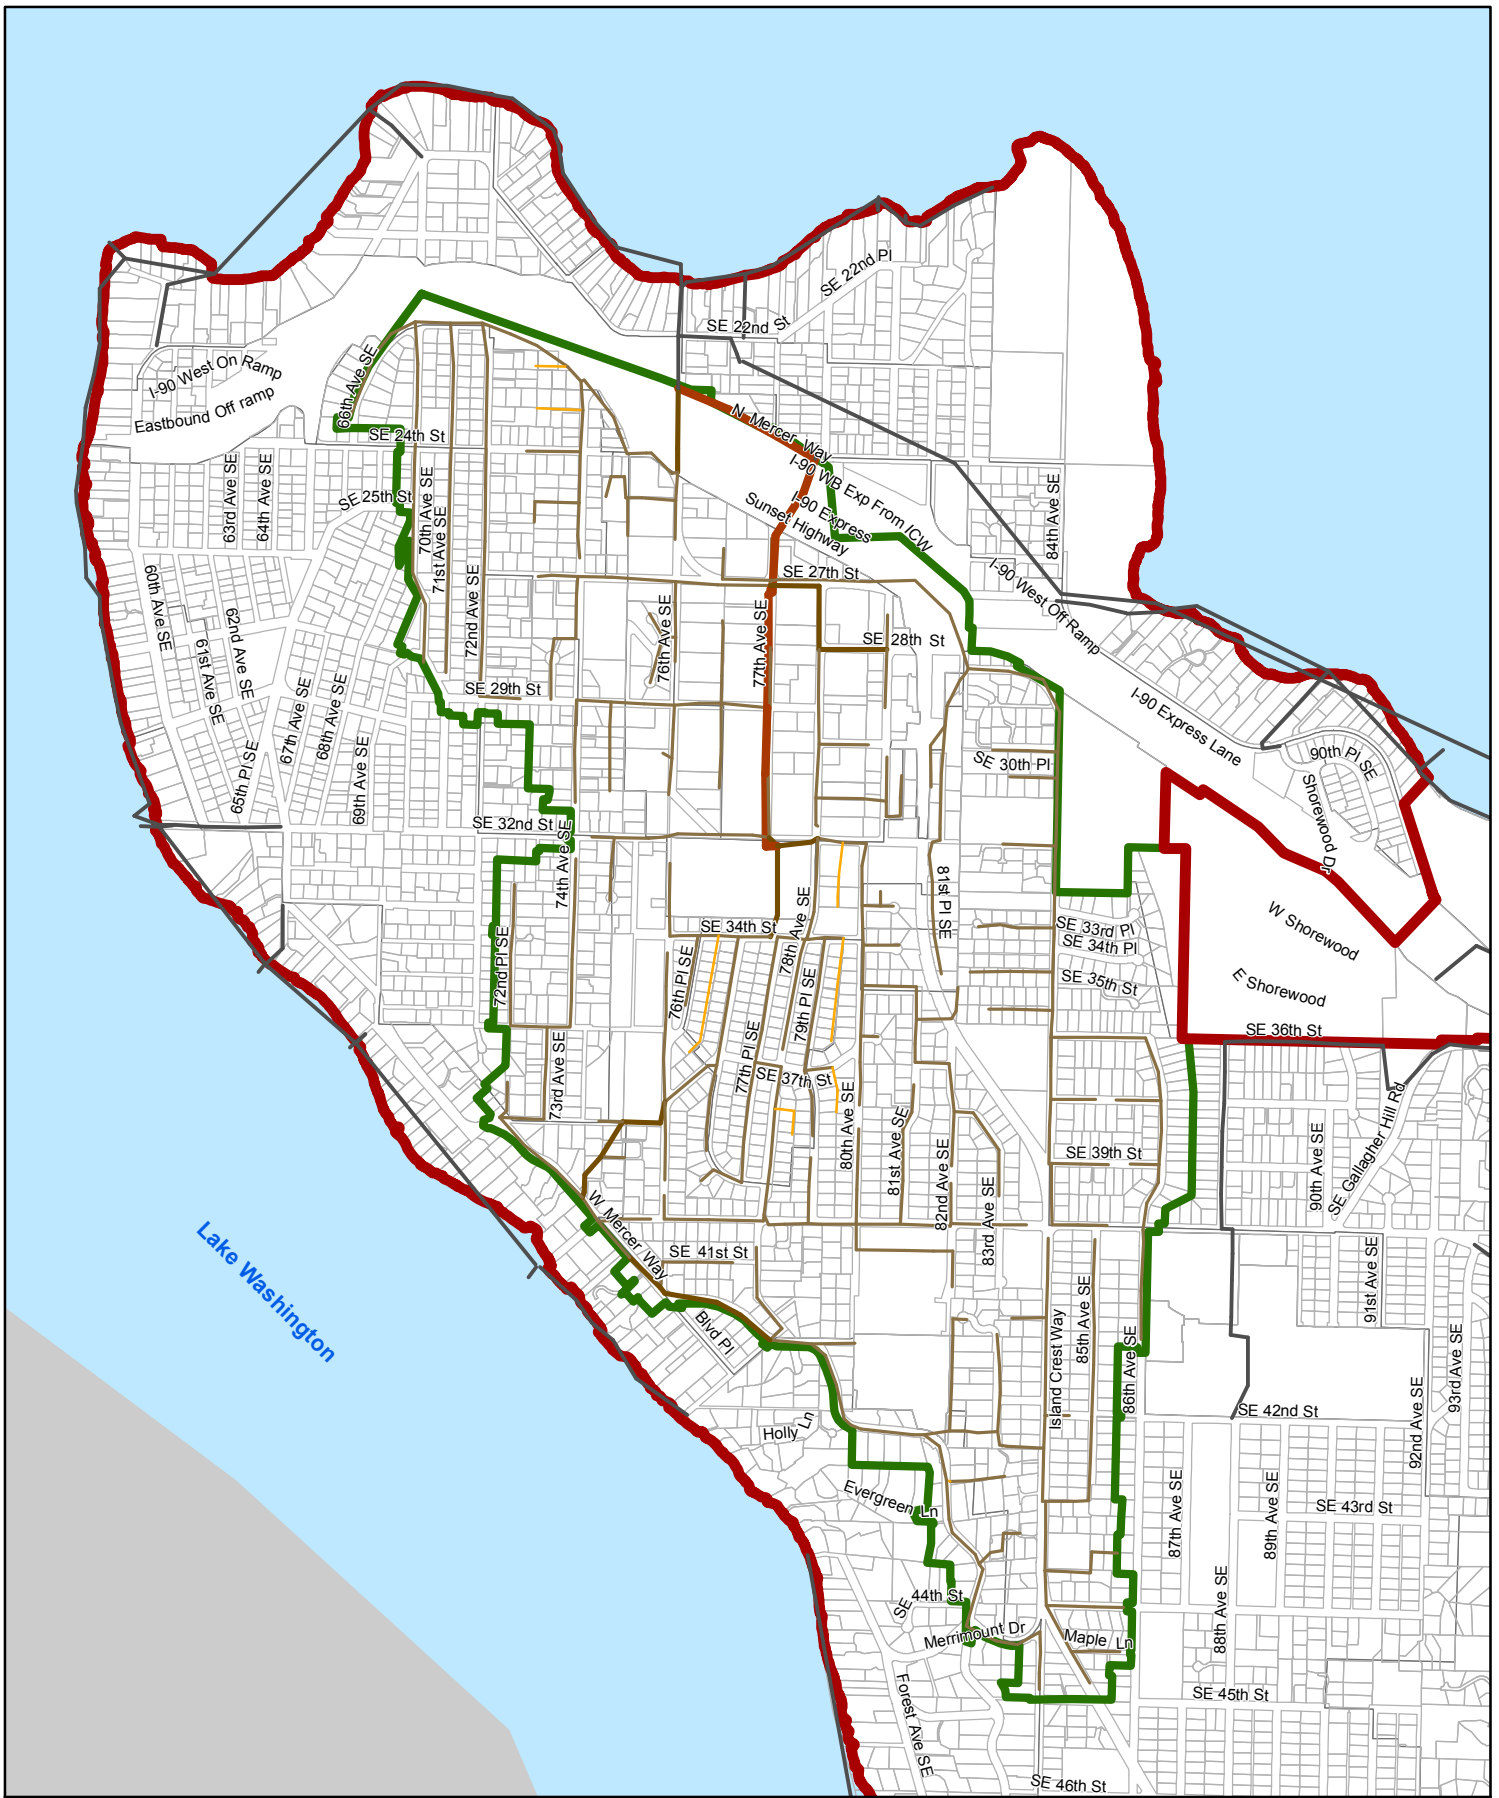
Figure 4.10
Modeled Collection System
 General Sewer Plan Update
 City of Mercer Island

Figure 4.10 presents the elements of the Study Area wastewater collection system included in the hydraulic model. Non-modeled pipelines are shown in grey. Table 4.11 presents a summary of the modeled sewer system by diameter and length of pipe. These totals only include length of pipes located within the Study Area.

Note, the MOUSE model included the City's Lakeline system, which was carried forward in the updated Mike Urban model. The Lakeline system is outside of the Study Area and was not verified or updated, as it was not included in the analysis.

Legend
 System not evaluated as part of the collection system analysis

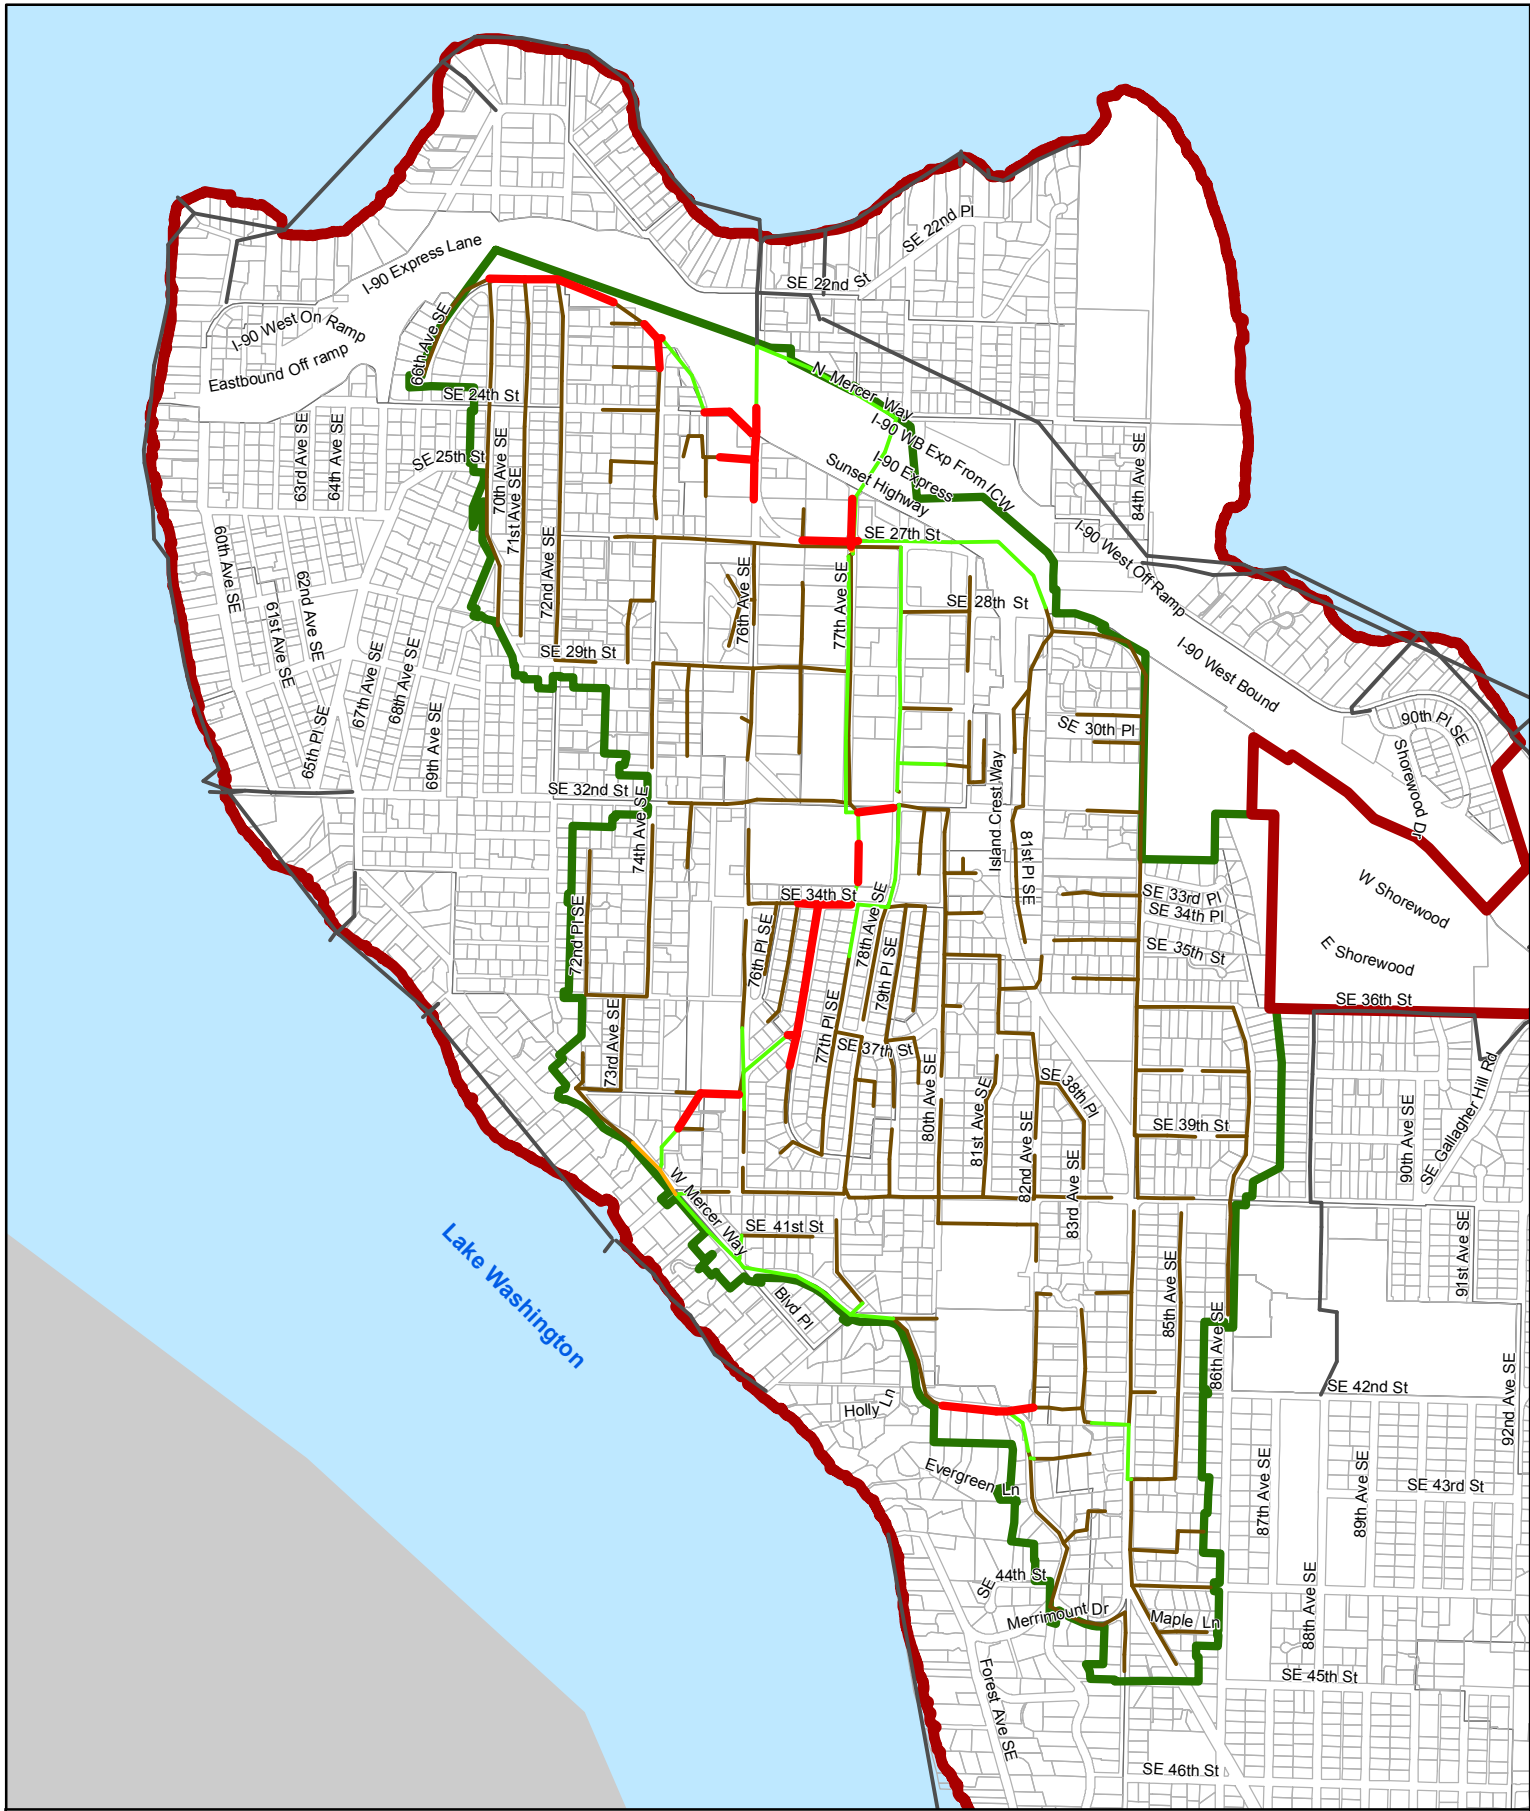
Figure 4.14
Collection System Capacity Deficiencies
- Existing Deficiencies
 General Sewer Plan Update
 City of Mercer Island

For the existing collection system, the PWWF was routed through the hydraulic model for the November/December 2011 design storm. In accordance with the established criteria for existing sewers, pipes that were surcharging were identified. Figure 4.14 shows the locations of the existing pipes at capacity in the study area in red. Red pipes are surcharging under PWWF conditions. Pipes highlighted in orange on Figure 4.14 correspond to pipes approaching surcharging (above 85 percent full, but not surcharging). Pipes highlighted in green and brown corresponds to pipes respectively flowing less than 85 percent full and less than 50 percent full under PWWF conditions. These pipes have

- Legend**
- Maximum d/D Ratio > 1
 - Maximum d/D Ratio between 0.85 and 1
 - Maximum d/D Ratio between 0.5 and 0.85
 - Maximum d/D Ratio less than 0.5
 - System not evaluated as part of the collection system analysis
 - Service Area Boundary
 - Study Area
 - Parcels
 - Zoning
 - Neighboring Cities
