CITY OF MERCER ISLAND

GENERAL SEWER PLAN

November 2018

FINAL

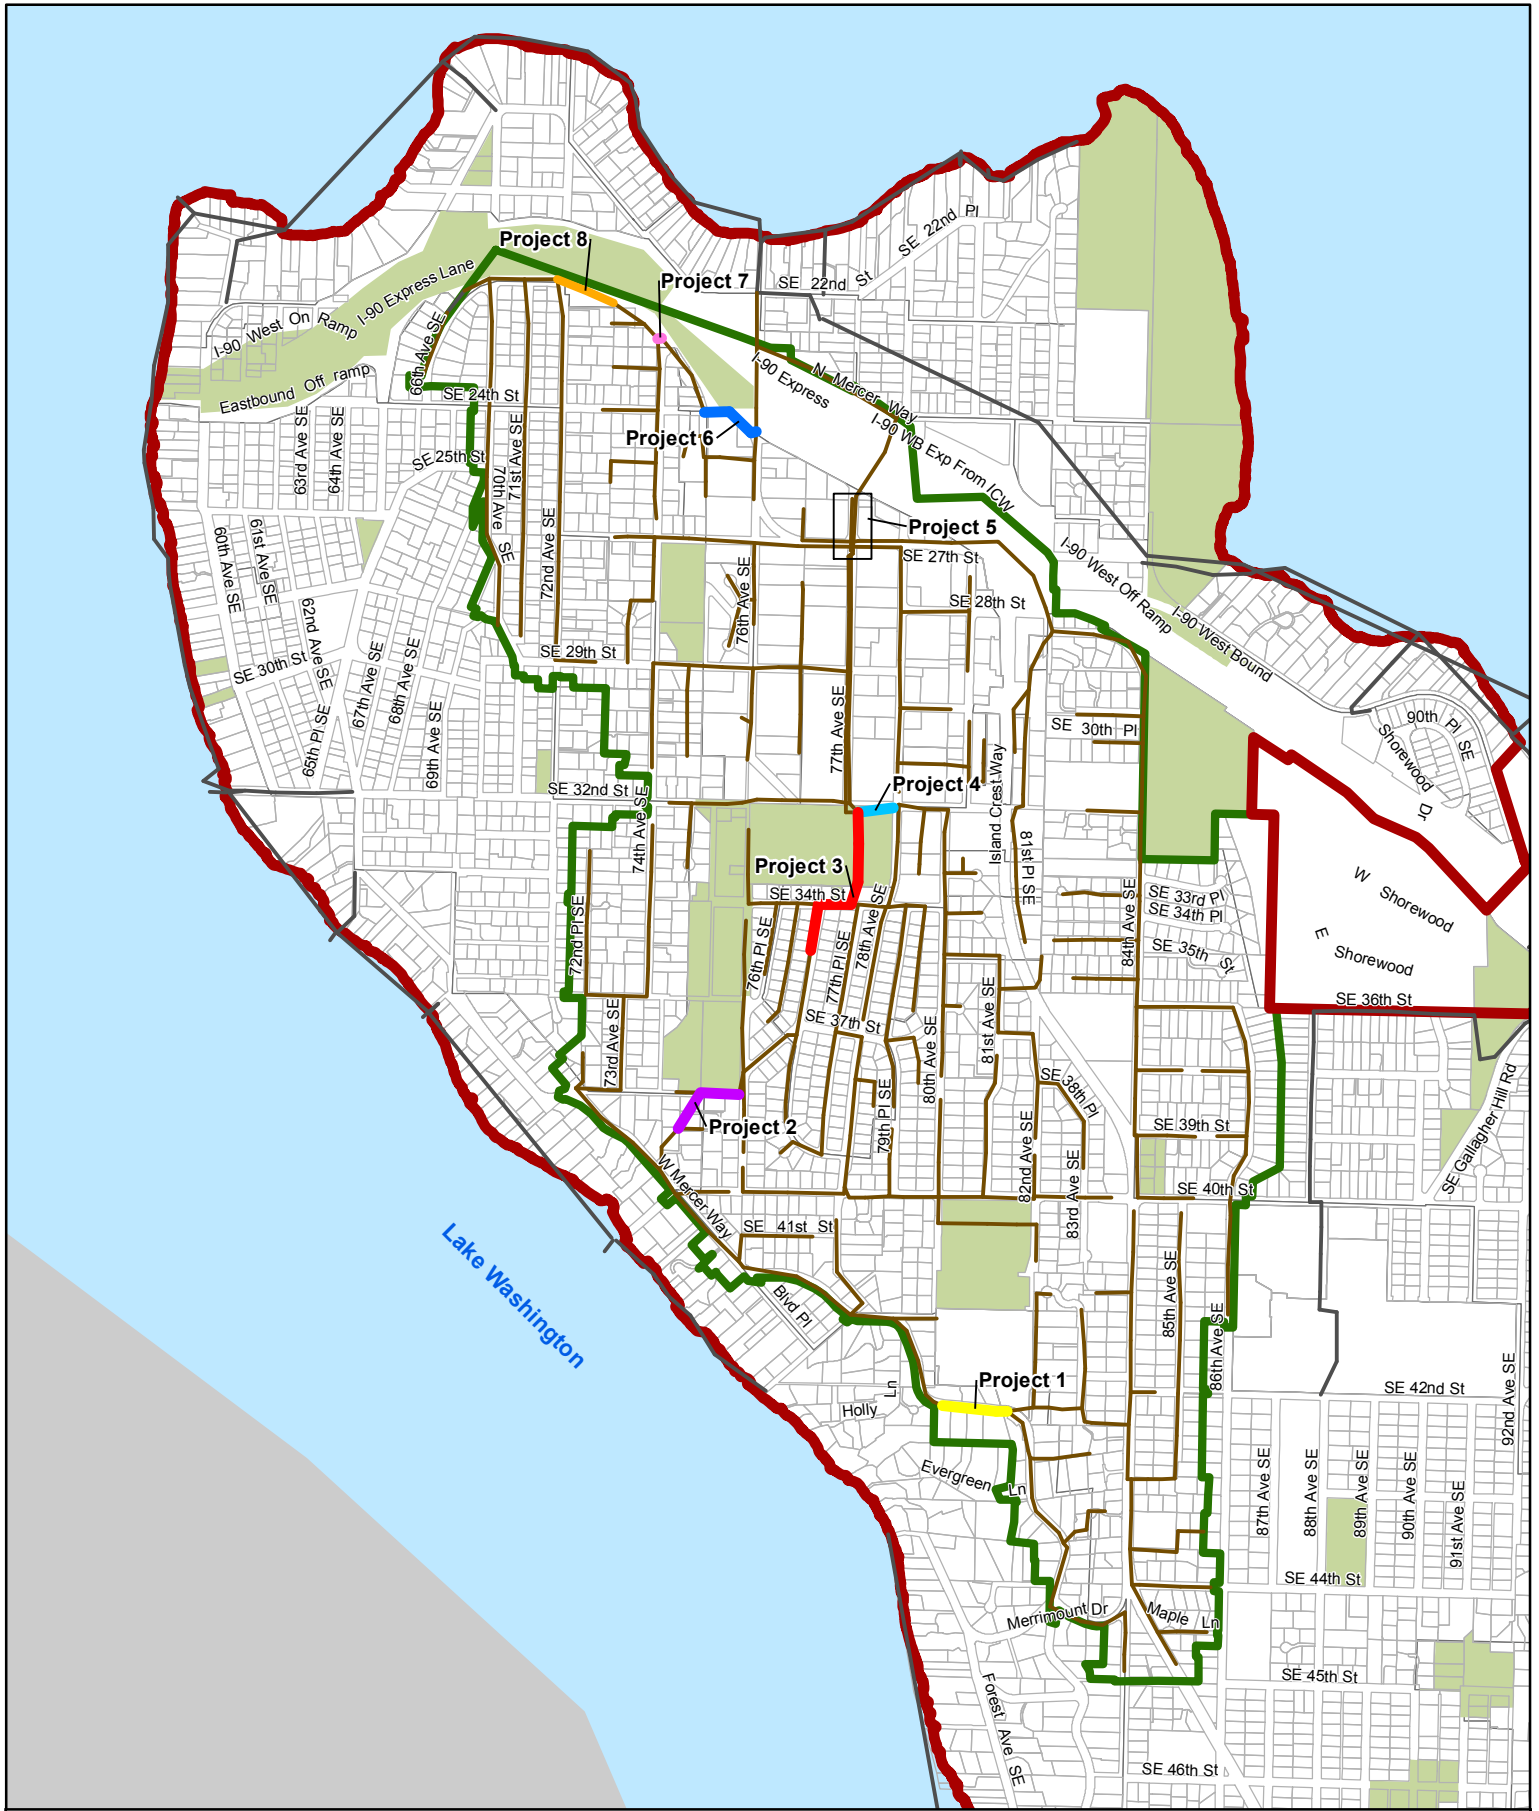
- Legend**
- Project 1
 - Project 2
 - Project 3
 - Project 4
 - Project 5
 - Project 6
 - Project 7
 - Project 8
 - Existing gravity system
 - System not evaluated as part of the collection
 - Service Area Boundary
 - Study Area
 - Parcels
 - Zoning
 - Neighboring Cities
 - Parks

Project 8	Pipeline	East of the intersection of 72nd Ave. S.E. and S.E. 22nd St., south of I-90	Upsize pipe	8	12	441	49-84	49-83	Capacity Deficient under existing and build-out conditions.	New problem due to flow re-allocation more upstream in the system than the former model.
Total (feet)						3,317

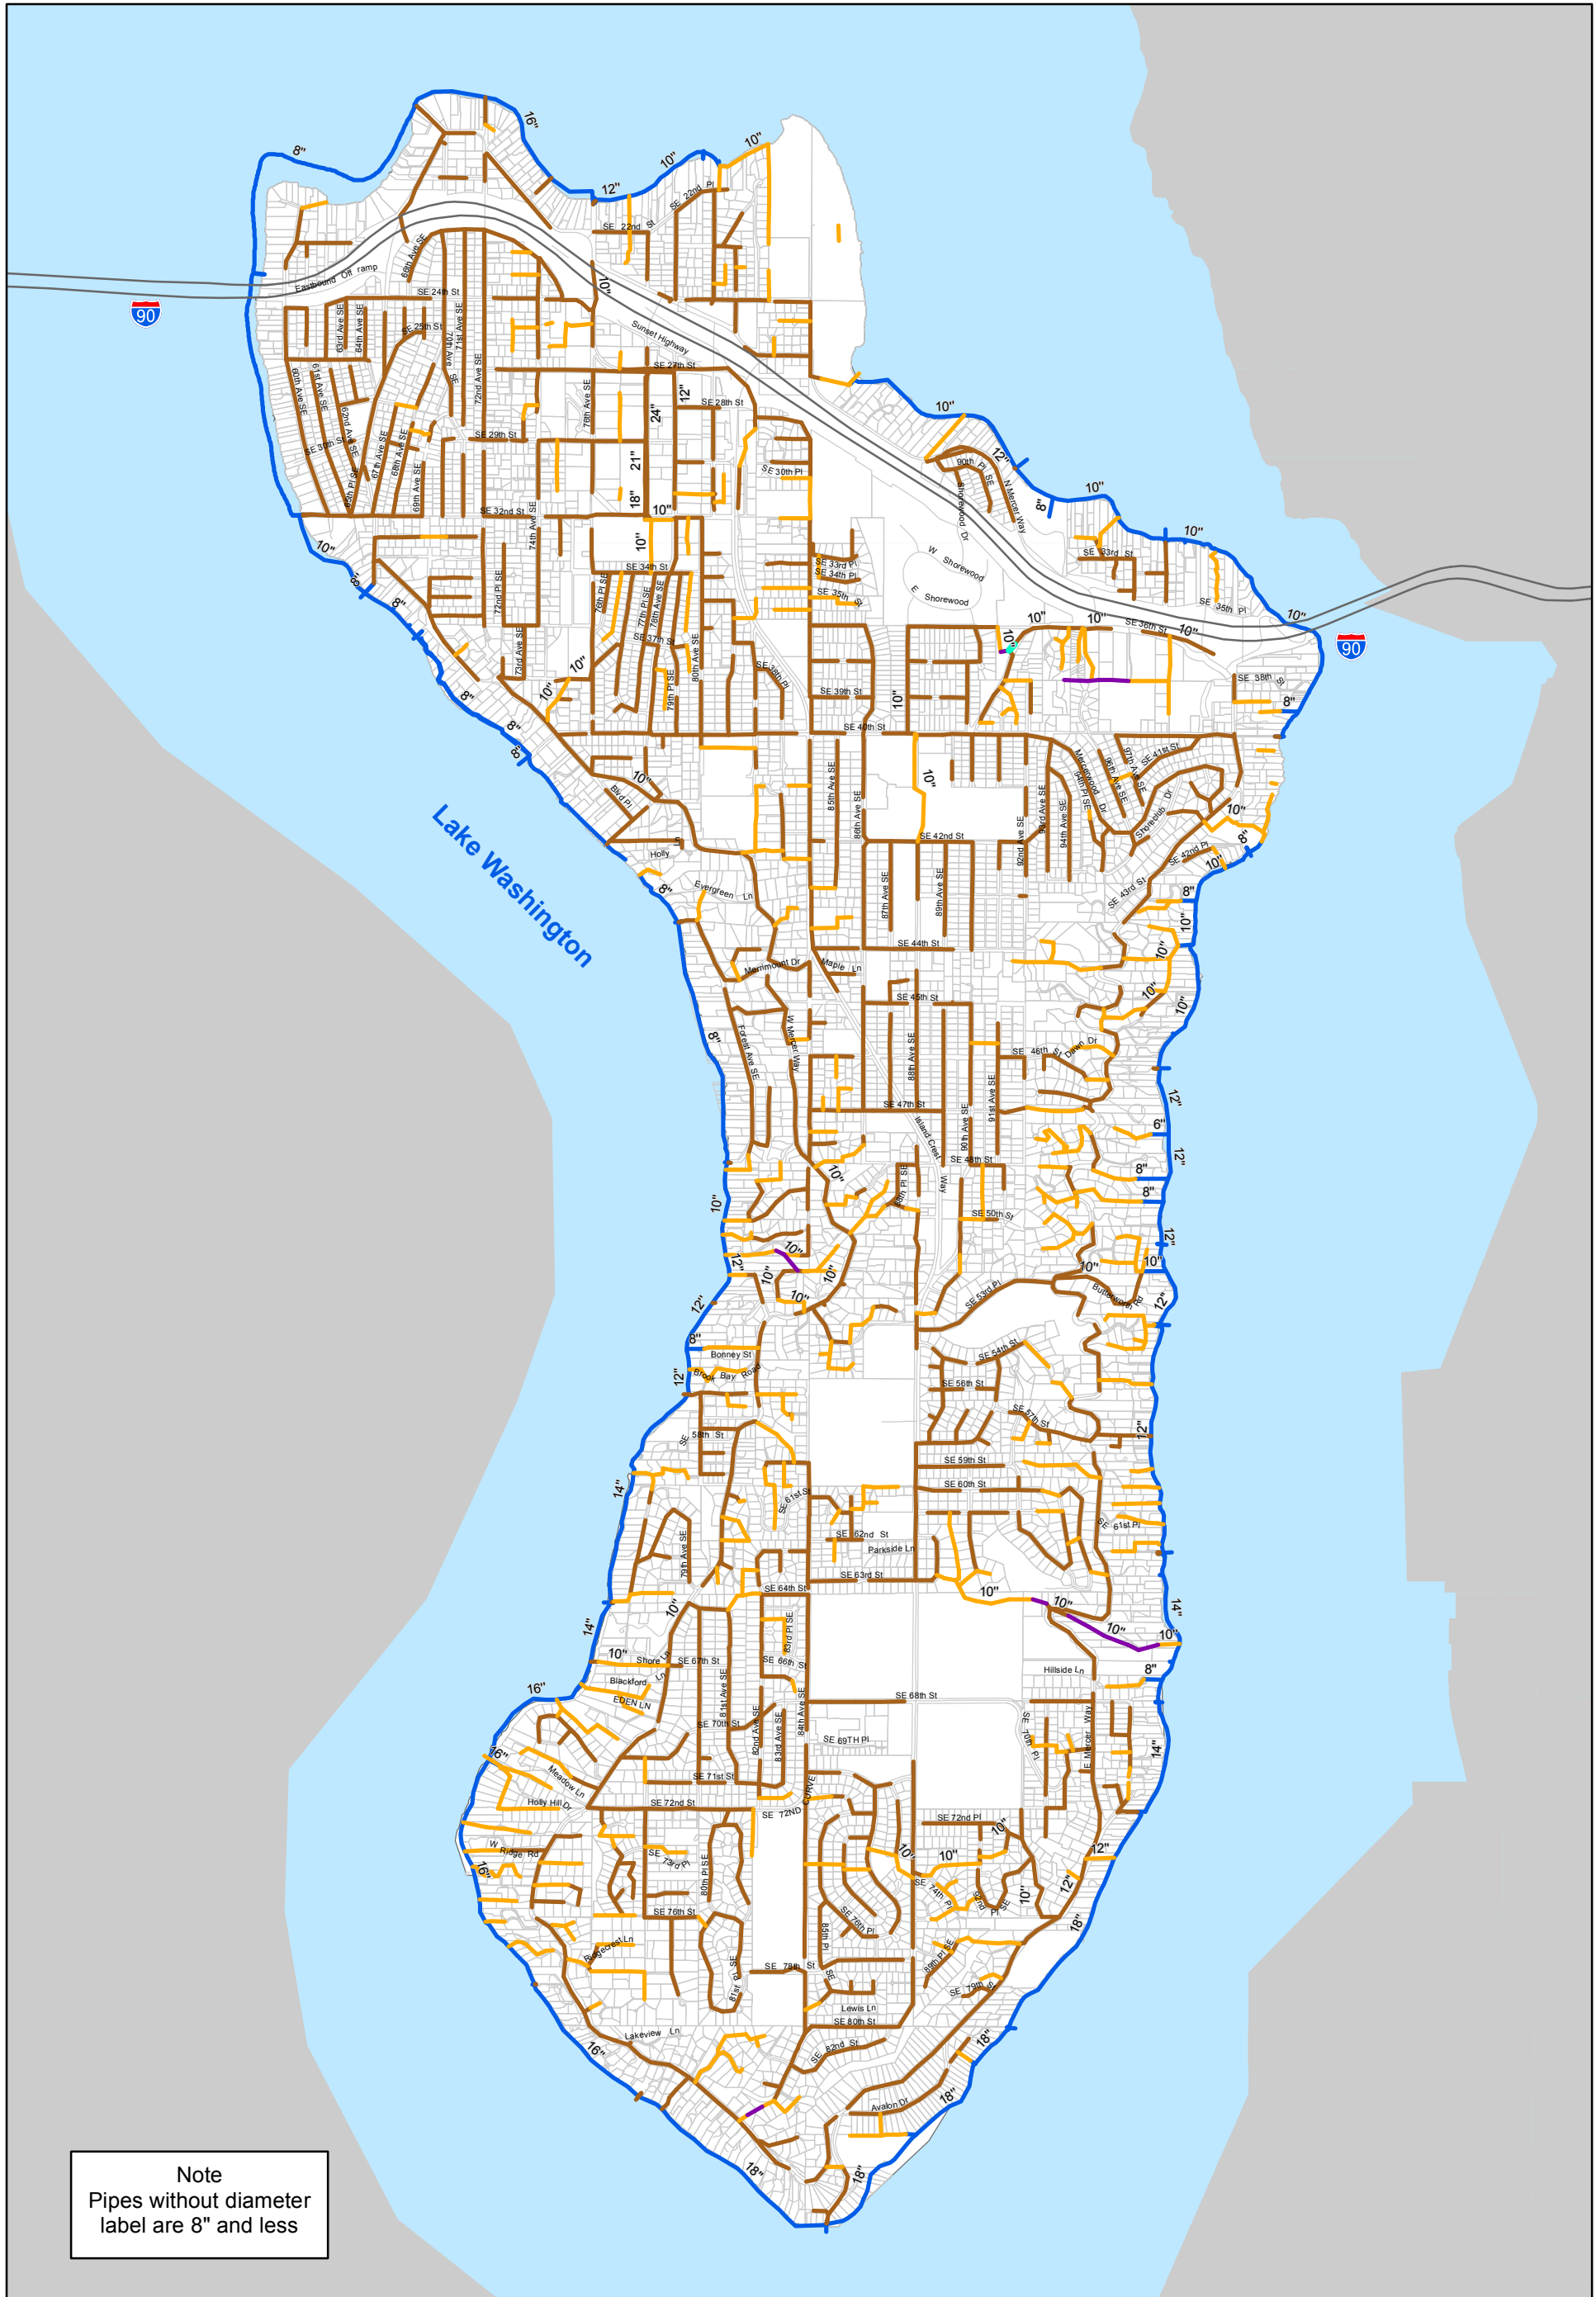
Note
Pipes without diameter
label are 8" and less

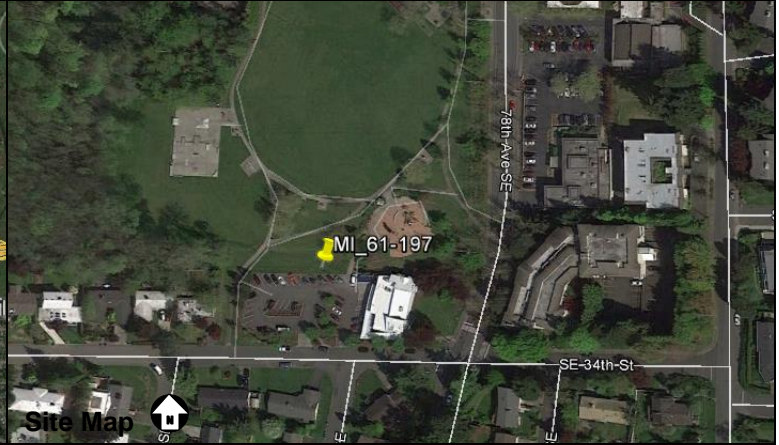
Project Name: Mercer Island TFM		City / State: Mercer Island, WA		FM Initials: SW	
Site Name: MI_61-197		Monitor Series: Flowshark AG		Monitor S/N: 21482	
Address/Location: Site is located within Mercerdale Park 153.00' North of 7719 SE 34th St				Manhole #: 61-197	
				GPS Coordinates: 47.580334°, -122.234807°	
				Pipe Height: 10.13"	
Access: Drive / Walk	Type of System:	Sanitary <input checked="" type="checkbox"/>	Storm <input type="checkbox"/>	Combined <input type="checkbox"/>	Pipe Width: 10.00"
					IP Address: 166.213.6.142

Date/Time of Investigation: 01/08/2016 @ 12:10		Manhole Depth: 5'	
Site Hydraulics: Smooth, slightly draws down through M/H chamber		Manhole Material / Condition: Concrete / Good	
Upstream Input: (L/S, P/S) None		Pipe Material / Condition: VCP / Good	
Upstream Manhole: Not Investigated		Mini System Character:	Residential <input checked="" type="checkbox"/> Commercial <input type="checkbox"/> Industrial <input type="checkbox"/> Trunk <input type="checkbox"/>
Downstream Manhole: Not Investigated		Telephone Information: Does not apply	
Depth of Flow:	2.80" +/- 0.25"	Access Pole #:	Does not apply
Range (Air DOF):	7.20" +/- 0.25"	Distance From Manhole:	Does not apply Feet
Peak Velocity:	1.87 fps	Road Cut Length:	Does not apply Feet
Silt:	0.00"	Trench Length:	Does not apply Feet

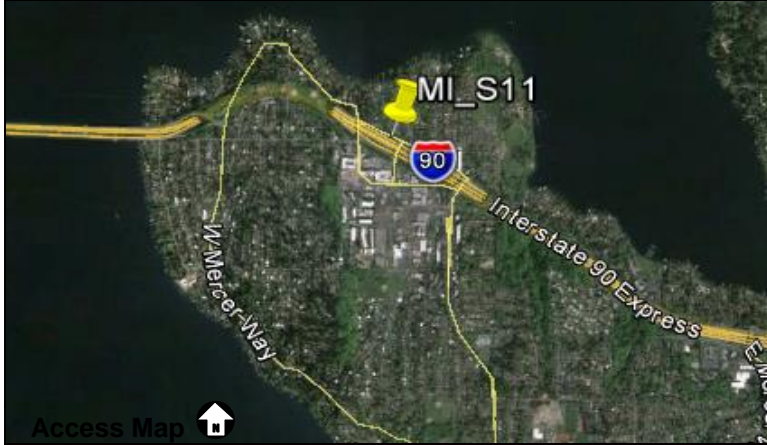
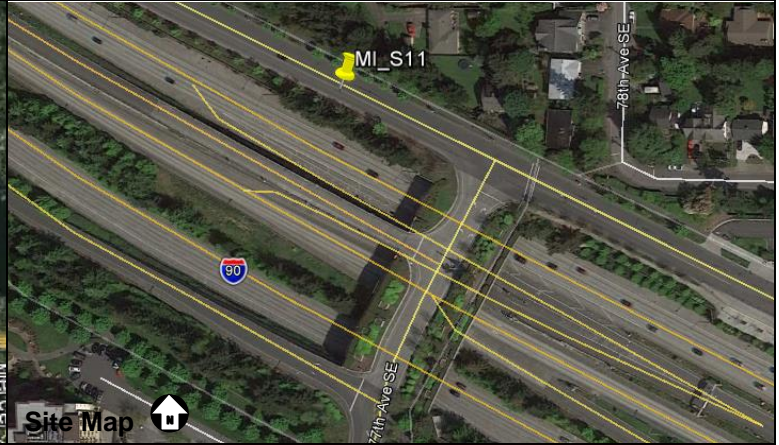
Project Name: Mercer Island TFM		City / State: Mercer Island, WA		FM Initials: SW	
Site Name: MI_S-11		Monitor Series: Flowshark AG		Monitor S/N: 21479	
Address/Location: Site is located on North bound left lane of N Mercer Way (Closest intersection 77 th Ave SE and N Mercer Way)				Manhole #: MI_S-11	
				GPS Coordinates: 47.589436°, -122.235152°	
Access: Drive / Walk				Pipe Height: 24.38"	
Type of System: Sanitary <input checked="" type="checkbox"/> Storm <input type="checkbox"/> Combined <input type="checkbox"/>				Pipe Width: 24.50"	
				IP Address: 166.213.6.134

Date/Time of Investigation: 02/25/2016 @ 13:00		Manhole Depth: 18.5'	
Site Hydraulics: Laminar Flow		Manhole Material / Condition: Concrete / Good	
Upstream Input: (L/S, P/S) None		Pipe Material / Condition: VCP / Good	
Upstream Manhole: Not Investigated		Mini System Character: Residential <input checked="" type="checkbox"/> Commercial <input checked="" type="checkbox"/> Industrial <input type="checkbox"/> Trunk <input type="checkbox"/>	
Downstream Manhole: Not Investigated		Telephone Information: Does not apply	
Depth of Flow:	7.11" +/- 0.13"	Access Pole #:	Does not apply
Range (Air DOF):	17.27" +/- 0.13"	Distance From Manhole:	Does not apply Feet
Peak Velocity:	1.11 fps	Road Cut Length:	Does not apply Feet
Silt:	0.00"	Trench Length:	Does not apply Feet

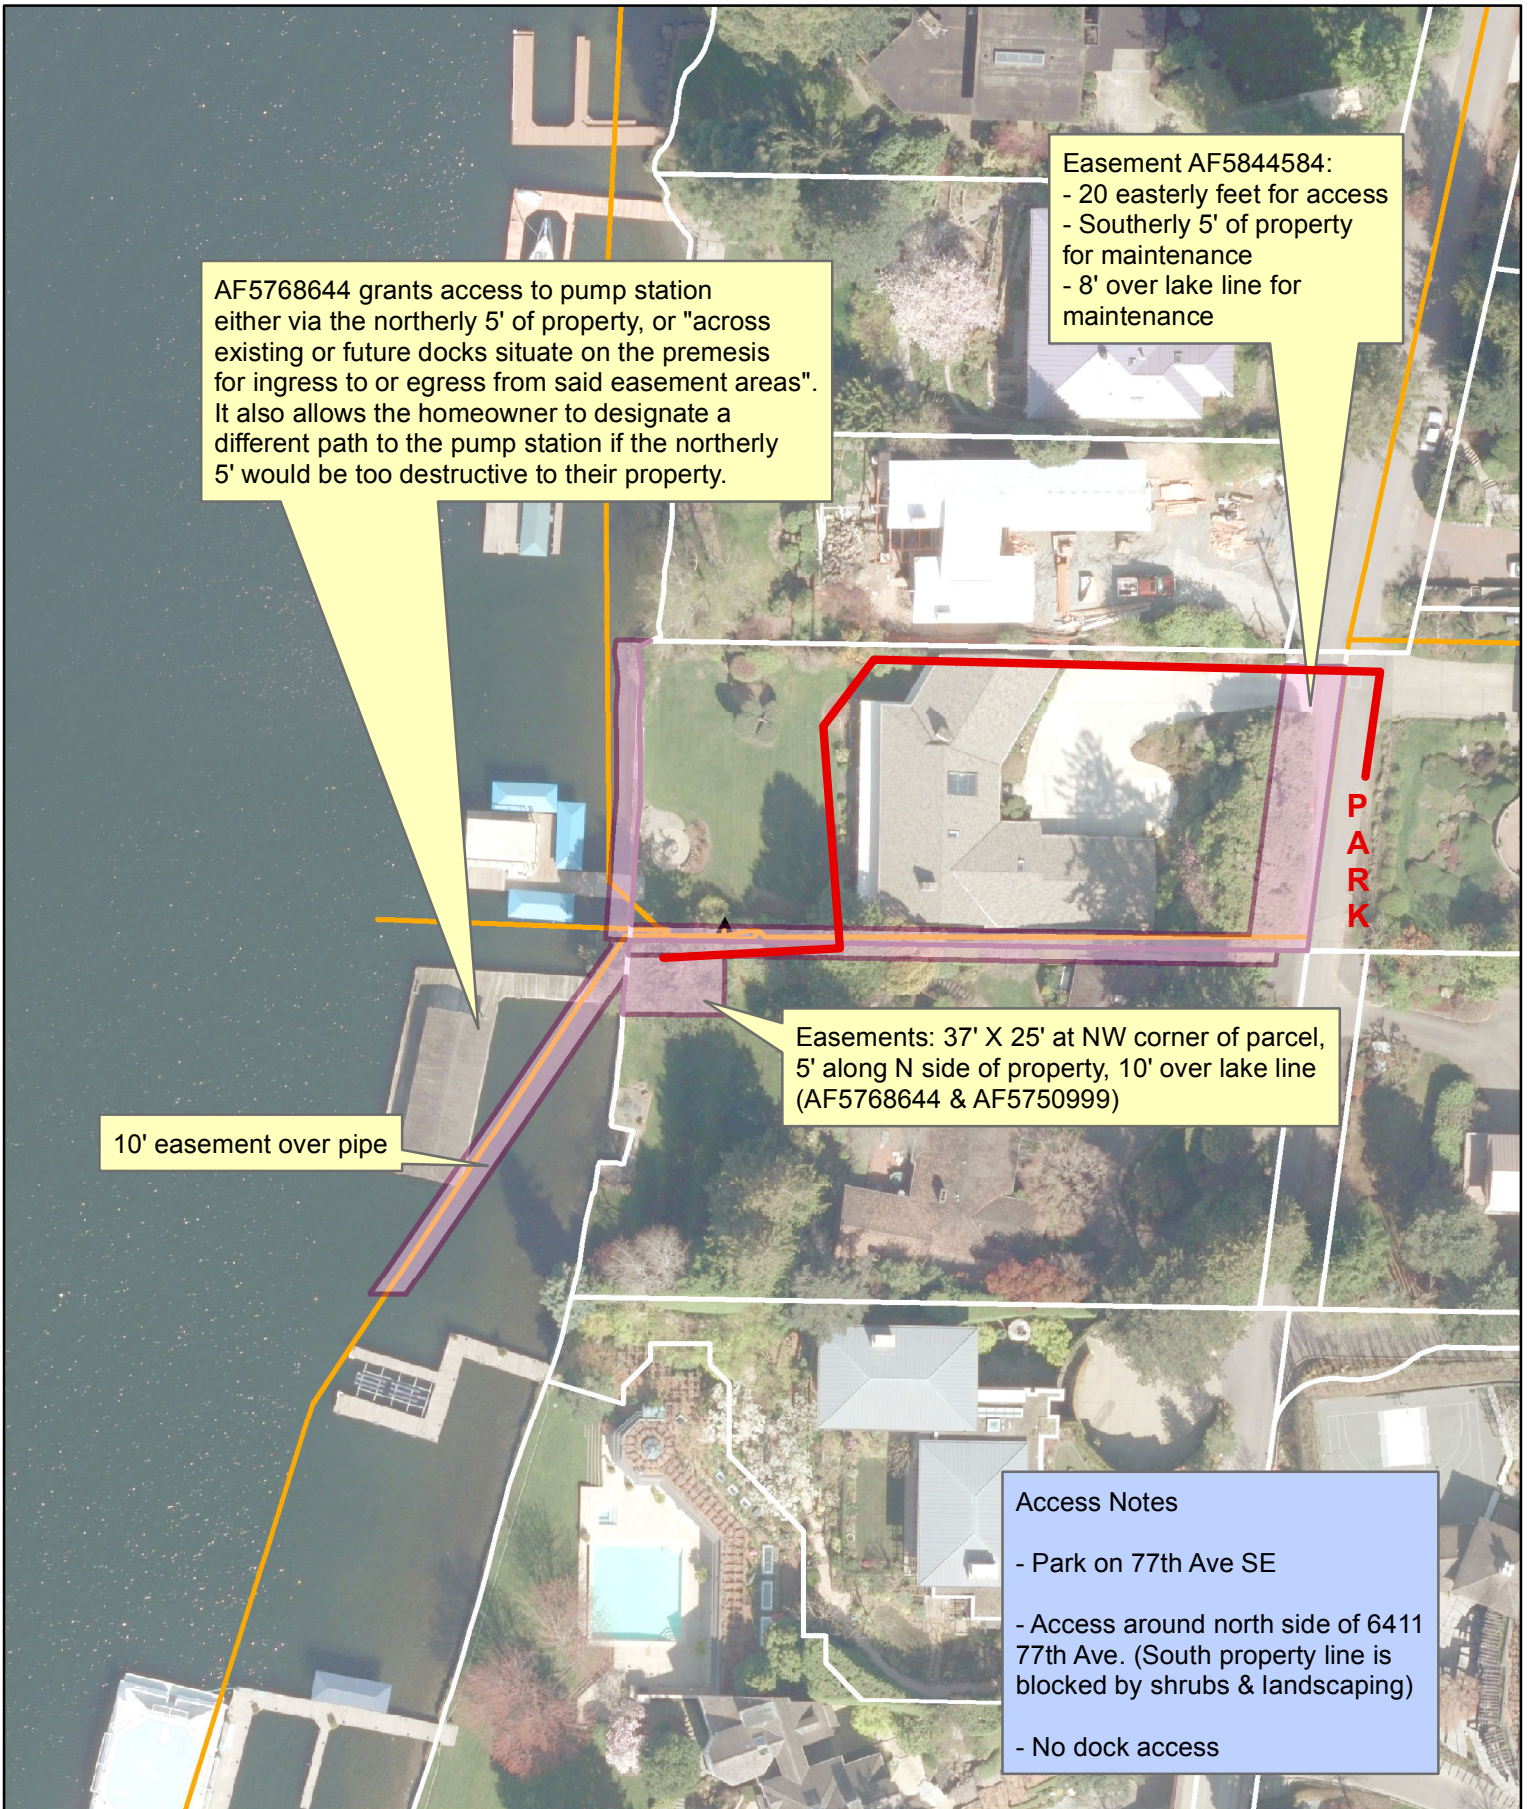
AF5768644 grants access to pump station either via the northerly 5' of property, or "across existing or future docks situate on the premises for ingress to or egress from said easement areas". It also allows the homeowner to designate a different path to the pump station if the northerly 5' would be too destructive to their property.
