MERCER ISLAND PARKS
OVERWATER STRUCTURES ASSESSMENT

DRAFT REPORT

May 30, 2014

Re: **Mercer Island Parks – Overwater Structures Assessment**

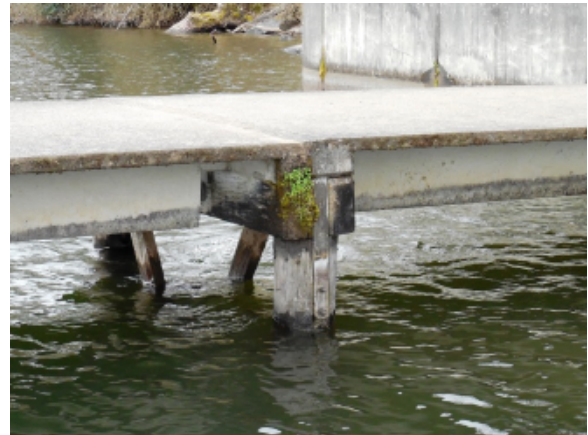
Photo 8A – Typical pier construction

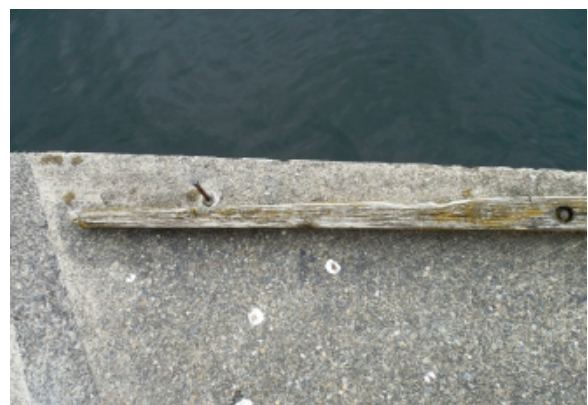
Photo 12A – Deteriorated / loose bull rail

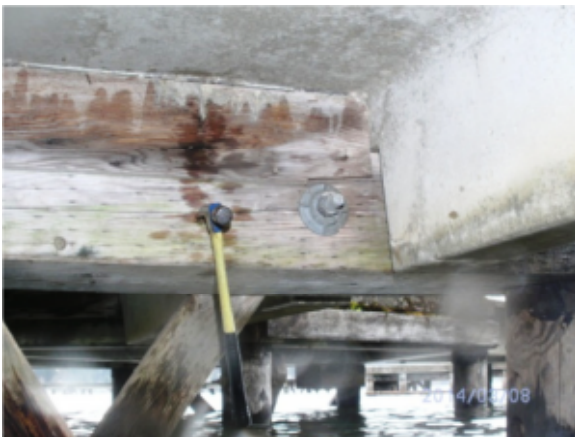
Photo 17A – Precast "T" and timber cap beam

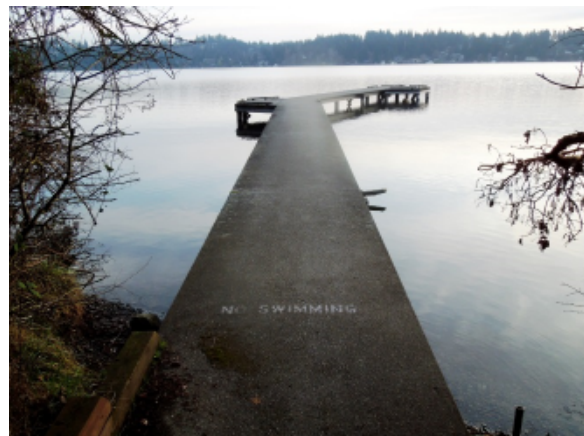
Photo 22A – Small pier

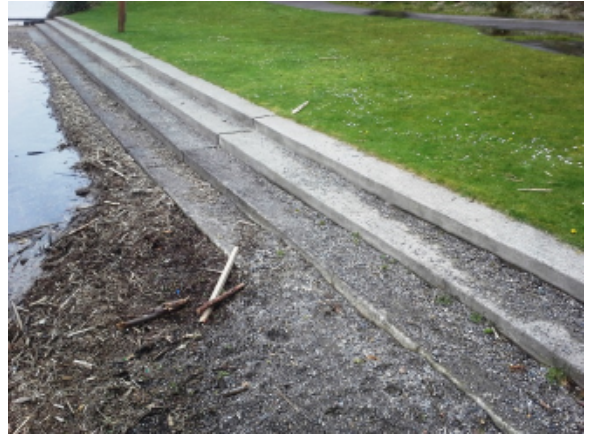
Photo 2B – Shoreline steps

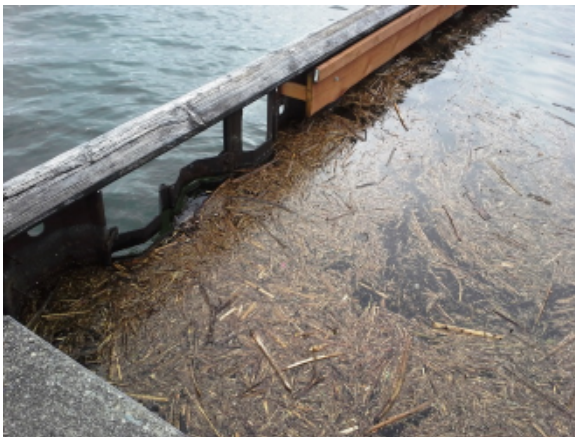
Photo 3B – Sheet piling with fish windows

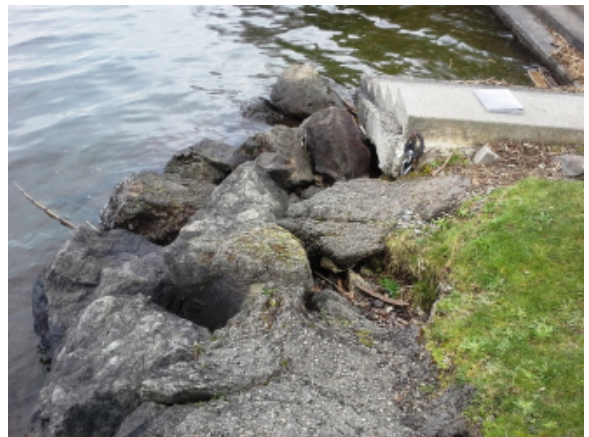
Photo 4B – Rock bulkhead / riprap bank

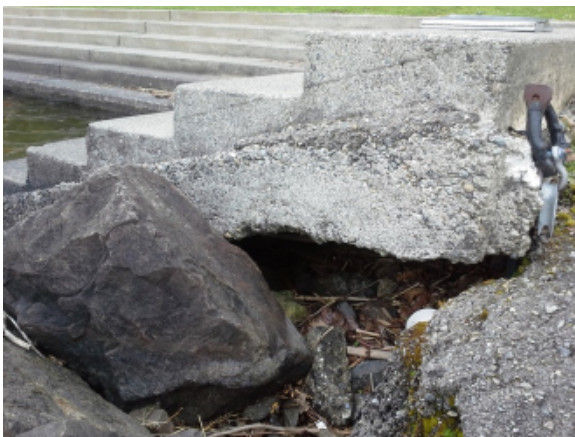
Another section of concrete stairs extends down into the water along the portion of shoreline south of the rock bulkhead. These stairs have been severely undermined by wave action. This has resulted in some cracking of the concrete. Beginning approximately 85 feet south of the bulkhead, a sheetpile wall has been installed at the toe of the concrete stairs. The sheetpile wall extends south approximately 65 feet to the south end of the stairs. A concrete cap has been placed along the top of the sheetpile wall. The cap is connected to the toe of the concrete stairs by bolts extending through the face of the cap and by steel plates that span between the tread of the lower step and the top of the concrete cap. Most of the bolt holes extending through the face of the pile cap are missing bolts. These open holes provide a conduit for wave action behind the sheetpile wall. In some areas gaps were observed between individual sheetpiles and between the tops of the sheetpile wall and pile cap. These gaps also provide conduits for wave action that could potentially undermine the toe of the adjacent stairs. In some areas, lateral deflection of the sheetpile wall occurred under hand pressure. This suggests poor embedment of the sheetpiles. The portion of the concrete

Photo 5B – Shoreline steps

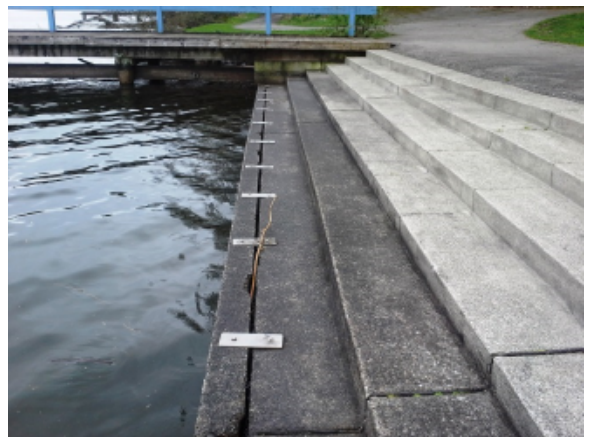
Photo 6B – Shoreline steps / added sheet piling

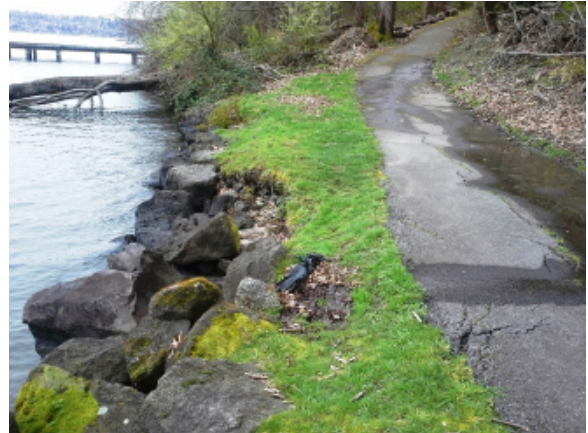
Photo 8B – Rock bulkhead / riprap bank

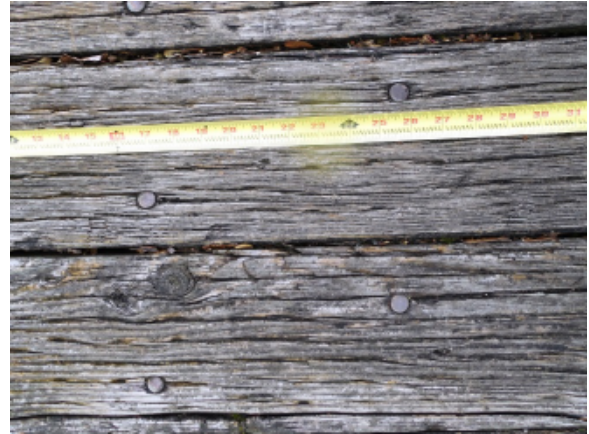
Photo 14B – Weathered wood decking

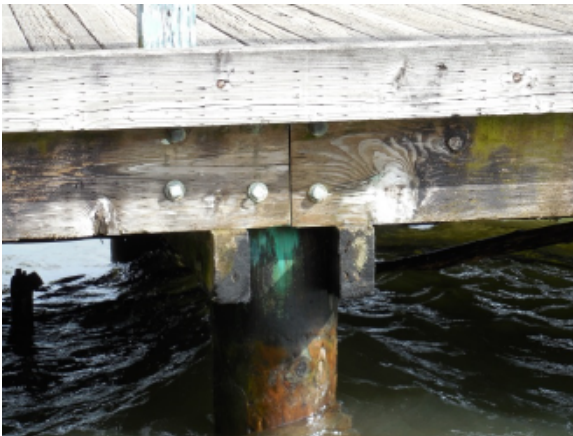
Photo 15B – Typical pier construction

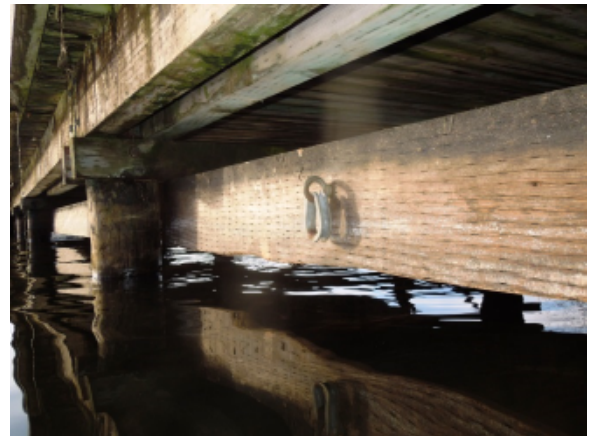
Photo 16B – Typical pier construction

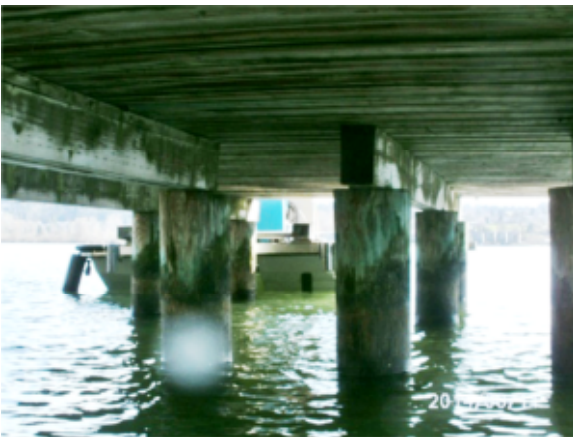
Photo 17B – Treated timber piles

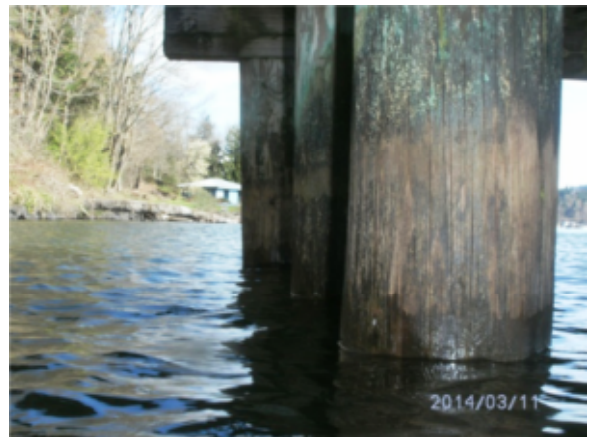
Photo 18B – Treated timber piles

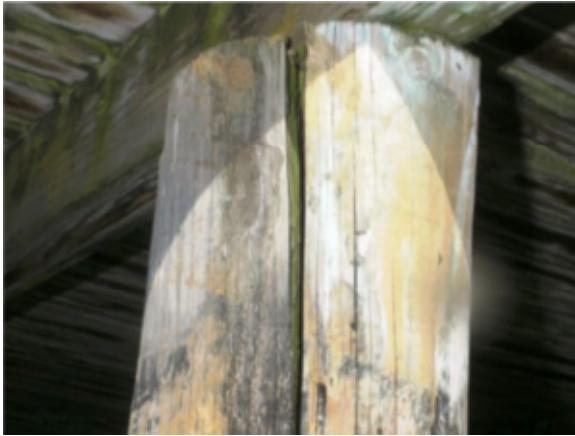
Photo 19B – Split pile

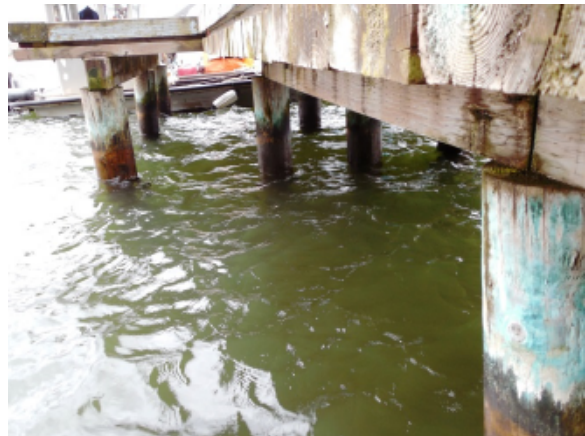
Photo 22B – Looking east along small pier

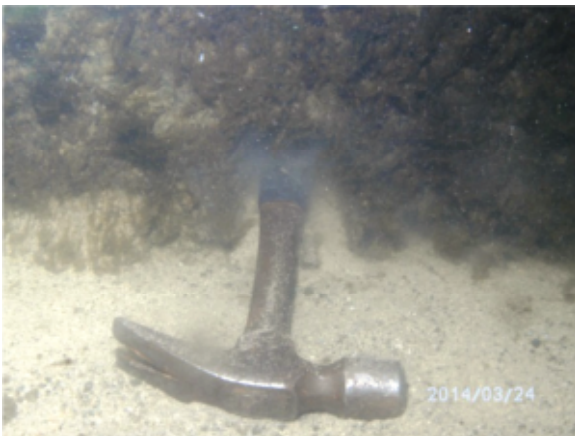
Photo 5C – Undermined bulkhead toe

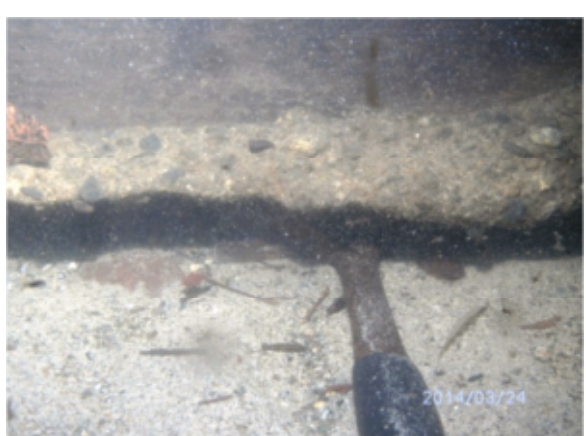
Photo 6C – Undermined bulkhead toe

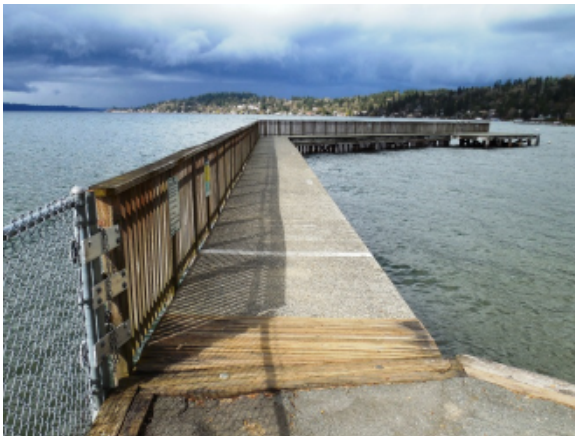
Photo **9C** – Large pier, looking north

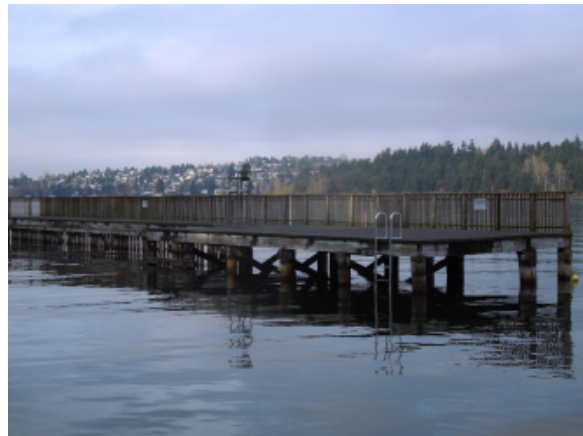
Photo **10C** – Large pier, looking south

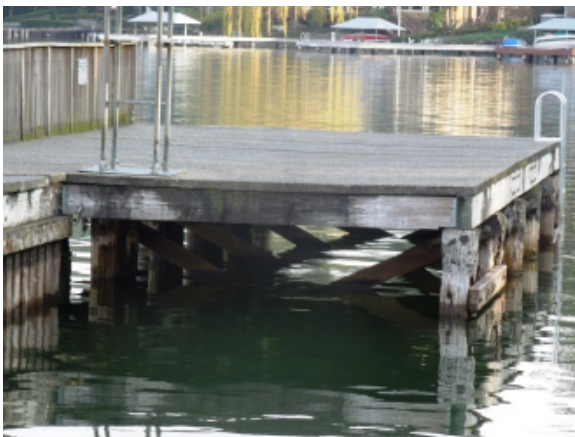
Photo **11C** – Large pier, north end

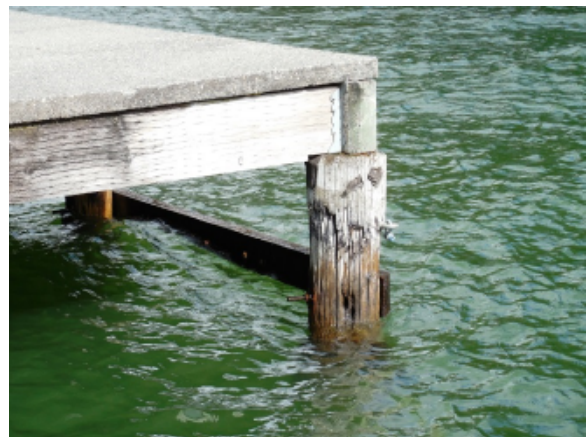
Photo **18C** – Large pier deck, stringers and pile

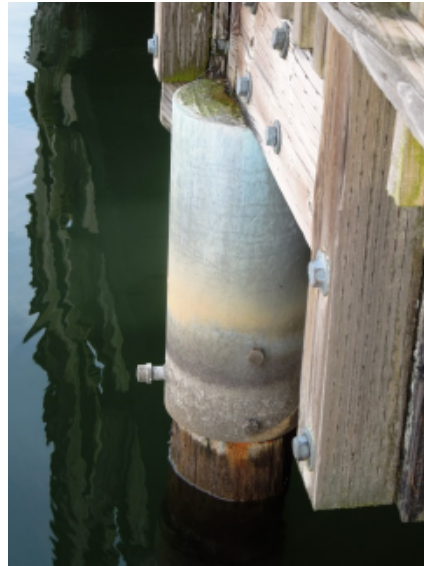
Photo 20C – “Canned” pile (previous repair)

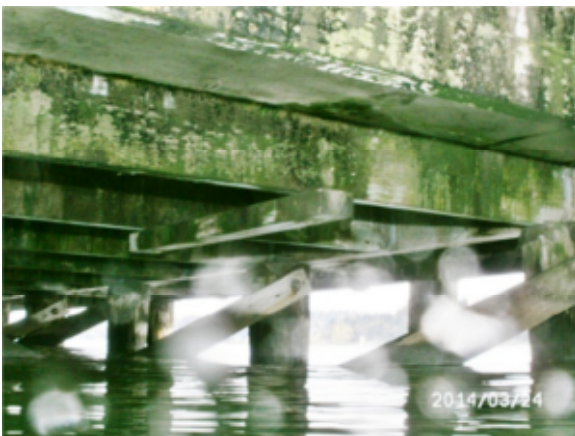
Photo 23C – Large pier substructure

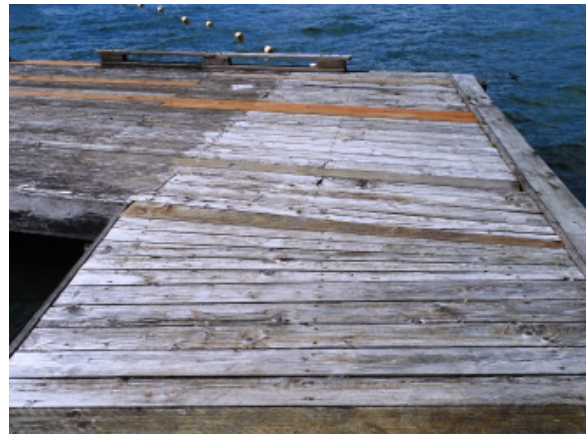
Photo 30C – Small pier decking, past repair
