City of Mercer Island

Americans with Disabilities Act

ADA Transition Plan

2022

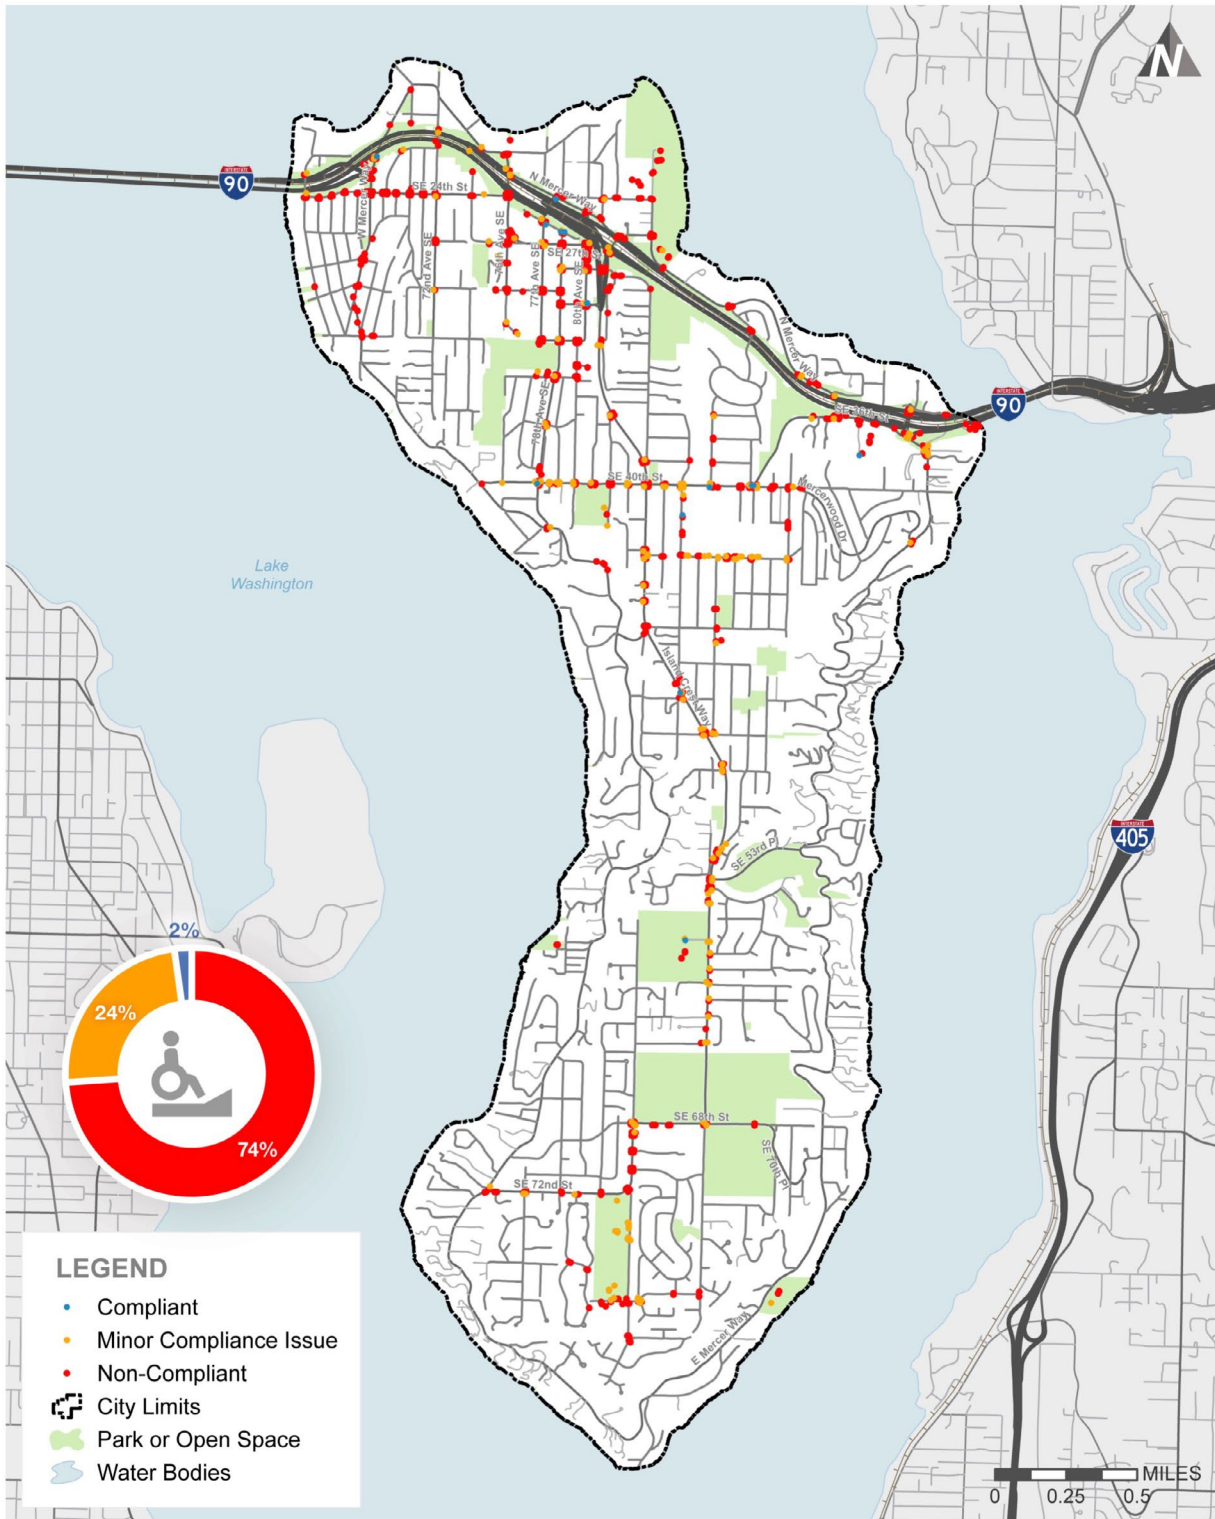
2-7

- Non-compliant ramp width, i.e., the ramping area is not present or too narrow (Figure 2-8).
- Non-compliant running slope, i.e., the ramp running slope is too steep (Figure 2-9). 288 curb ramps have running slopes greater than 8.3%.
- Non-compliant cross slope, i.e., the cross slope is too steep (Figure 2-10). 503 curb ramps have cross slopes greater than 2%, 312 of which have cross slopes greater than 3%.
- Several minor non-compliant features, such as flare slope, detectable warning surface (DWS) placement, receiving ramp, etc.

Non-Compliant Curb Ramp

Curb ramps are designed and constructed to tie into the existing roadway. As noted previously, steep or otherwise constrained locations may make it infeasible to meet ADA grade standards. When it is not feasible to remove all curb ramp barriers, ramps may be built to the maximum extent feasible (MEF) to satisfy ADA requirements. This planning level Self-Evaluation did not examine whether non-compliant ramps were built to the maximum extent feasible. See Section 5.1 for additional information regarding MEF documentation.

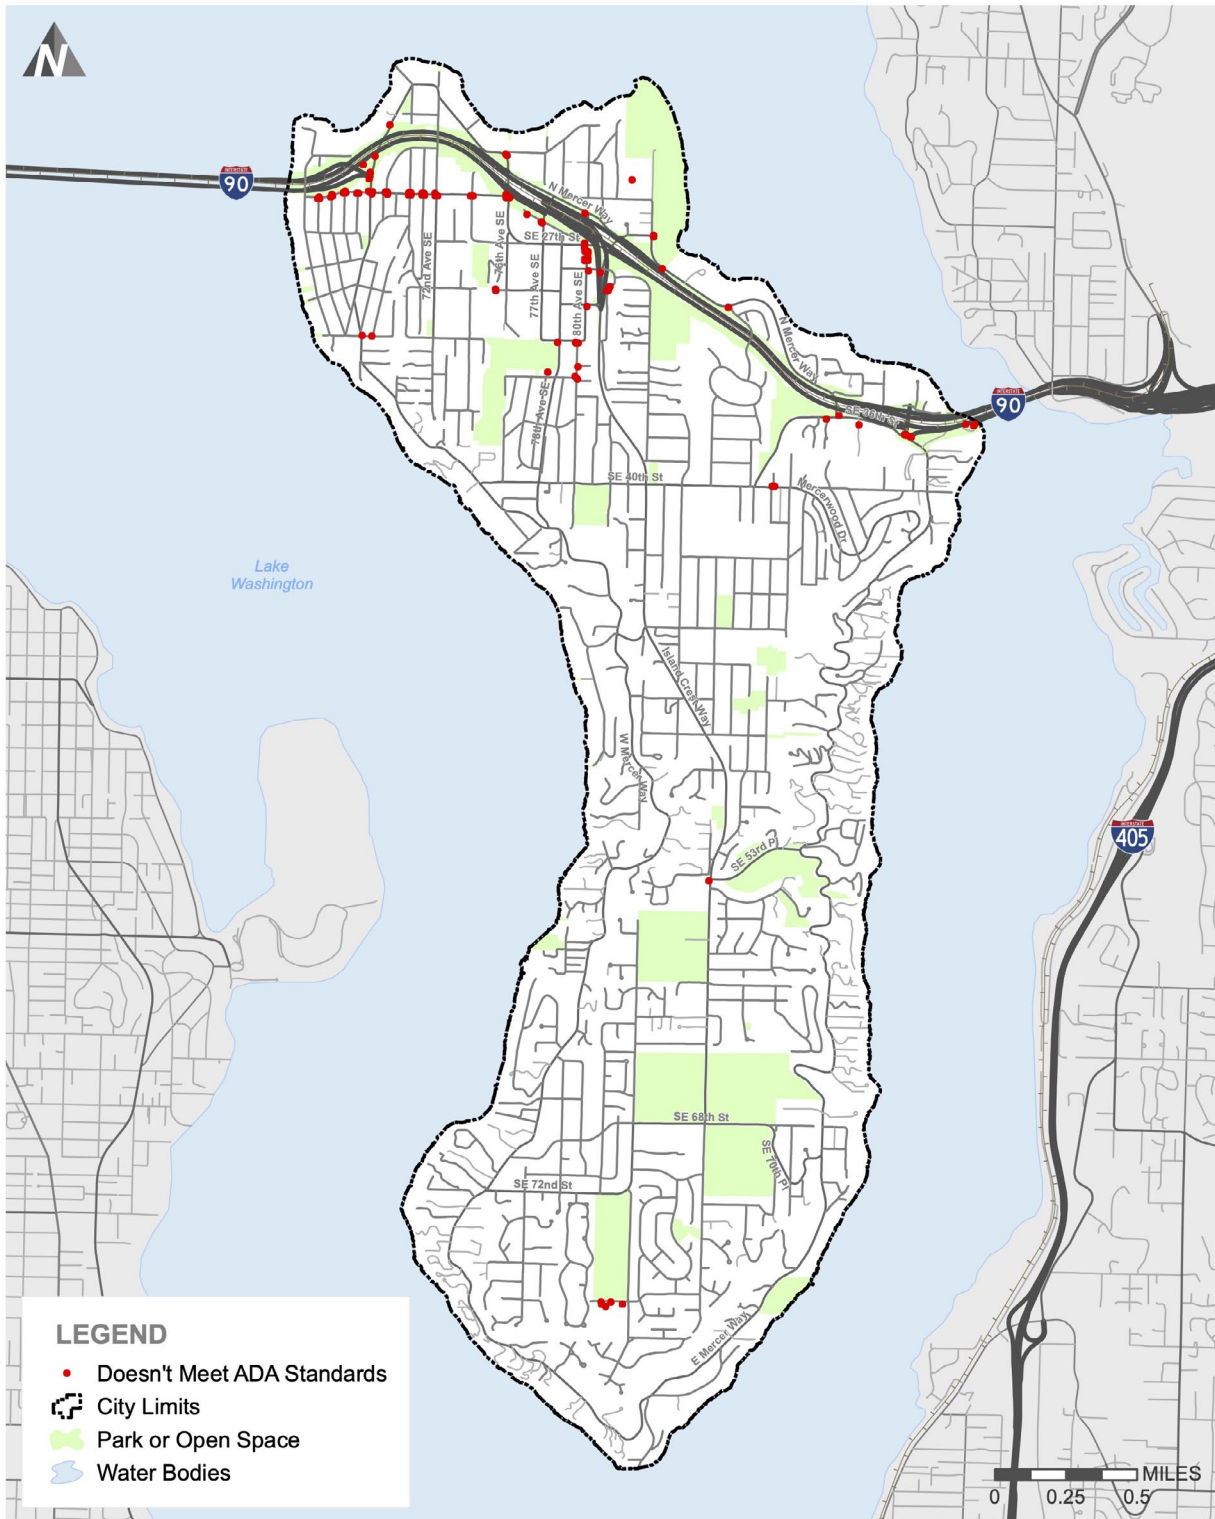
FIGURE
2-8

Curb Ramp Width

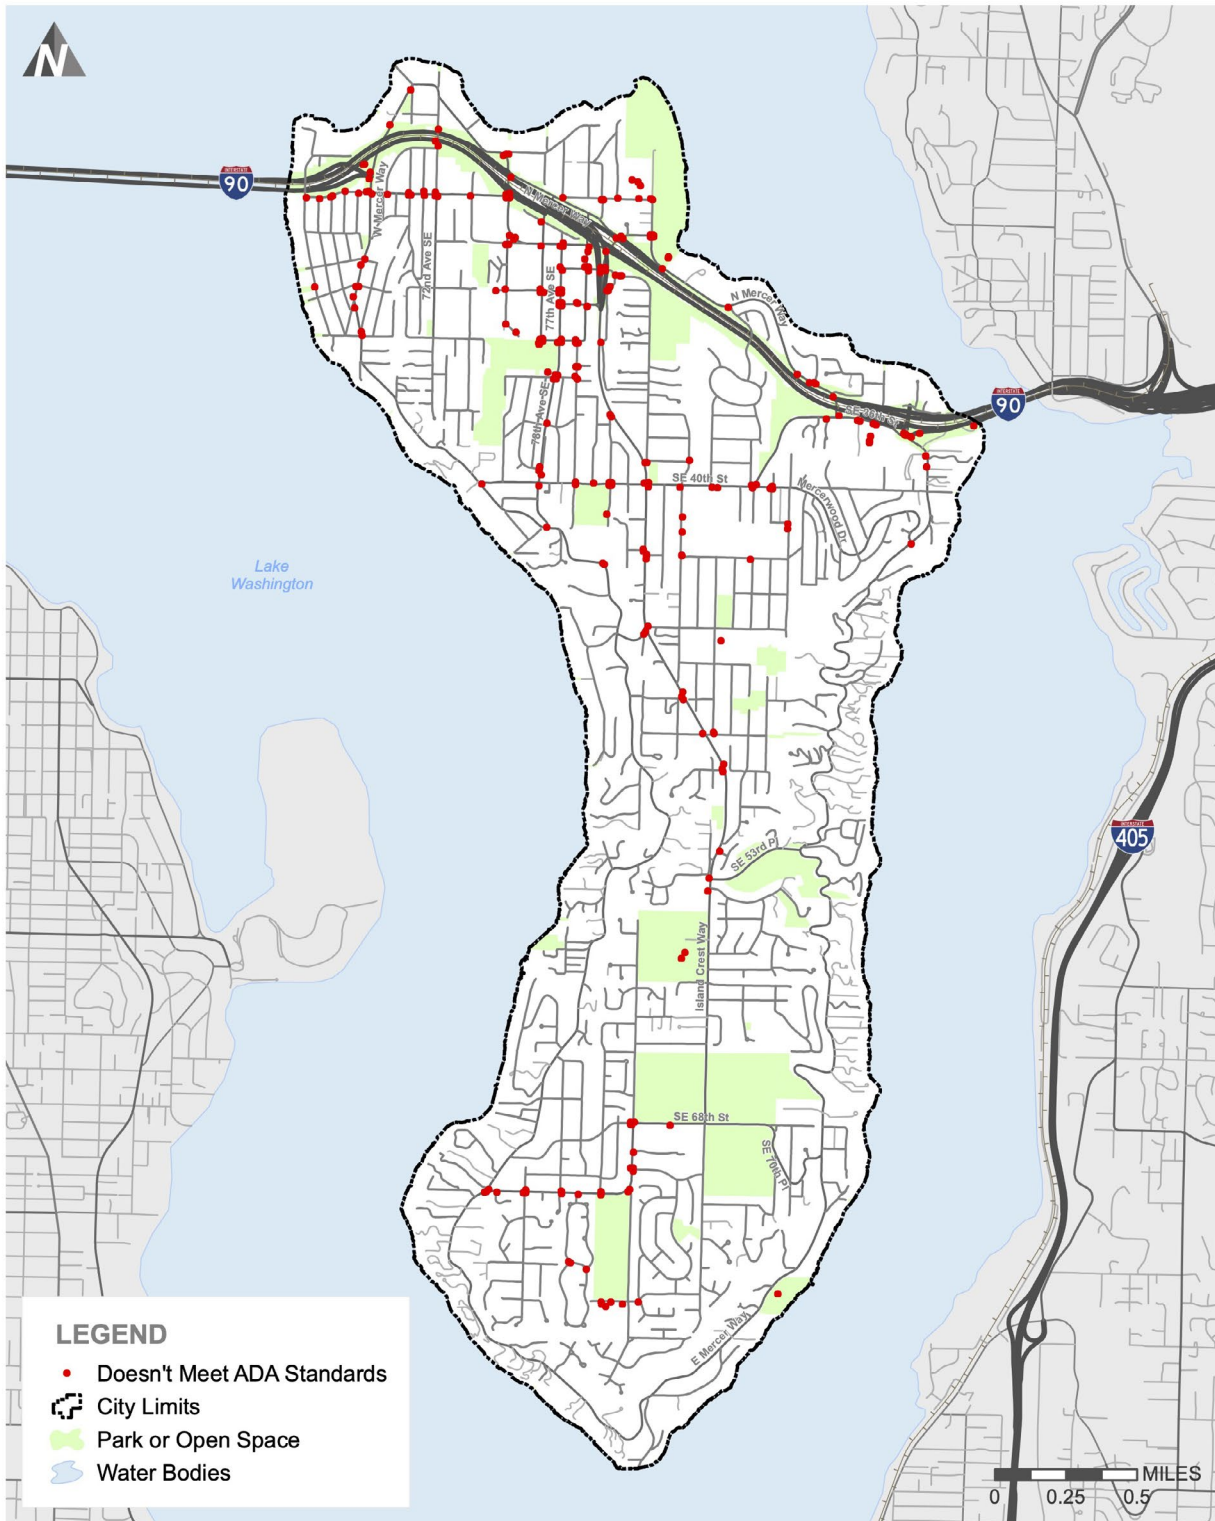
2-9

Curb Ramp Running Slope

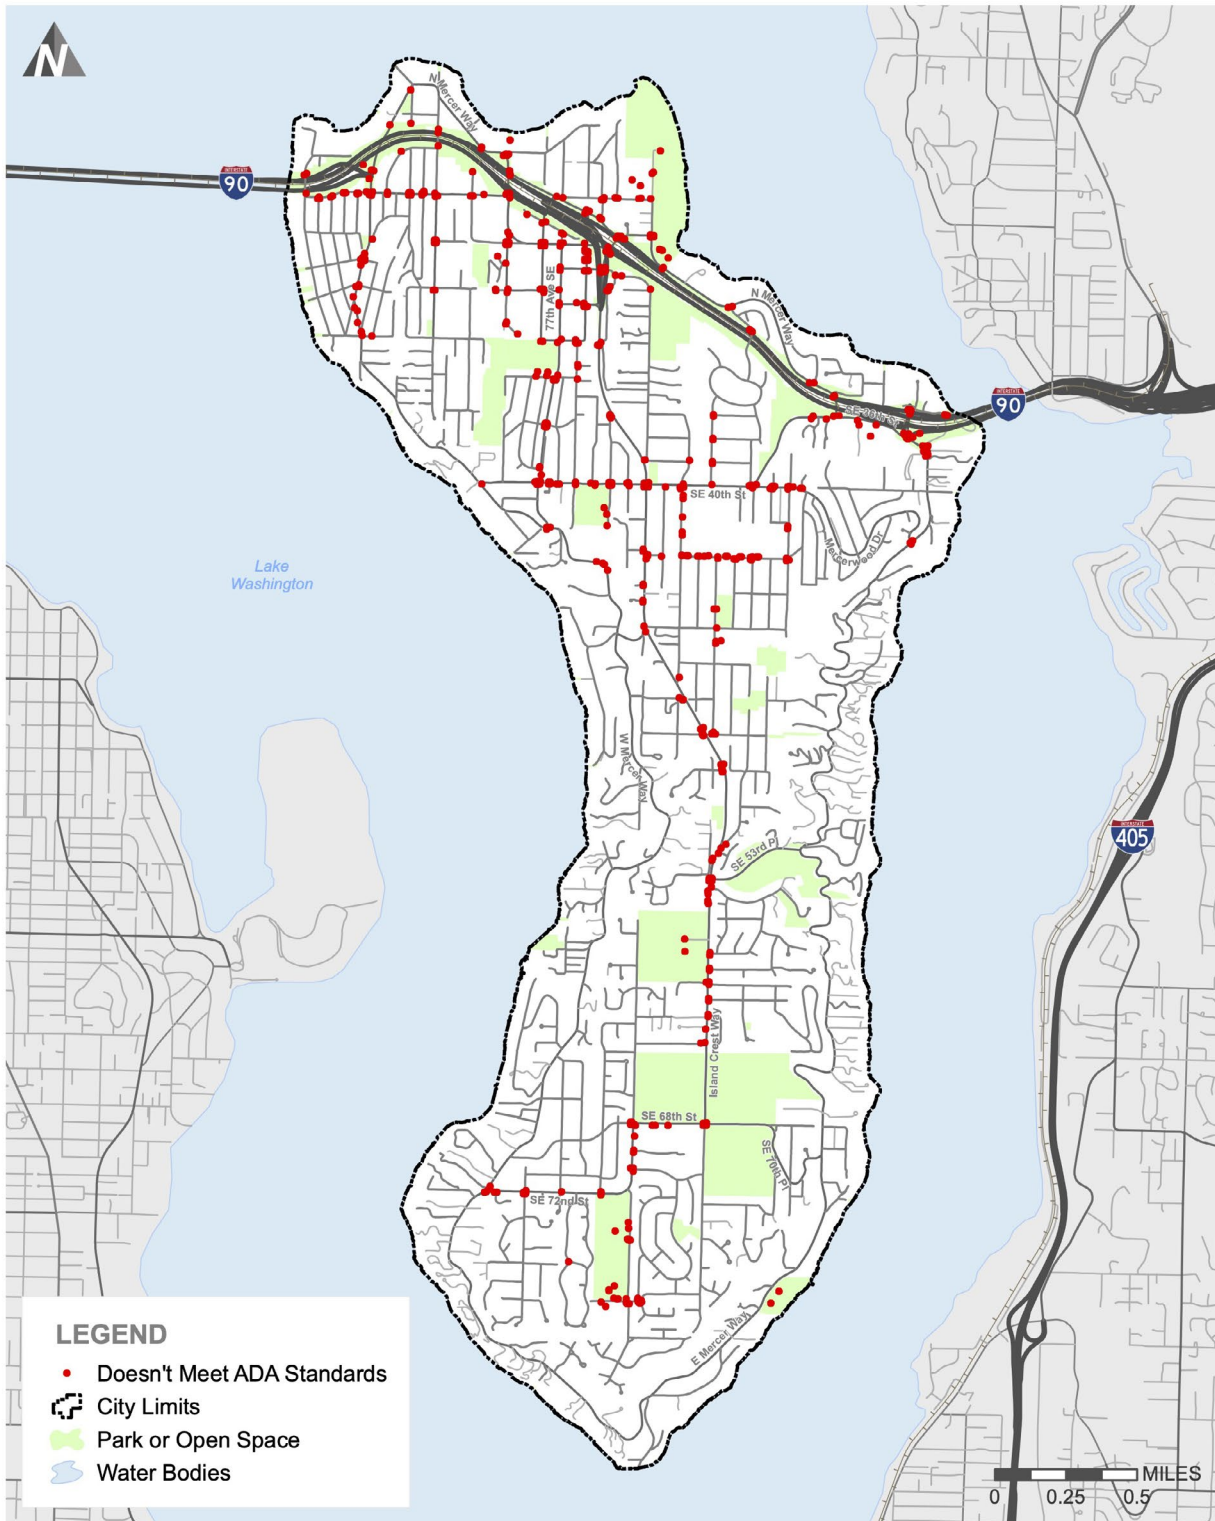
FIGURE
2-10
transpogroup

Curb Ramp Cross Slope
City of Mercer Island ADA Transition Plan

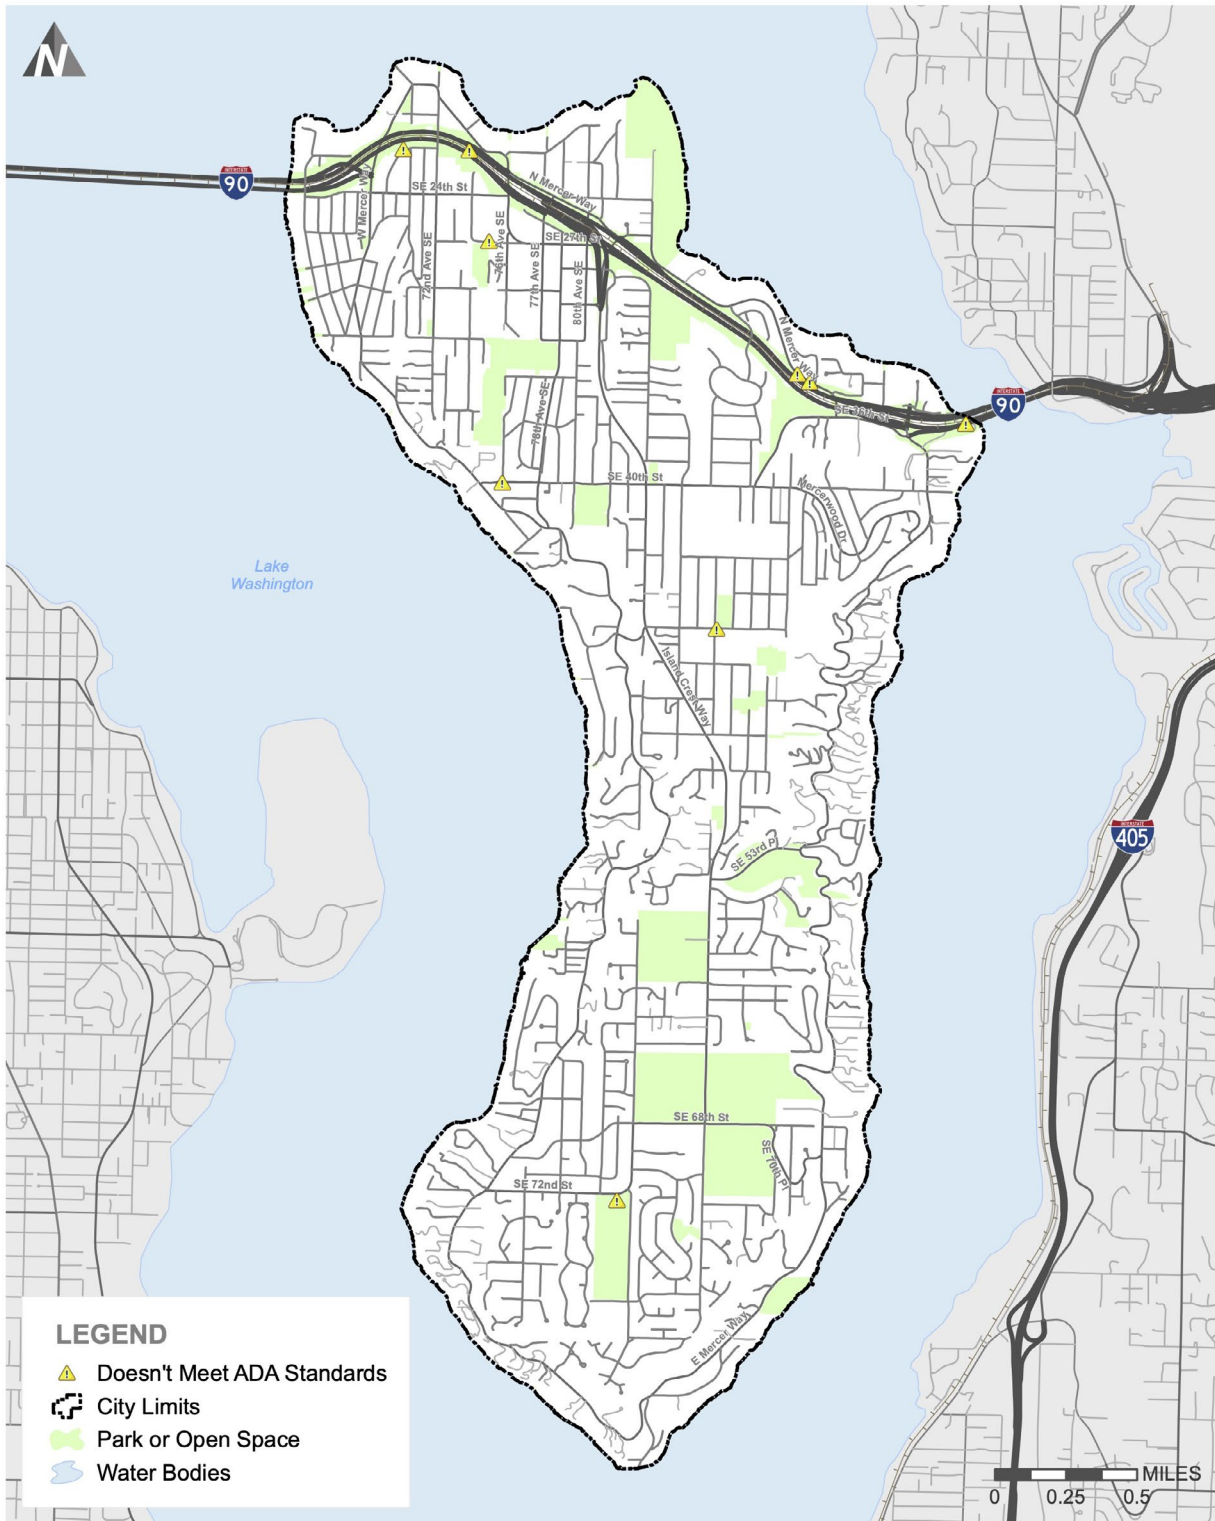
2-11

Curb Ramp No Receiving Ramp

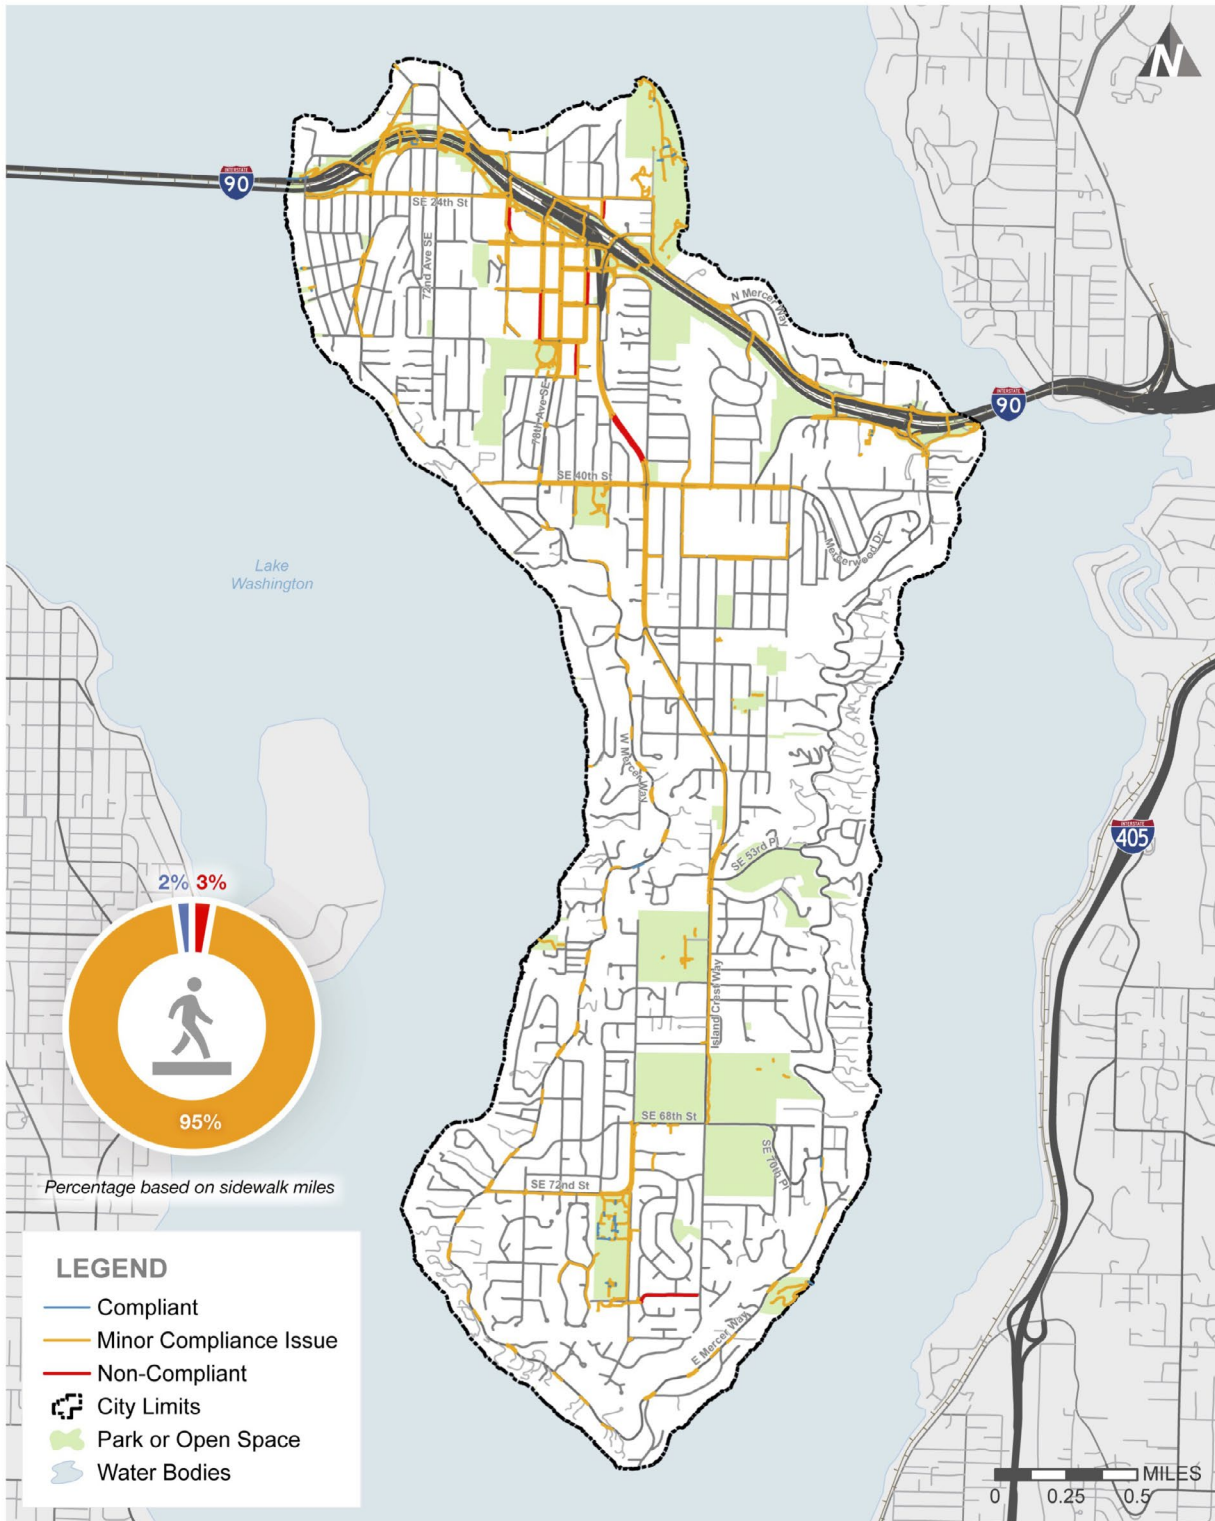
2-12

Approximately 34 miles of sidewalk were inventoried with approximately 98% not meeting ADA standards (see Table 2-2 and Figure 2-12). Grinding, patch repair, and full reconstruction are potential solutions for removing the sidewalk barriers depending on the severity of the barrier.

Non-Compliant Sidewalk

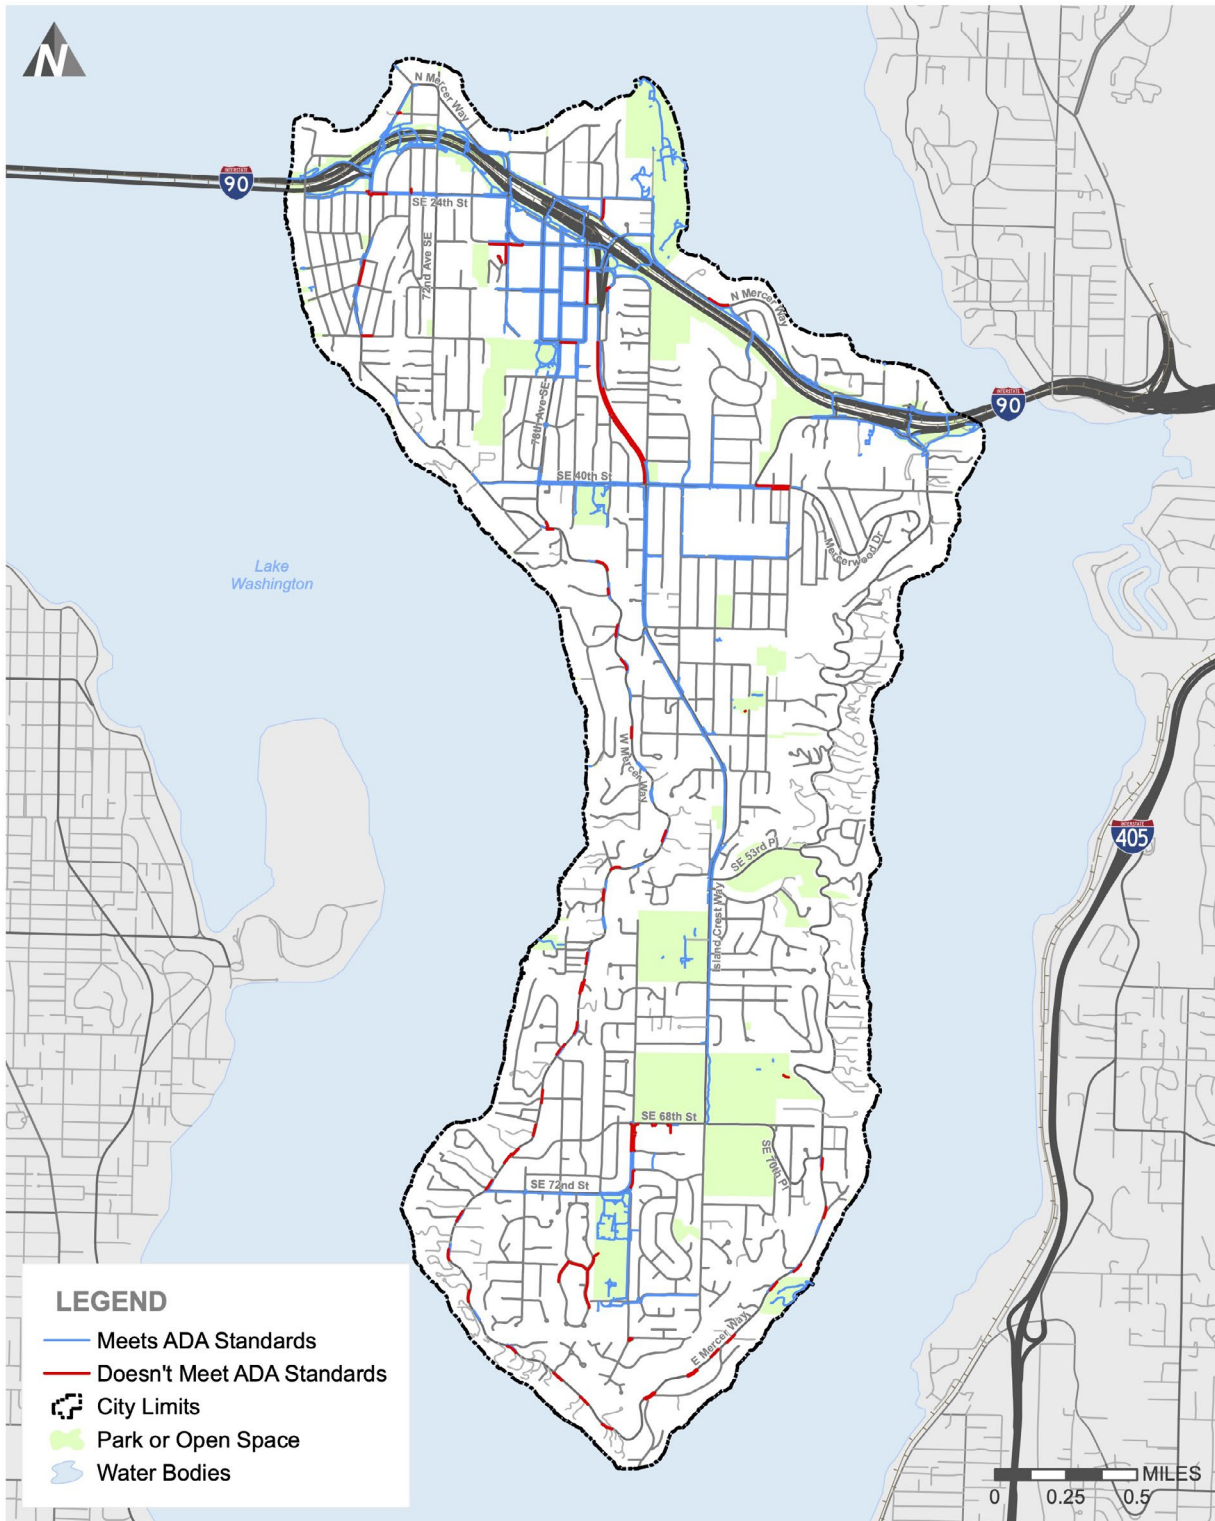
FIGURE
2-13
transpogroup

Sidewalk Width
City of Mercer Island ADA Transition Plan

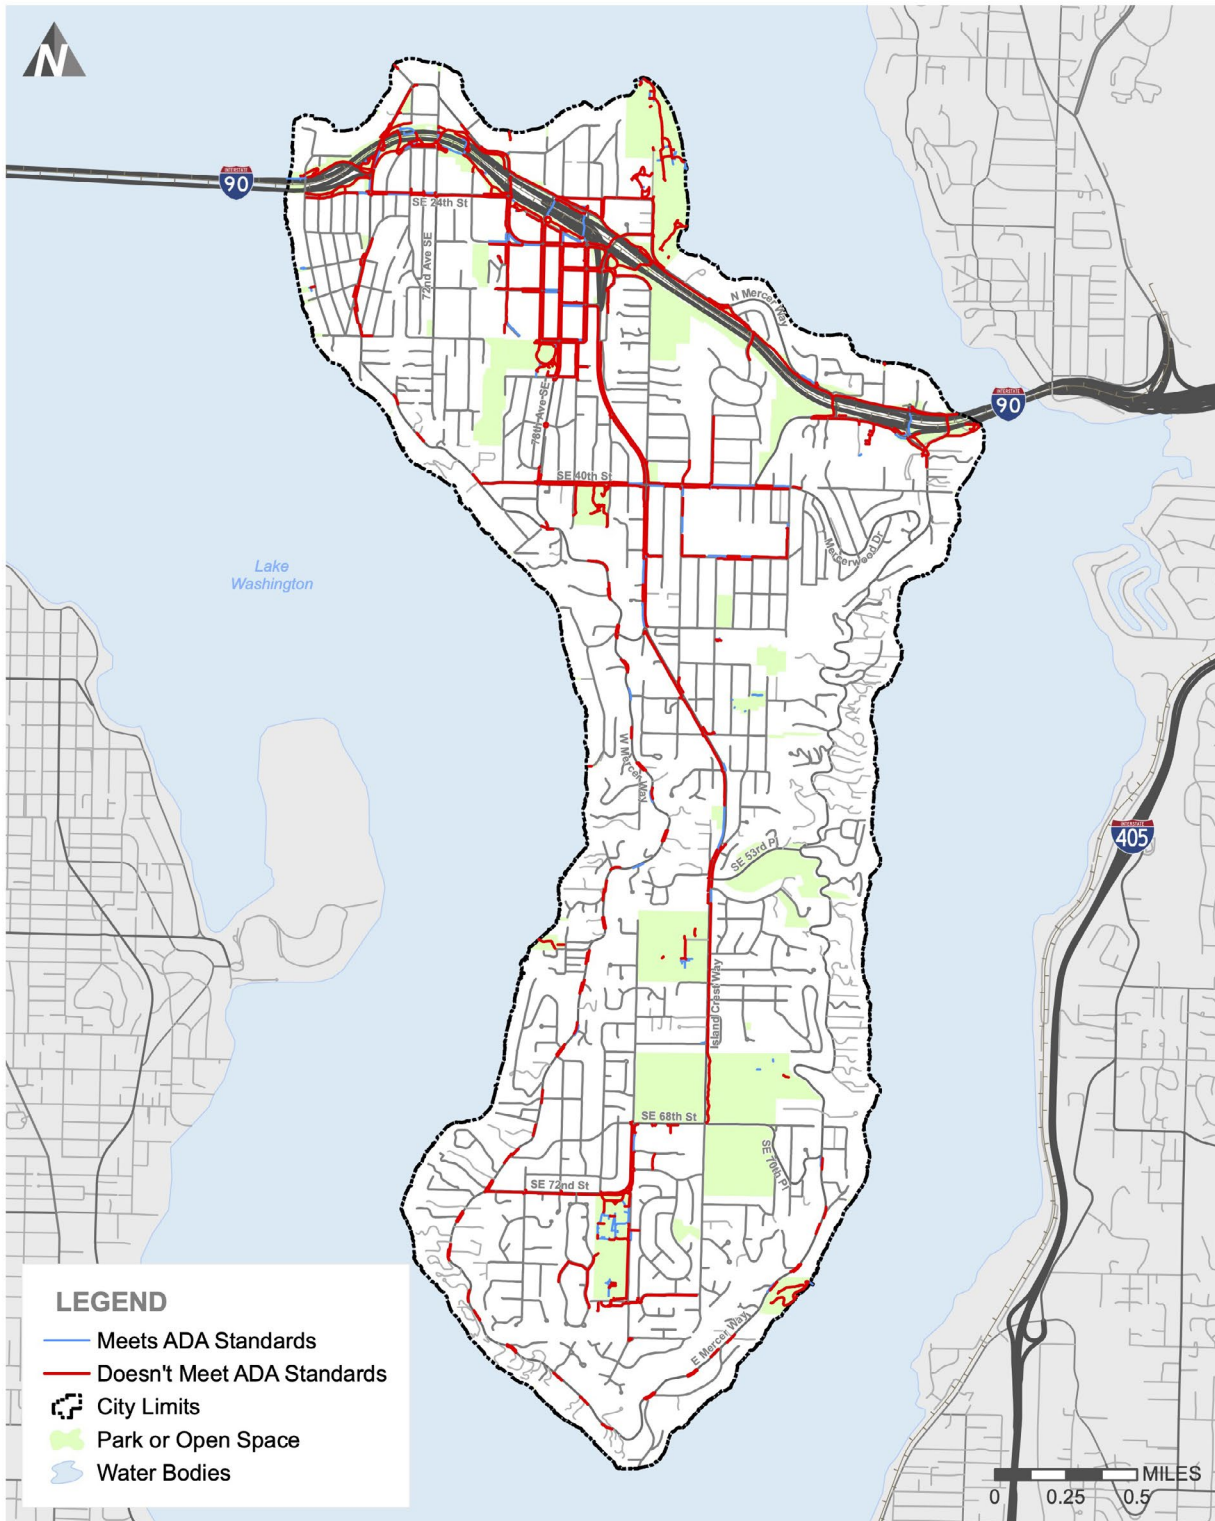
2-14

Sidewalk Cross Slope
City of Mercer Island ADA Transition Plan

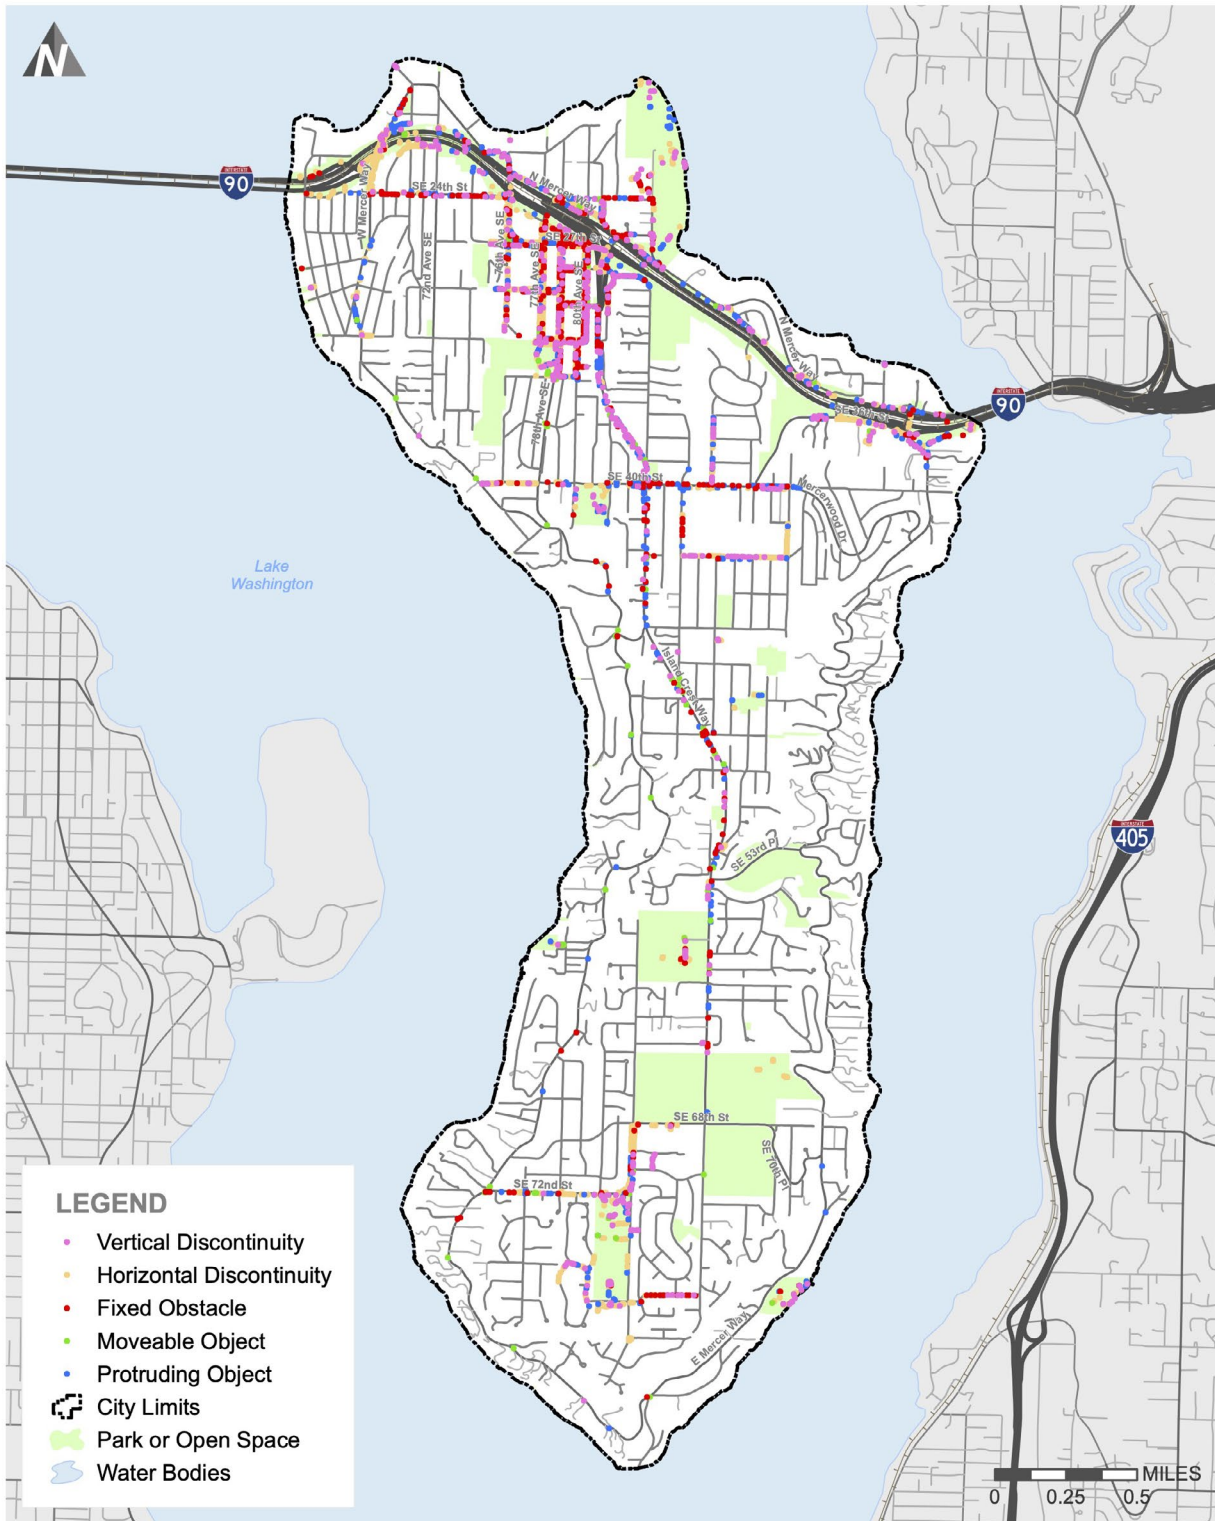
FIGURE 2-15
transpogroup 77

Sidewalk Barriers

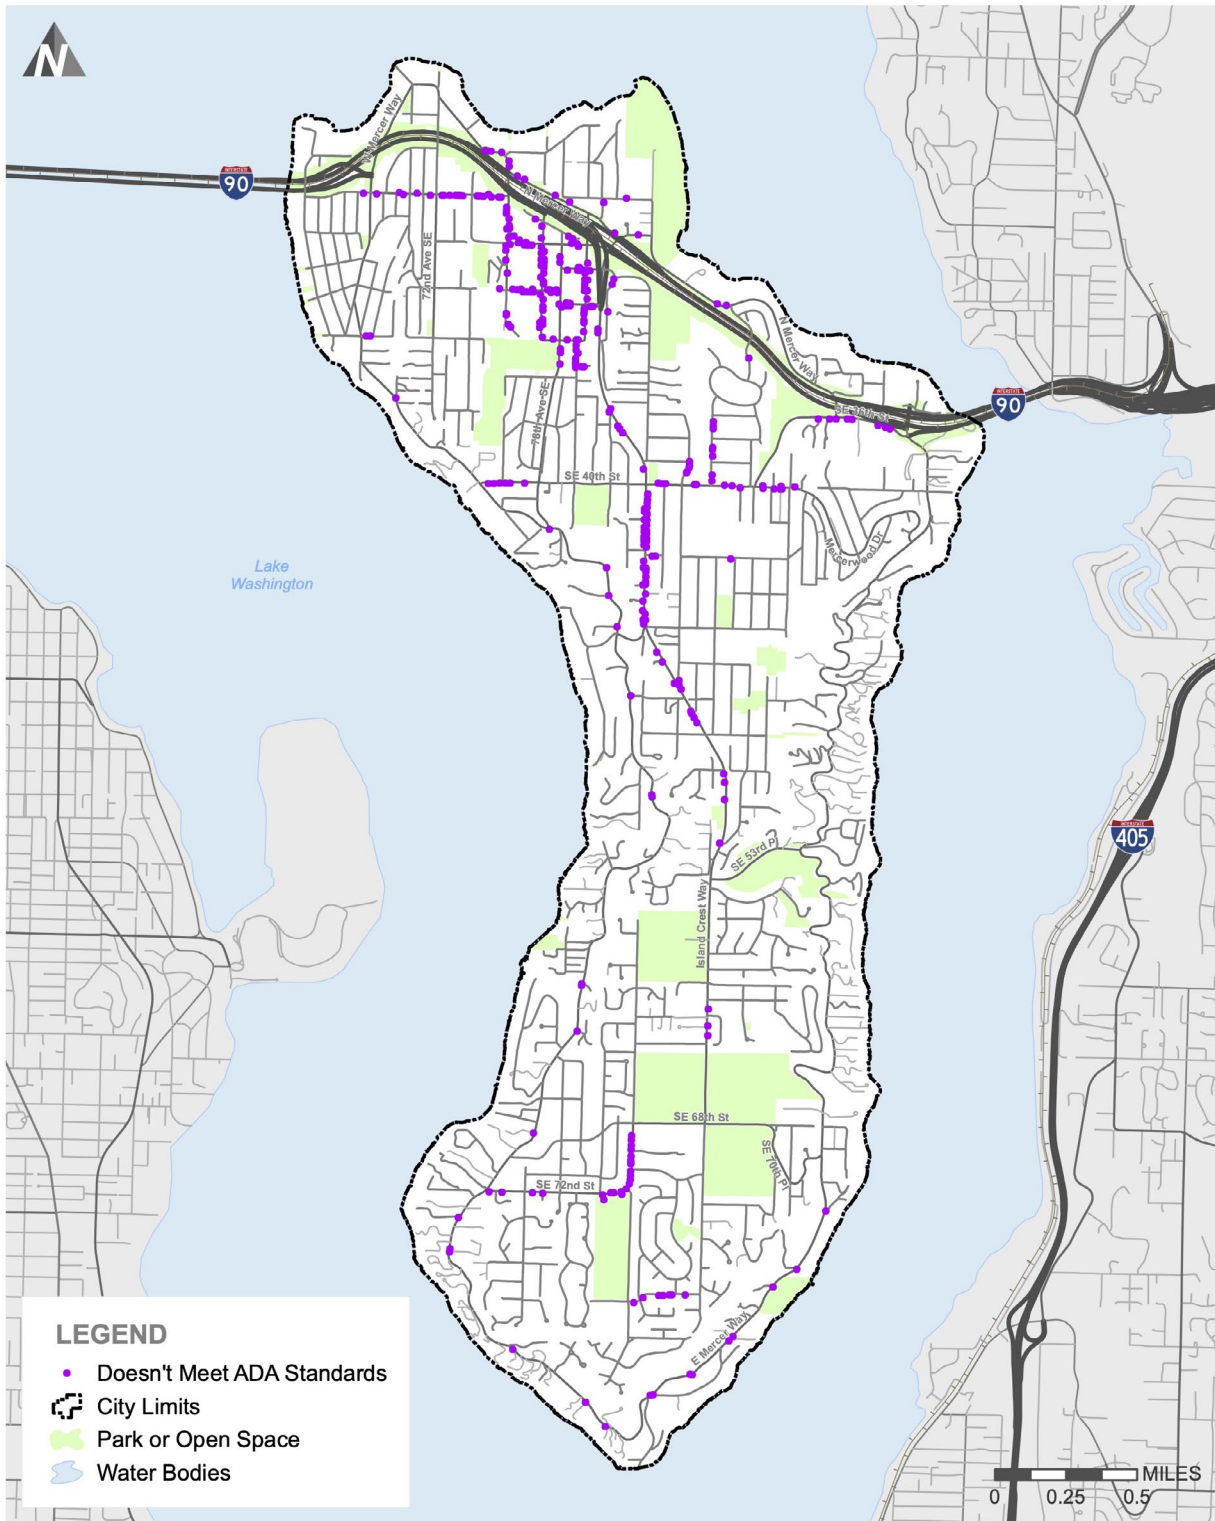
Non-Compliant Driveways Along Sidewalk

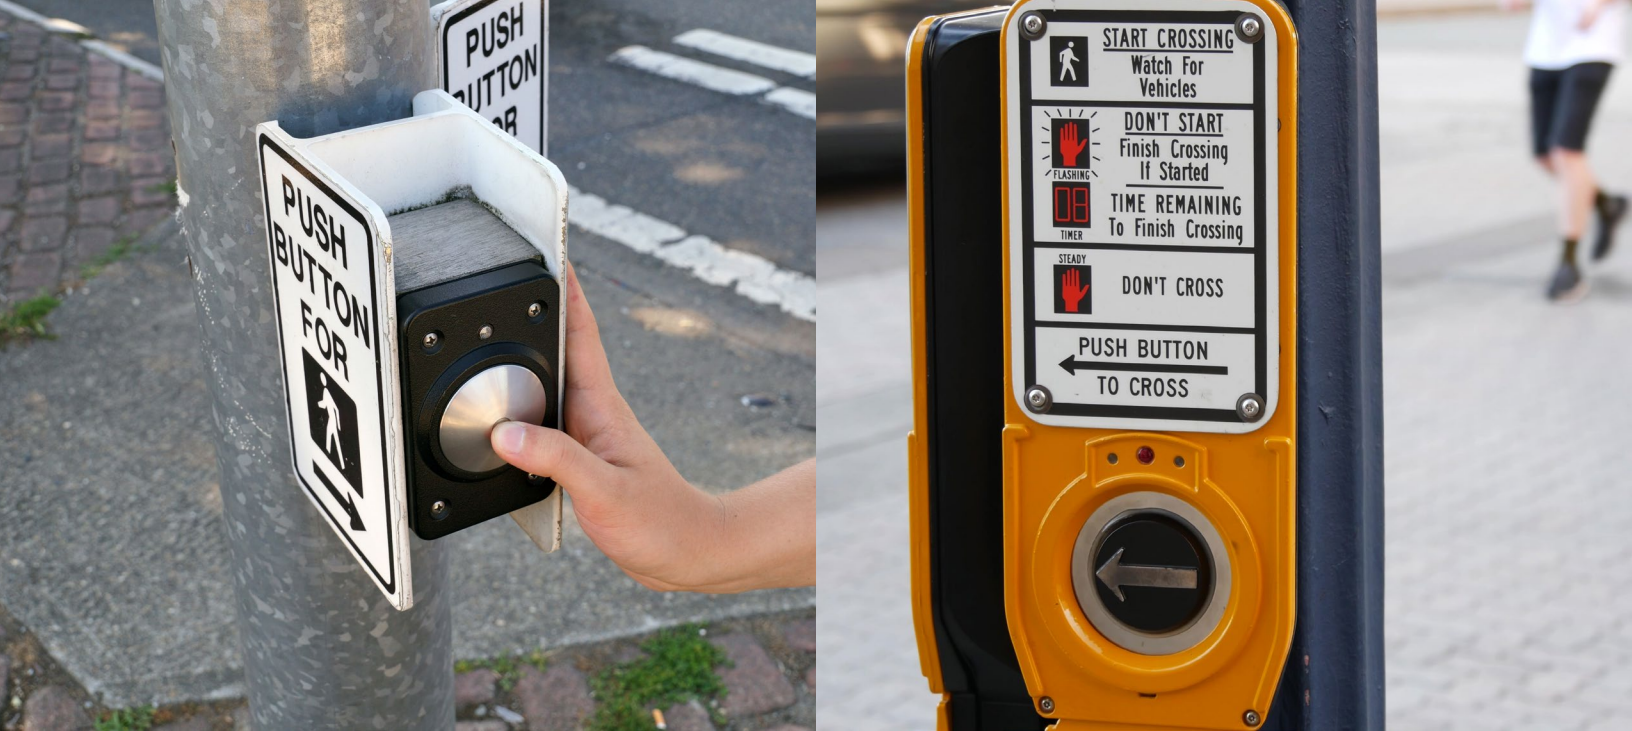
Figure 2-17 “H-style” (left) and APS-style pedestrian pushbutton (right)

All of the 84 inventoried pedestrian pushbuttons were not fully ADA compliant. The non-compliant pedestrian pushbuttons include non-APS style buttons to be replaced and APS-style buttons to be reprogrammed or relocated.

Approximately 86% of pedestrian pushbuttons in the city are an older “H-style” design (see Figure 2-17 top). This style of pushbutton can be upgraded to increase accessibility but must be fully replaced with an accessible pedestrian signal (APS)-style pushbutton to achieve full ADA compliance (see Figure 2-17).

The requirement to use APS-style pushbuttons is relatively new and lack of compliance is typically due to a crossing not being upgraded over time to reflect evolving requirements. Pushbuttons are typically upgraded to APS-style in groups rather than individually. As a result, APS-style additions and upgrades usually occur on an intersection-by-intersection basis.

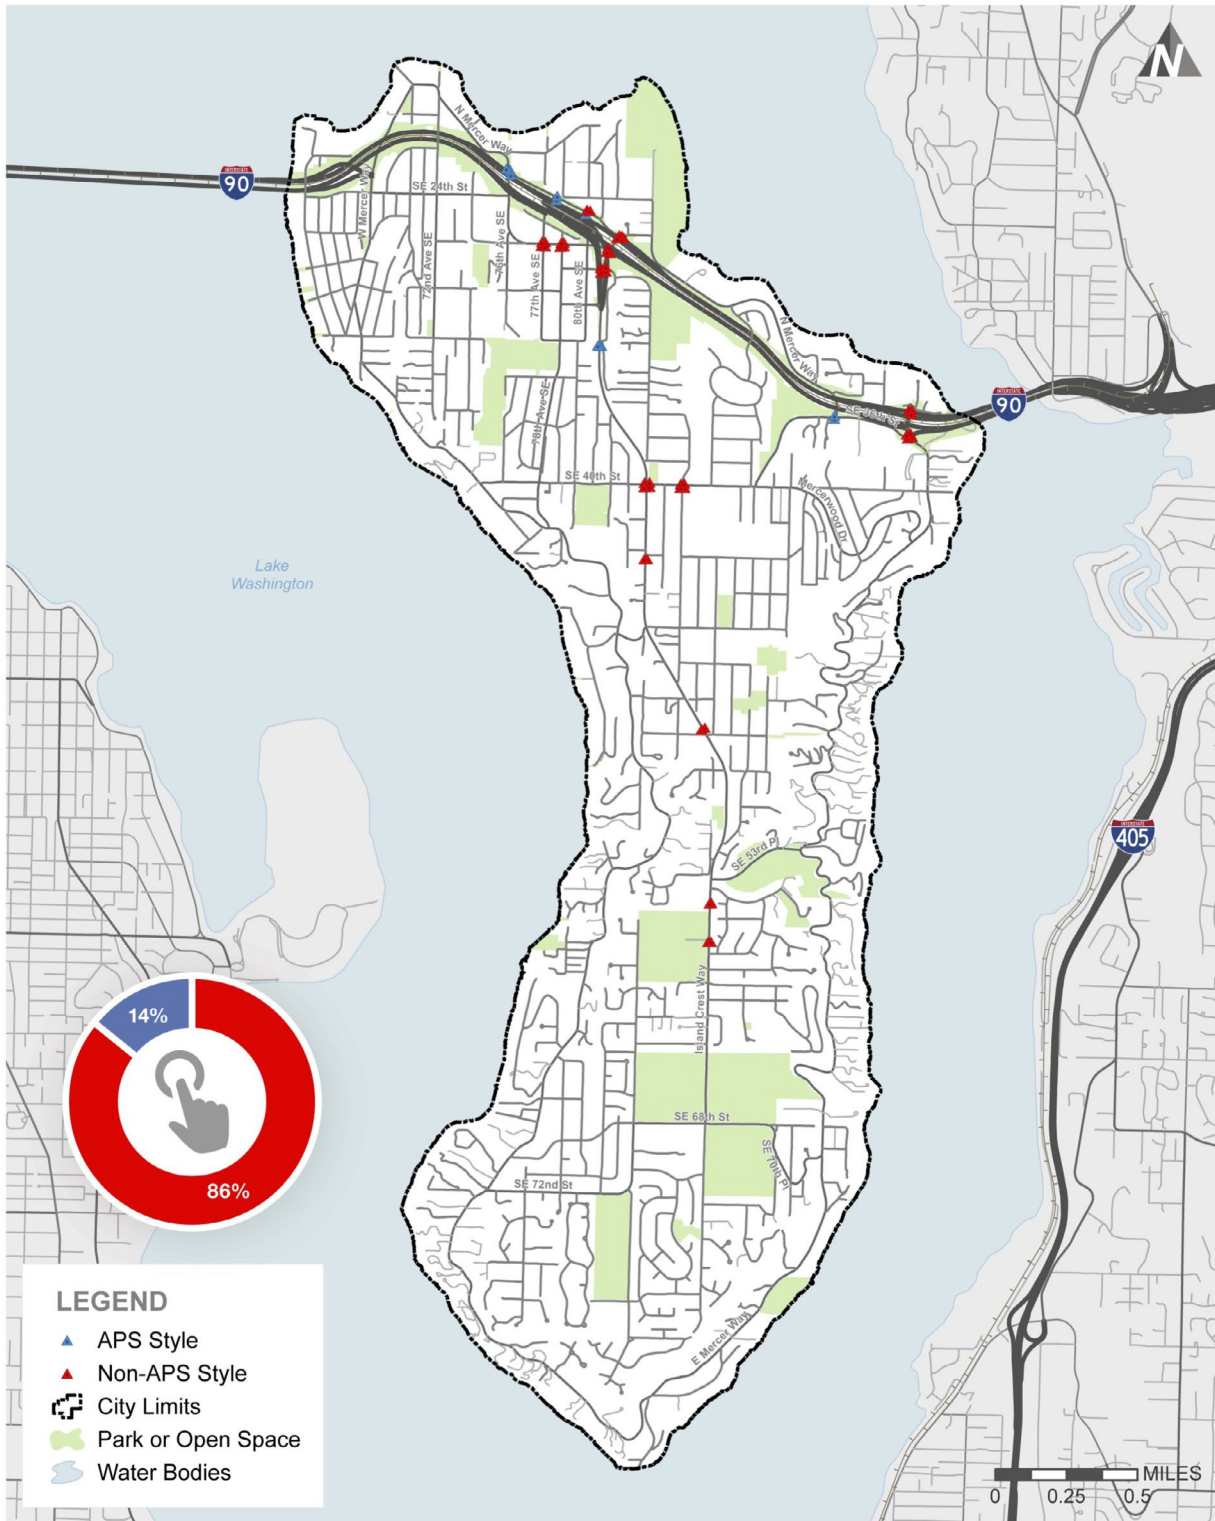
Figure 2-18 demonstrates the type and locations of these pushbuttons throughout the city.

Signal Push Buttons: APS and Non-APS

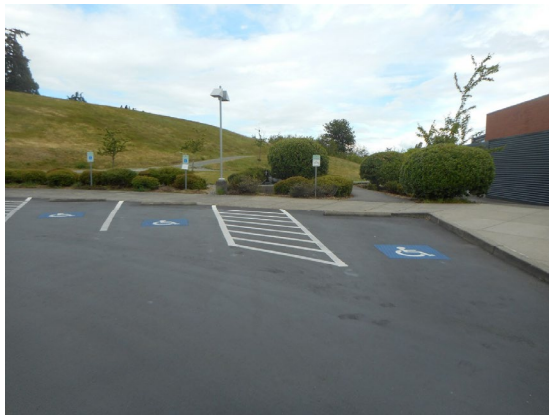
Upper Left: Accessible parking signs are mounted too low.

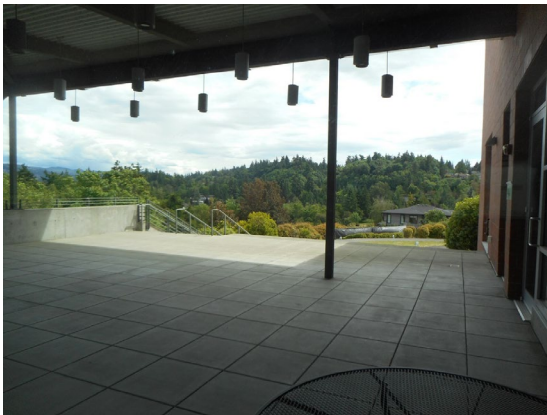
- Upper Left: Terrace does not provide edge protection &/or a guardrail between terrace and seating steps.
- Upper Right: Door between Mercer Rm. & Landing Rm. is recessed 11", and does not provide the required clearance on the push side.
- Lower Left: Fire alarm pull stations are mounted too high. 48" max. AFF required.

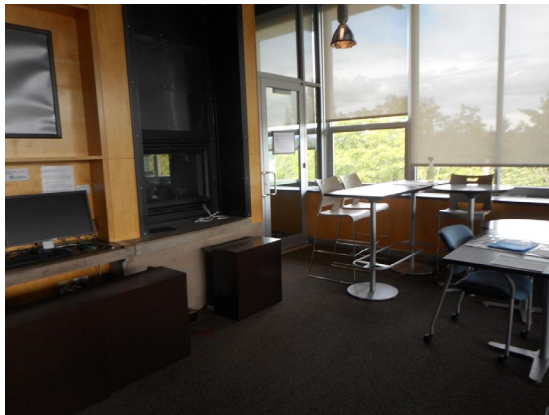
- Upper Left: Landing Rm. & Game Rm. require tables with accessible seating.
- Upper Right: Numerous door have 7-1/2" high bottom rail with hold open devices. Bottom surface of door on push side is required to be a smooth surface to 10" AFF.
- Lower Left: Surface mounted latching mechanisms obstruct the required 10" bottom smooth surface required on the push side.
