City of Mercer Island

Americans with Disabilities Act

ADA Transition Plan

2022

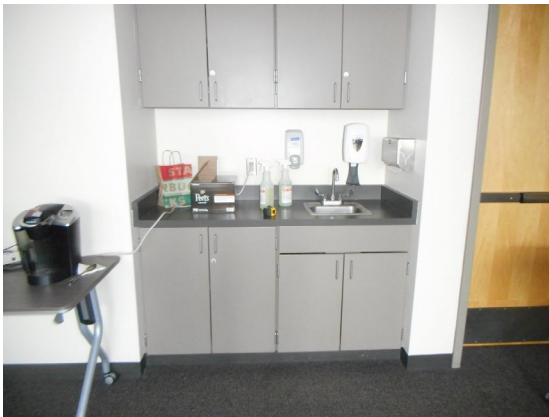
- Upper Left: Entry level meeting rooms have countertops with sinks above the required 34" max. AFF height, and do not provide the forward approach knee space below sink.
- Upper Right: Slater Rm. public restroom does not provide an accessible stall of the min. required size.
- Lower Left: Mercer Rm. above countertop outlets and switches are not accessible for a side reach.

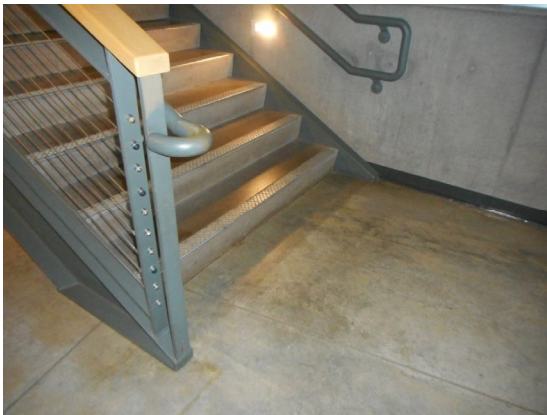
- Upper Left: Stair handrail protrudes into the accessible route.
- Upper Right: Gymnasium does not provide an accessible drinking fountain at required height, and with a forward approach knee space.
- Lower Left: Fitness Rm. drinking fountain is mounted at standing person height. An accessible drinking fountain at required height, and with a forward approach knee space is required.

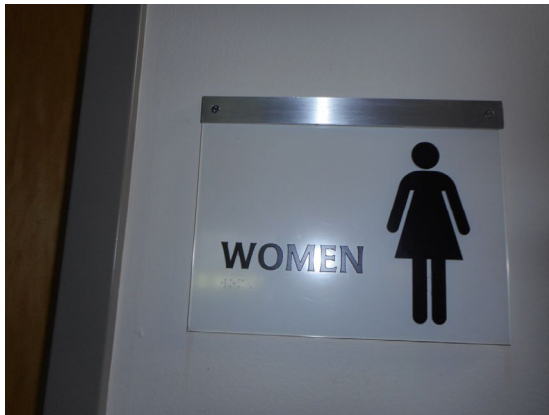
- Upper Left: Restroom signage does not provide the International Symbol of Accessibility.
- Upper Right: Locker room benches do not provide the required back support, and are not of the required size for accessibility. Each locker room requires an accessible bench.
- Lower Left: Toilet in the accessible stall is required to be 16" min. - 18" max. from the side wall. Many of these toilets are mounted too far from wall.

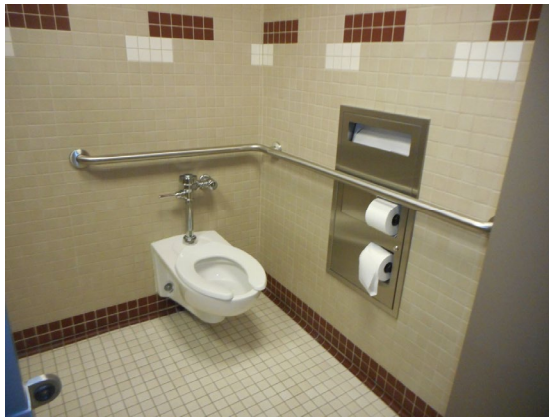
- Upper Left: The length of the L-shaped grab bar section behind toilet is too short. Many grab bars are mounted too high. 1-1/2" between the grab bar and adjacent surface is required. Dispenser encroaches on clearance.
- Upper Right: Height of the sink rim exceeds the max. 34" AFF.
- Lower Left: At least one of the large lockers must be accessible.

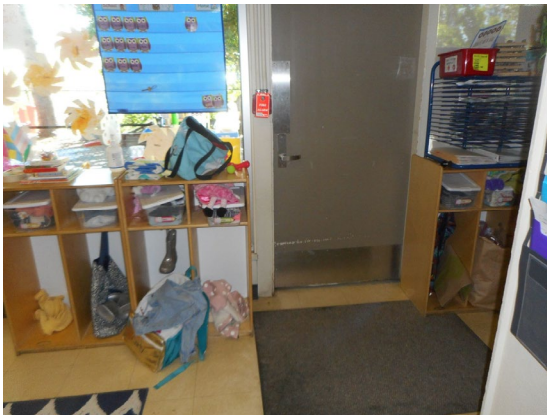
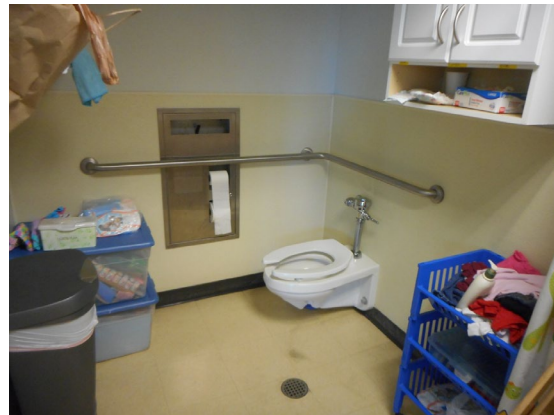
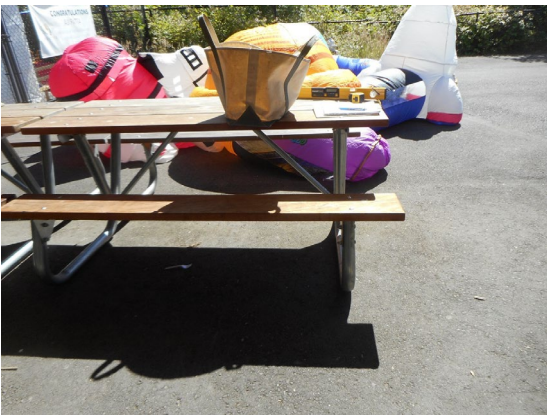
Community and Events Center

- Upper Left: Cabinetry blocks the required door maneuvering clearance at Daycare entry door.
- Upper Right: Wall mounted cabinets protrude into the required clear floor space at toilet. The length of the L-shaped grab bar section behind toilet is too short.
- Lower Left: Picnic tables in Daycare Center do not provide an accessible seat.

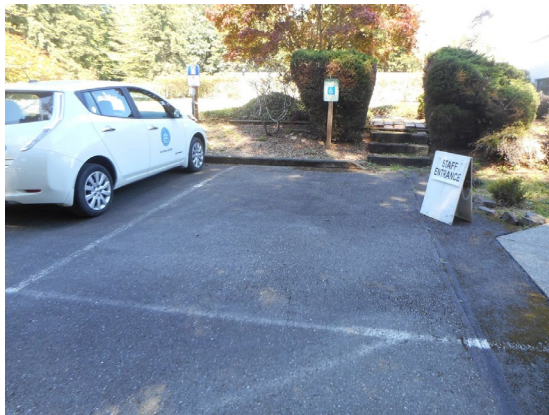
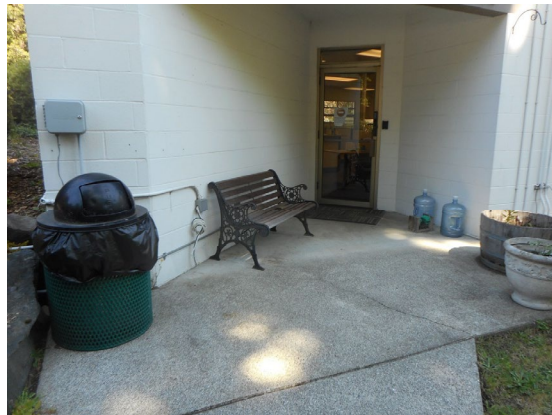
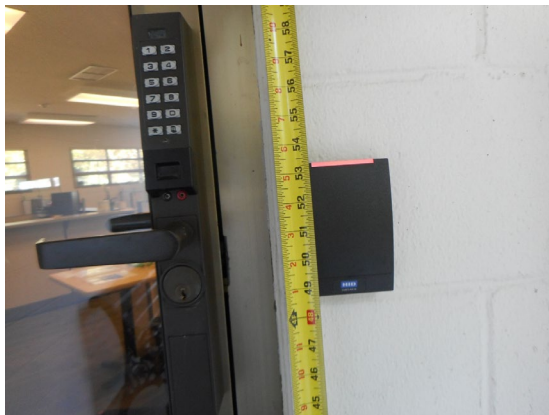
Maintenance Building

- Upper Left: Accessible parking sign is required to be remounted to 60" min. above pavement to bottom surface.
- Upper Right: Entry door lacks the required maneuvering clearance space.
- Lower Left: Entry door hardware is mounted above accessible reach.

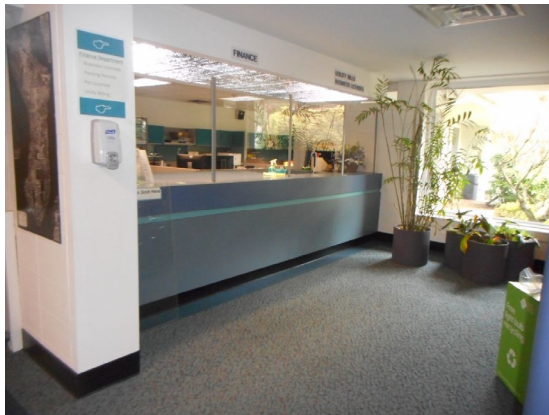
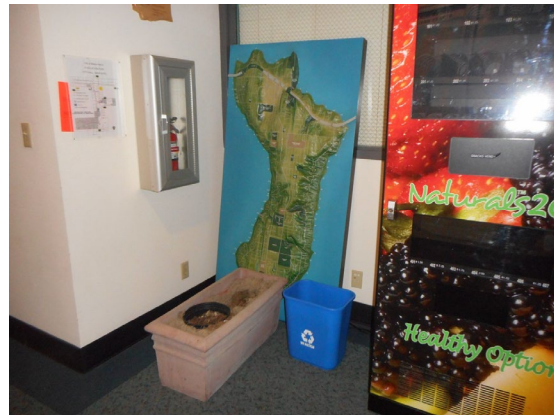
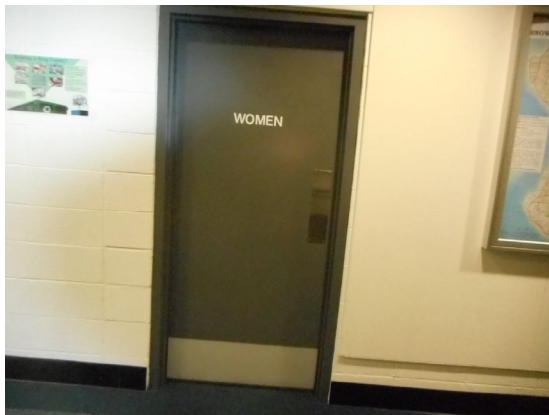
City Hall

- Upper Left: Business License area requires an accessible counter.
- Upper Right: Fire extinguishers and their cabinets required to be located at an accessible height.
- Lower Left: Accessible restroom signage is required.

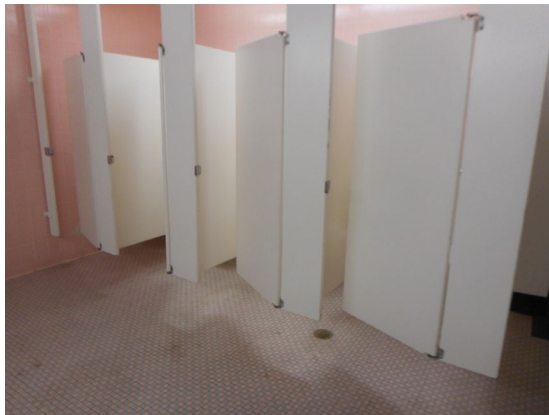
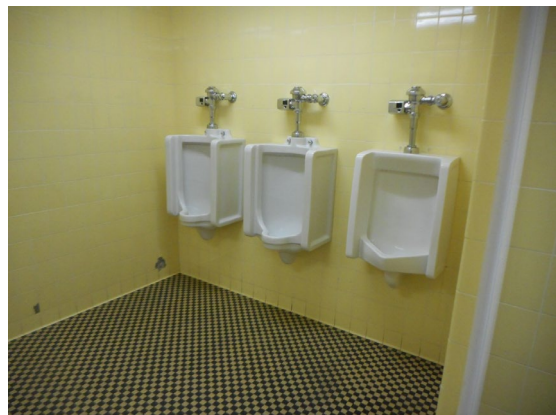
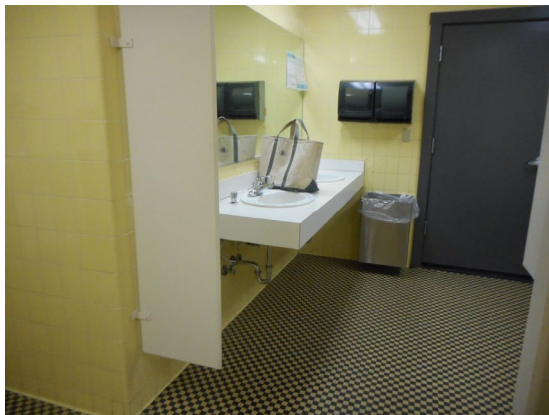
City Hall

- Upper Left: Restrooms adjacent to Licensing area shall provide an accessible stall.
- Upper Right: Men's restroom adjacent to Licensing area shall provide an accessible urinal.
- Lower Left: Men's restroom adjacent to Licensing area shall provide an accessible lavatory with compliant knee & toe space.

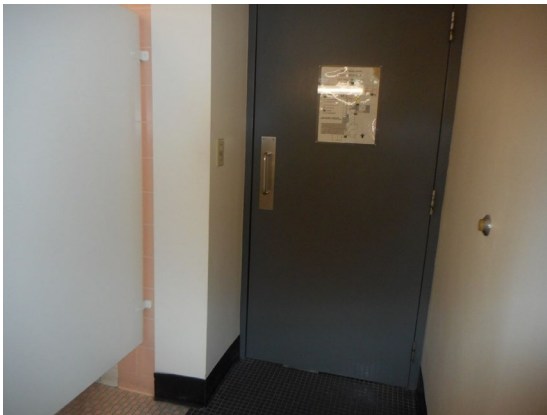
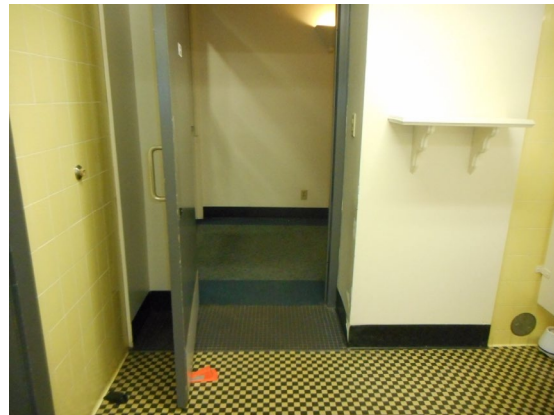
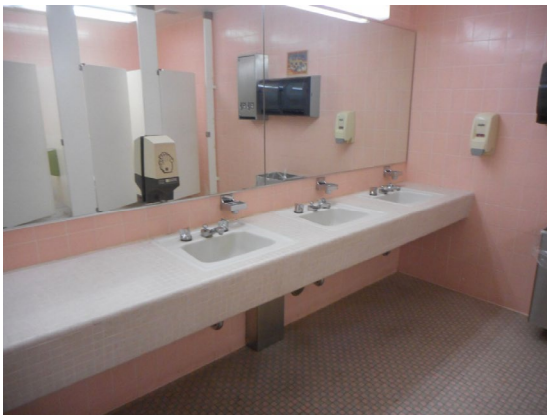
City Hall

- Upper Left: Restroom entry doors require min. 18" maneuvering clearance on pull side (or a power door operator).
- Upper Right: Restroom entry doors require min. 18" maneuvering clearance on pull side (or a power door operator).
- Lower Left: Women's restroom near Licensing shall have at least one lavatory with accessible controls on faucets, and exposed pipes isolated from contact.

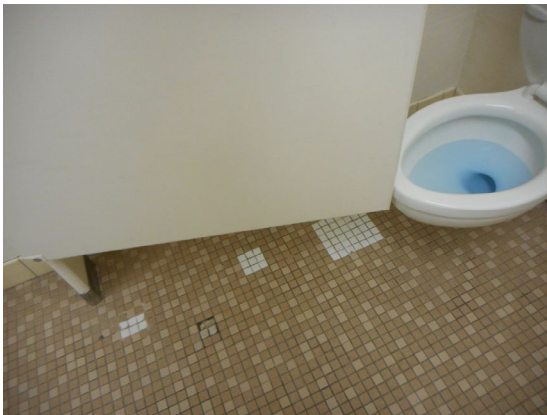
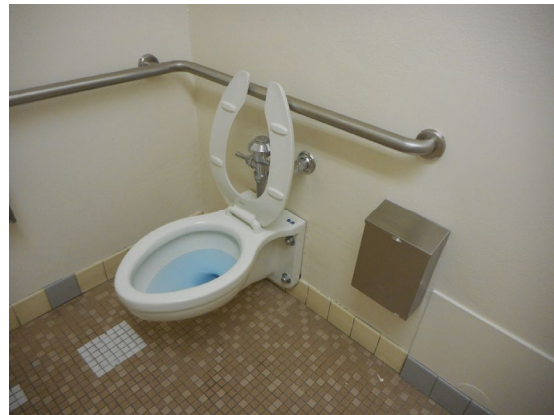
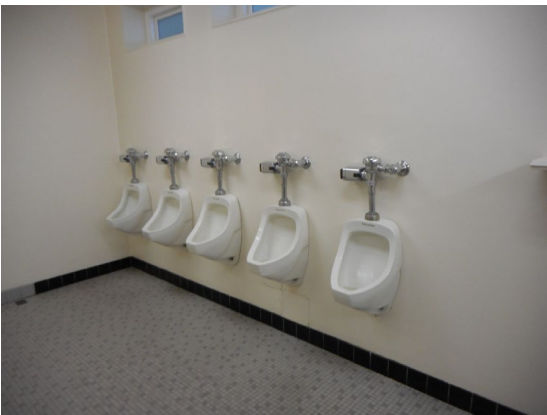
City Hall

- Upper Left: Women's restroom near Courtroom: door to accessible compartment located on wrong side of compartment and swings in.
- Upper Right: Women's restroom near Courtroom: toilet location should be adjusted. Flush control should be on open side.
- Lower Left: Men's restroom near Courtroom: one urinal should be accessible.

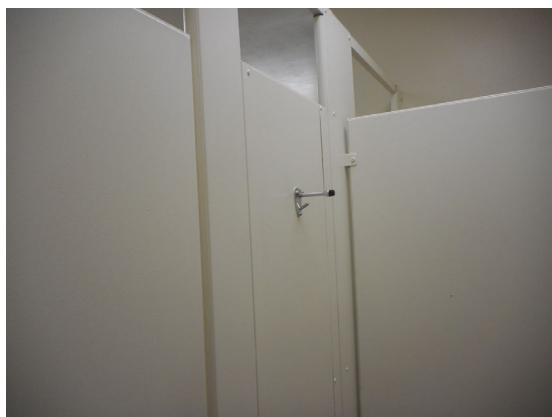
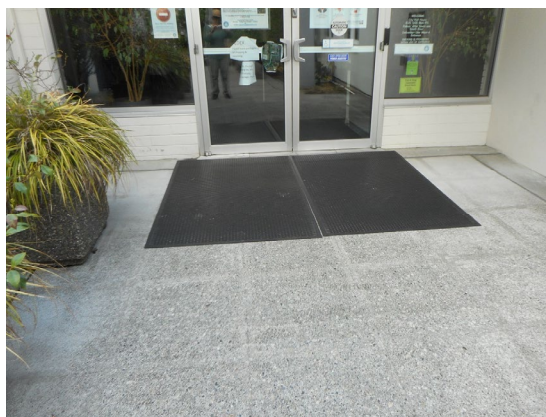
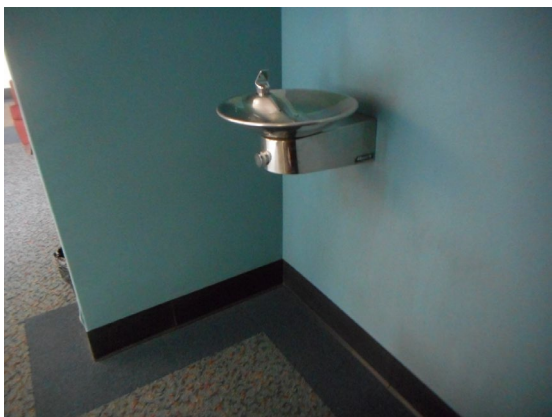
City Hall

- Upper Left: Coat hooks and dispensers in accessible toilet stalls shall be mounted at accessible heights.
- Upper Right: Rubber mats at entries shall be secured.
- Lower Left: Drinking fountain near courtroom entry should be a hi-low type for both wheelchair users and standing persons.

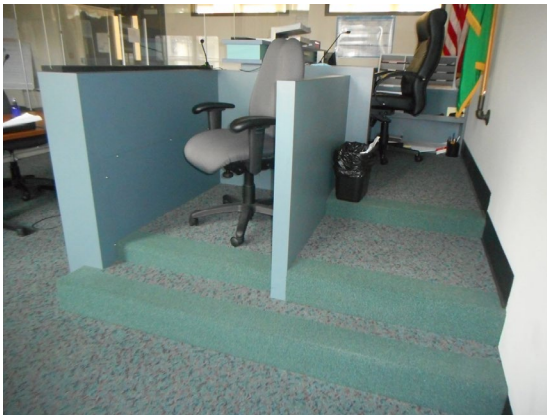
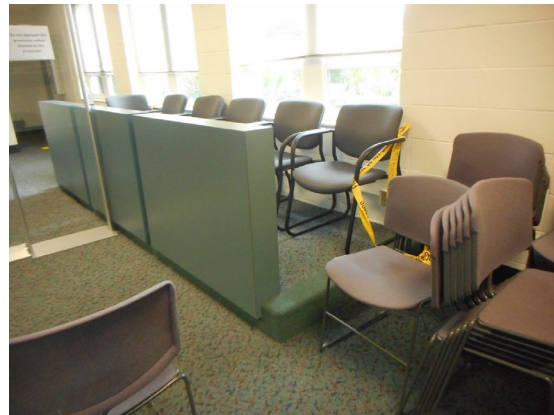
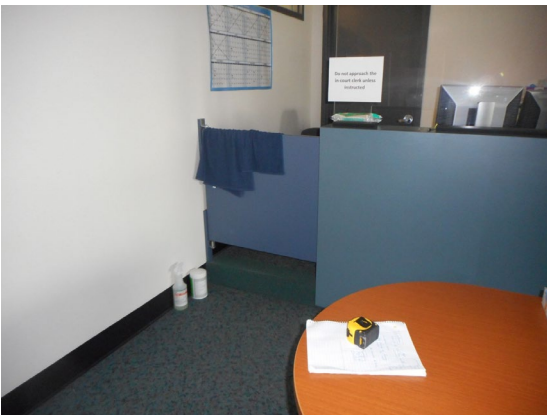
City Hall

- Upper Left: Courtroom: witness box and judge's platform have stairs (no accessible route).
- Upper Right: Courtroom: juror's area has stairs (no accessible route).
- Lower Left: Courtroom: court clerk counter required to be lowered to 36" AFF max.

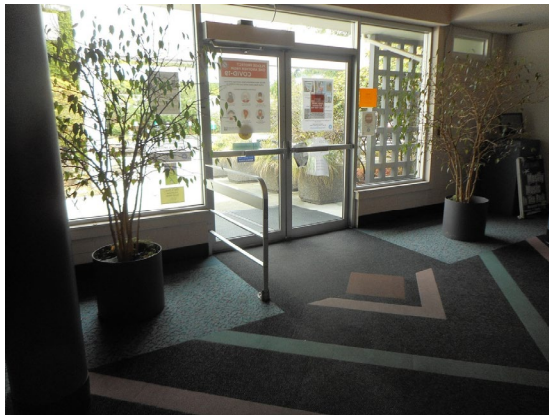
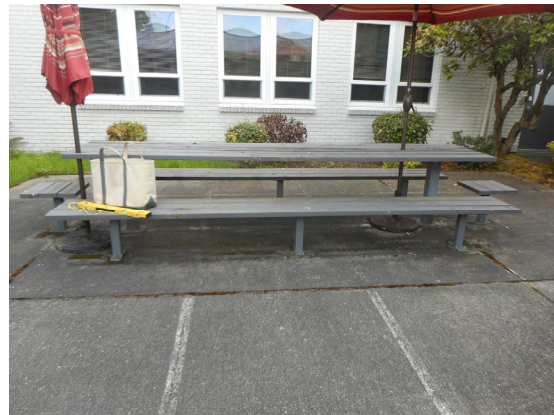
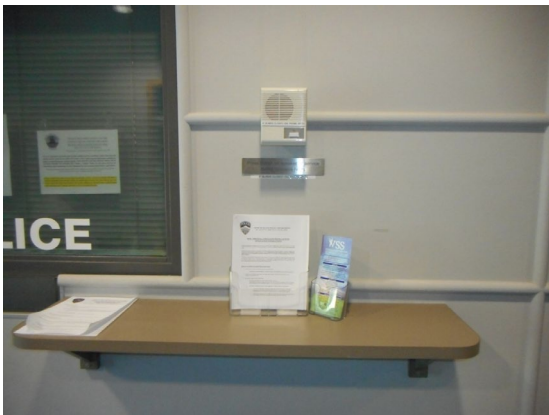
City Hall

- Upper Left: Exterior sidewalk approaching main entry has an excessive slope.
- Upper Right: Picnic table requires an accessible seat.
- Lower Left: Police Lobby: Service call button should be at accessible height. Countertop shall be lowered to 36" max. AFF.

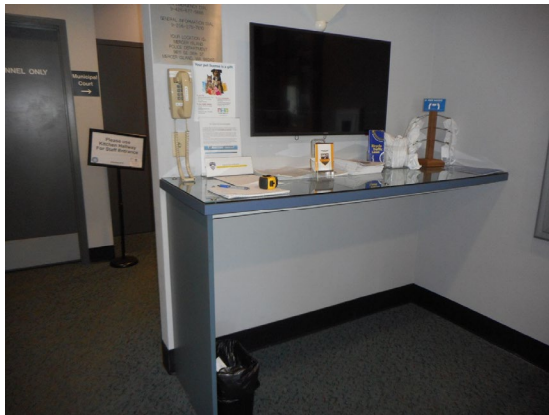
City Hall

Upper Left: Police Lobby: telephone and counter should be lowered to accessible height.

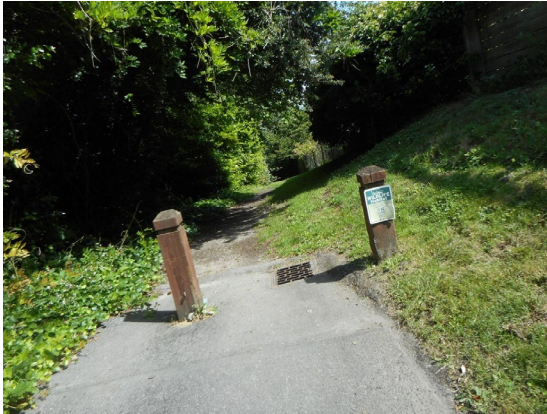
77th Ave. SE Street End

Upper Left: Park entry lacks an accessible route. No parking is provided.

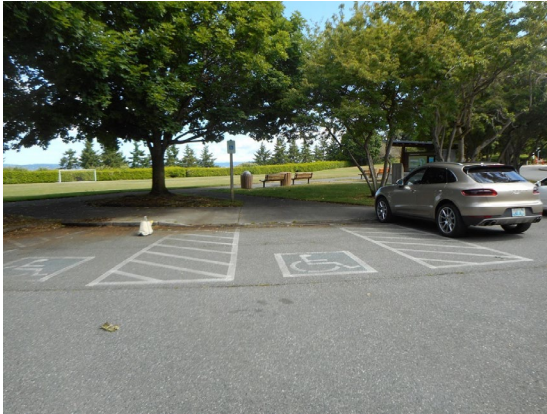
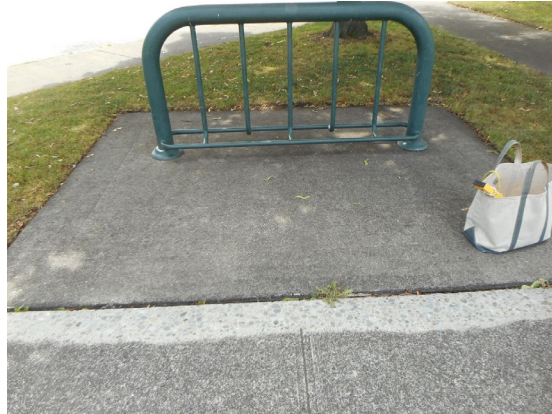
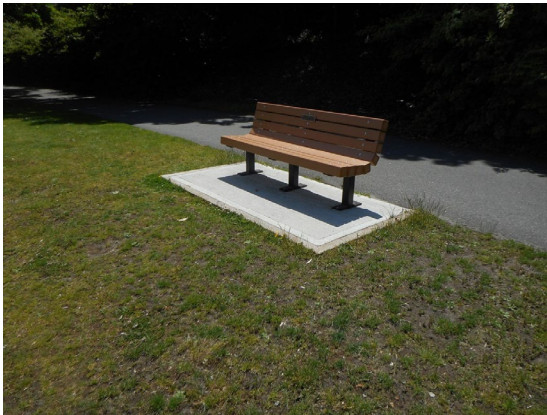
Aubrey Davis Park

- Upper Left: Accessible parking sign is required on westernmost stall in the western parking lot
- Upper Right: 30"x48" clear floor space is required on one end of bike rack.
- Lower Left: 30"x48" clear floor space is required on one end of bench.

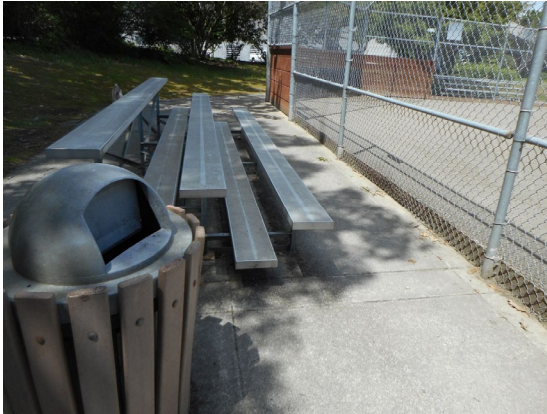
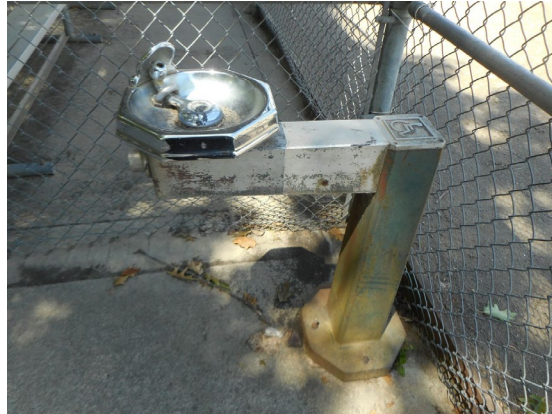
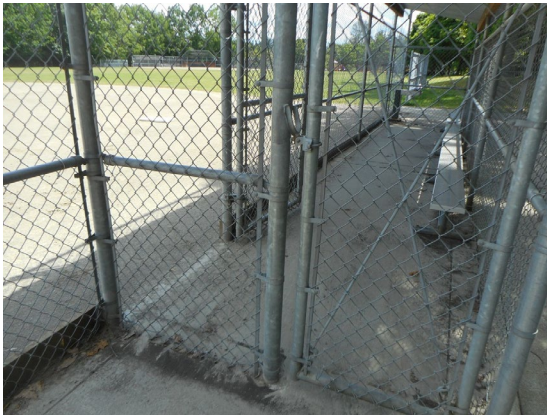
Aubrey Davis Park

- Upper Left: Bleachers require wheelchair seating (with signage).
- Upper Right: Only low level drinking fountain is provided. Hi-low drinking fountain required.
- Lower Left: Team dugout gates require 32" min. wide openings with maneuvering space on pull side.

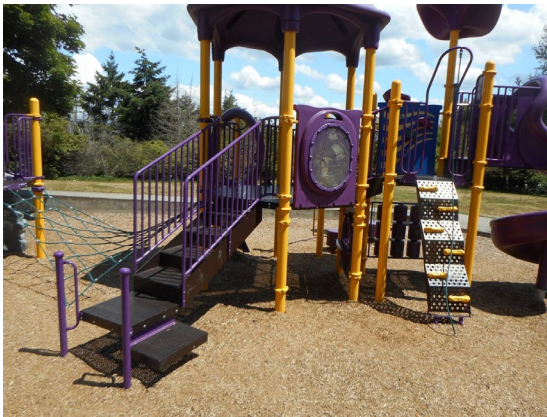
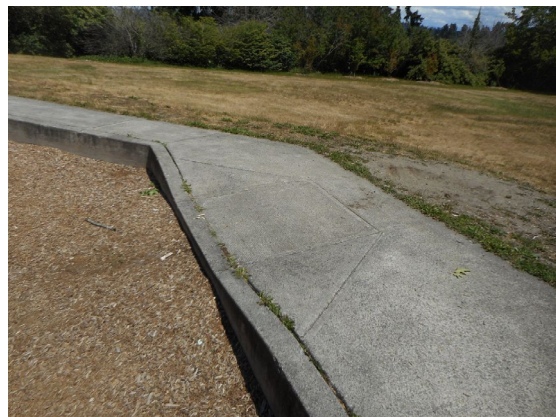
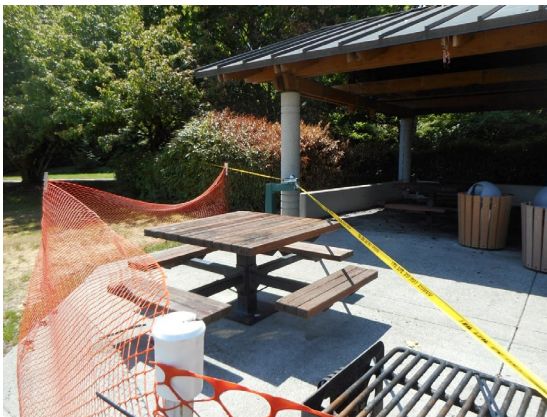
Aubrey Davis Park

- Upper Left: Ground surfaces of all play areas must be compliant and require periodic inspections & maintenance.
- Upper Right: A compliant ramp is required for the play area east of Feraglia Fields.
- Lower Left: 5% of picnic table seating should be accessible.

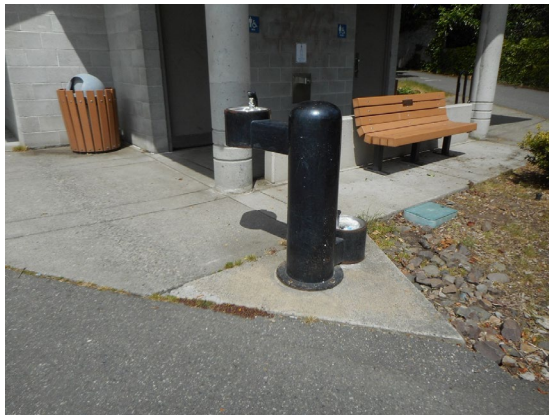
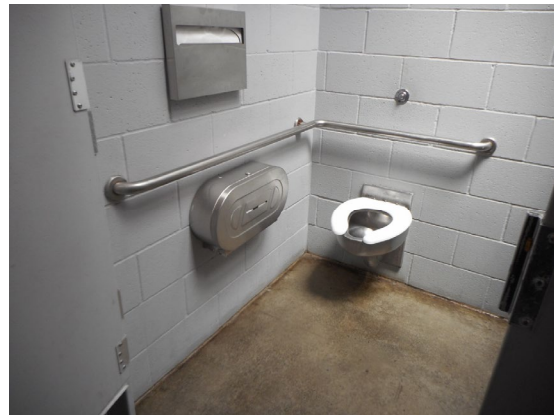
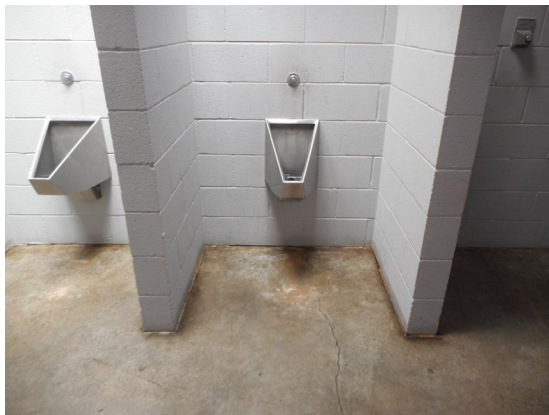
Aubrey Davis Park

- Upper Left: Only low level drinking fountain is provided. Hi-low drinking fountain required.
- Upper Right: Toilet in Men's restroom by Feroglia Fields should be relocated (centerline is in excess of 18" from corner).
- Lower Left: 1 urinal in Men's restroom by Feroglia Fields should be lowered to accessible height (17" max. AFF).

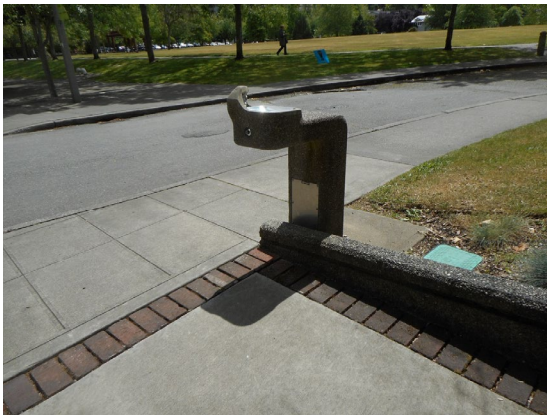
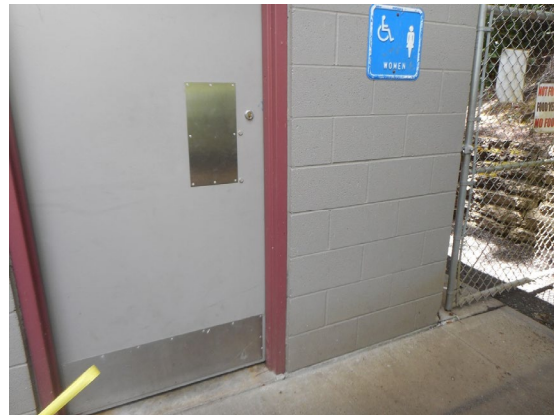
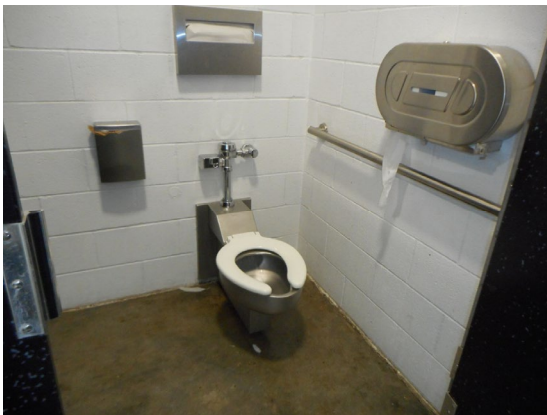
Bicentennial Park

- Upper Left: Only low level drinking fountain is provided. Hi-low drinking fountain is required for both wheelchair users and standing persons.
- Upper Right: Restroom signage lacks Braille.
- Lower Left: Women's restroom: toilet location should be adjusted, rear wall grab bar is required, and dispensers should be relocated within accessible reach ranges.

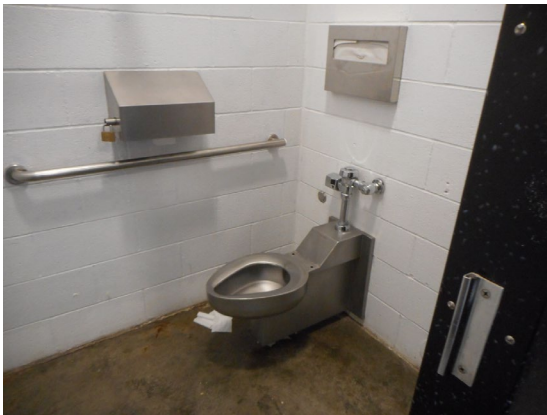
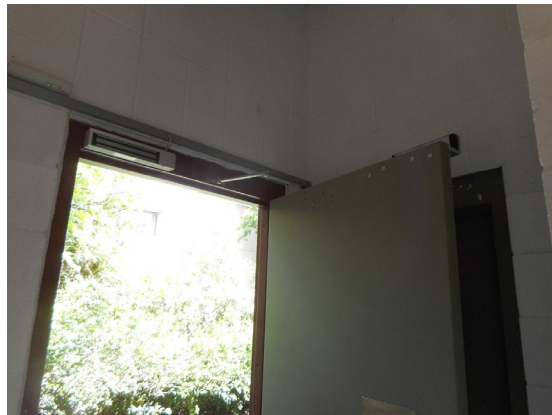
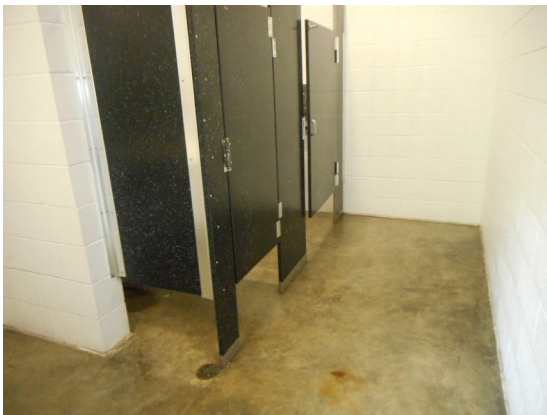
Bicentennial Park

- Upper Left: Men's restroom: toilet seat height is non-compliant, rear wall grab bar is required, dispensers shall be relocated within accessible reach ranges.
- Upper Right: Restroom door closers should be adjust due to excessive force required to open.
- Lower Left: Women's accessible stall door should be self-closing.

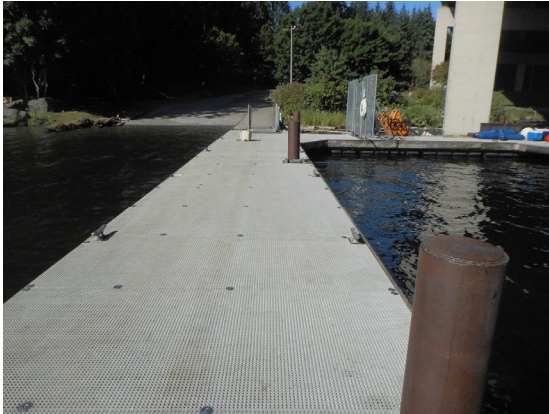
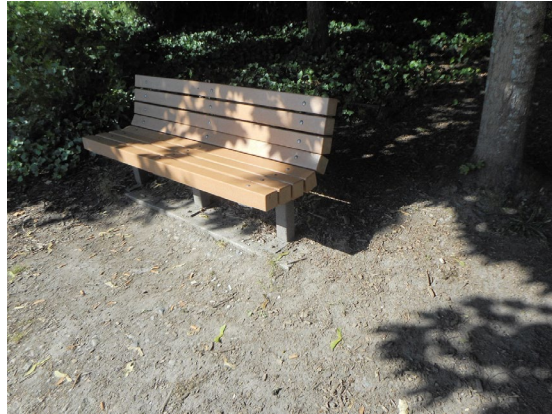
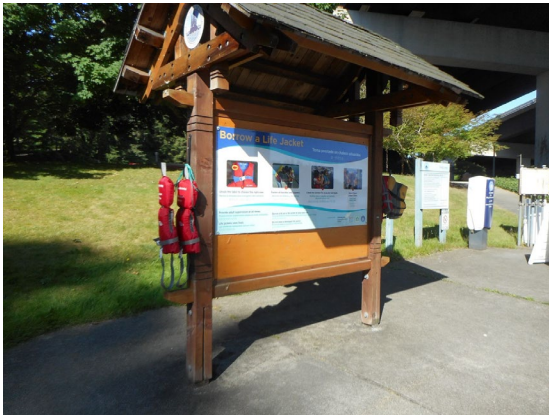
Mercer Island Boat Launch

- Upper Left: Gangway to boat launch pier requires an accessible route.
- Upper Right: 30"x48" clear floor space is required on one side of bench, and an accessible route shall be provided.
- Lower Left: Life jacket hooks are mounted too high. Lower one of each type to 48" max. AFF.

ITEM 1: LIFE JACKET HOOK - INFORMATION SIGN	Lower one hook for each type of life jackets to borrow down to 48" max. accessible height.	A max. 48" and min. 15" reach for any approach, which should be applied. Existing condition: Hooks for life jackets to borrow measured 5'-0" high. Owner/maintenance item.	P	O	1	2	1 EA	\$0
Barrier	522	Where an accessible bench is to be provided, the bench is not 42" long, 20" - 24" deep, with a 17" - 19" high seat an 18" high back (unless affixed to a wall) OR the bench lacks a 30"x48" clear floor adjacent to one end of the bench.	Citation	2010 ADA Stds. 903

ITEM 2: BENCH NEAR SCULPTURE	Recommendation: Provide level clear floor space (concrete pad) adjacent to one end of the bench and 44" wide (per Code) paved walkway from existing sidewalk at an angle to ensure compliant running slope of 5% or 1:20 max. (If running slope is greater than 1:20, provide compliant ramp with running slope of 1:12 max. 60" min. long landings top and bottom and continuous handrails both sides with 12" min. extensions beyond top and bottom of ramp.) Assumed length of path (without a ramp) is 30'-0".	Although not required under 2010 ADA scoping, E&A recommends providing a compliant 30"x48" clear floor space to one side of the bench. Existing condition: bench is located in lawn, and no clear floor space is provided.	P	O	1	2	34 LF	\$1,201

ITEM 3: GANGWAY TO BOAT LAUNCH PIER	Provide 44" min. (per Code) wide (clear between handrails) aluminum gangway structure with max. running slope of 8.33% or 1:12, or a min. of 30'-0" in length. Slope shall be measured based on median water level of Lake Washington.	Existing condition: Slope of existing gangway to floating boat launch pier measured up to 28% and is less than 30'-0" in length. EXCEPTIONS: 1. Accessible routes serving floating fishing piers and platforms shall be permitted to use Exceptions 1, 2, 5, 6, 7, and 8 in 1003.2.1.2. Where the total length of the gangway or series of gangways serving as part of a required accessible route is 30'-0" min., gangways shall not be required to comply with 405.2 (1:12 slope). Section - 1003.2.1.2: 1. Where an existing gangway or series of gangways is replaced or altered, an increase in the length of the gangway shall not be required to comply with 1003.2 unless required by 202.4. 2. Gangways shall not be required to comply with the max. rise specified in 405.6. 5. Where gangways connect to transition plates, landings specified by 405.7 shall not be required. 6. Where gangways and transition plates connect and are required to have handrails, handrail extensions shall not be required. Where handrail extensions are provided on gangways or transition plates, the handrail extensions shall not be required to be parallel with the ground or floor surface. 7. The cross slope specified in 403.3 and 405.3 for gangways, transition plates, and floating piers that are part of accessible routes shall be measured in the static position. 8. Changes in level complying with 303.3 and 303.4 shall be permitted on the surfaces of gangways and boat launch ramps.	P	O	1	2	1	EA	\$6,000

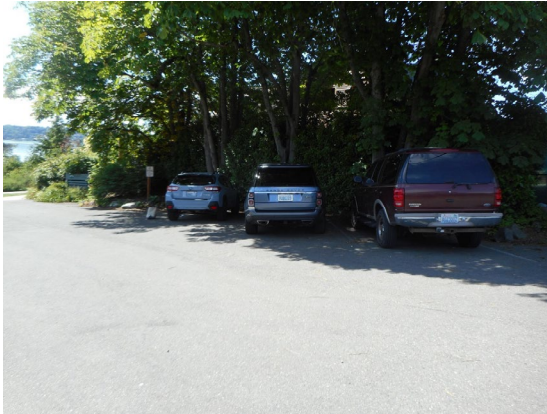
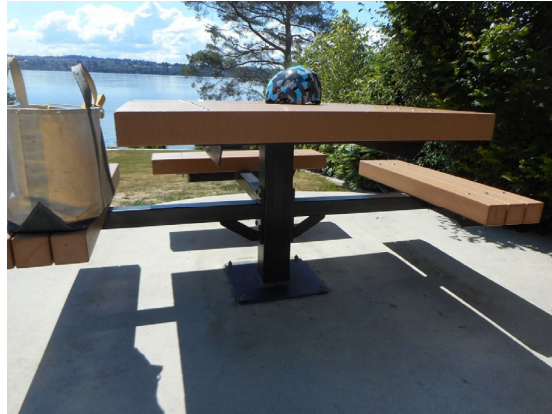
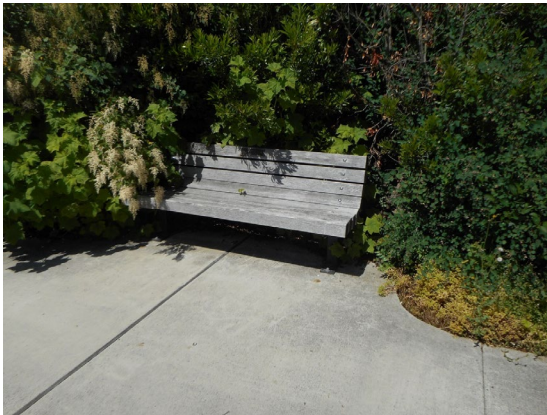
Calkins Landing

- Upper Left: Parking is provided for 3 vehicles, however no accessible parking is provided.
- Upper Right: Knee clearance at accessible picnic table seat is encroached on by steel supports.
- Lower Left: Bench requires an adjacent clear floor space at one end.

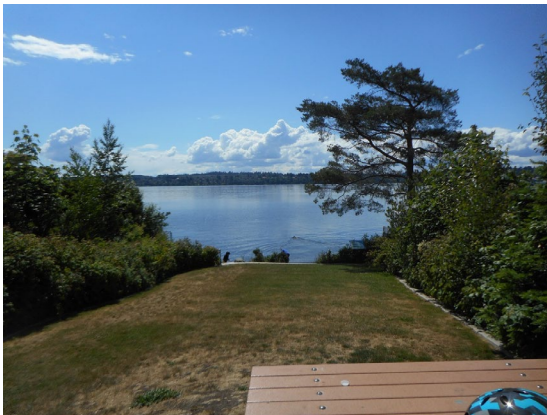
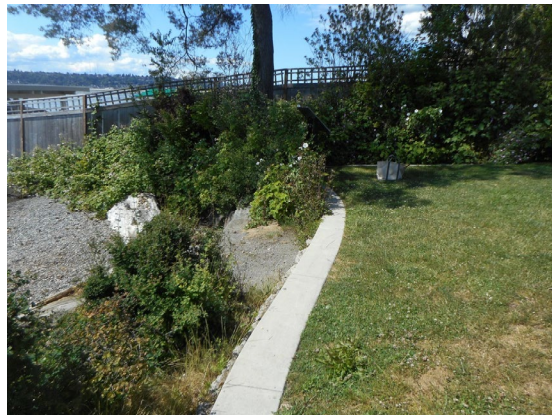
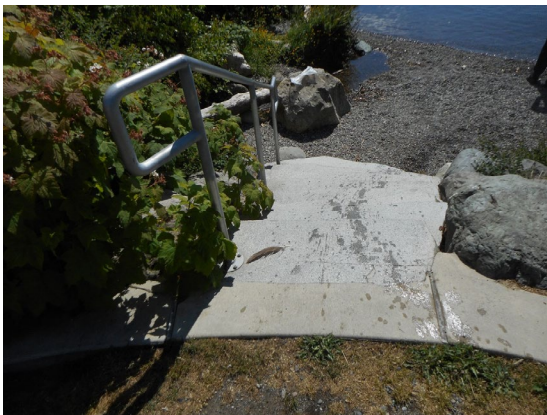
Calkins Landing

- Upper Left: Accessible sidewalk ends at picnic table.
- Upper Right: No accessible route is provided to the beach.
- Lower Left: No accessible route is provided to the beach.

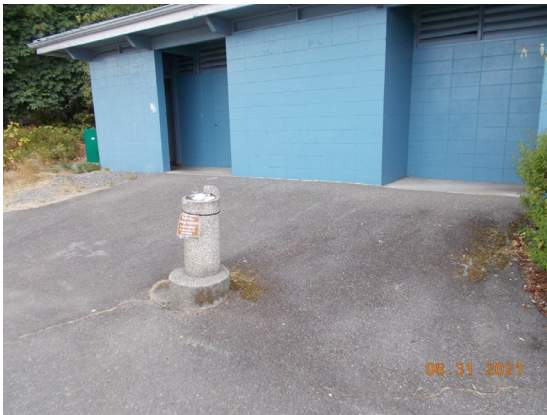
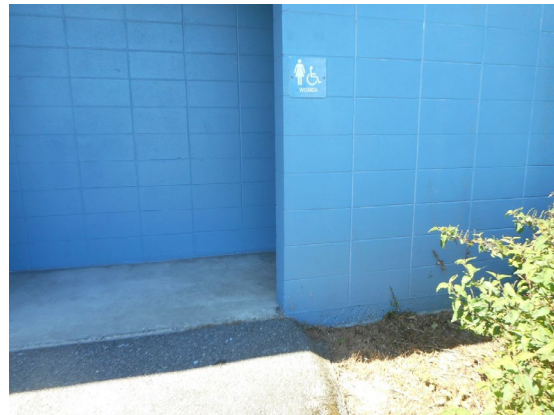
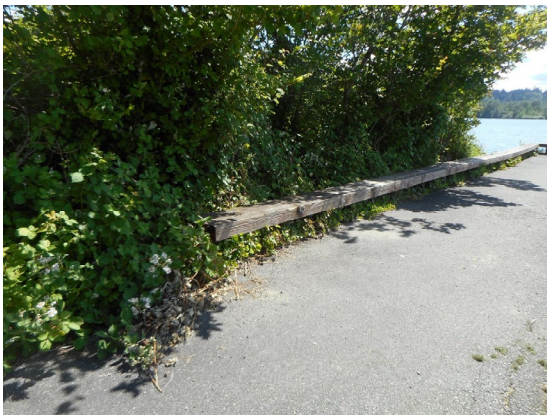
Clarke Beach Park

- Upper Left: Route to restrooms has an excessive slope.
- Upper Right: Restroom signage lacks an adjacent clear floor space below.
- Lower Left: 30"x48" clear floor space is required along each leg of the pier's continuous bench.

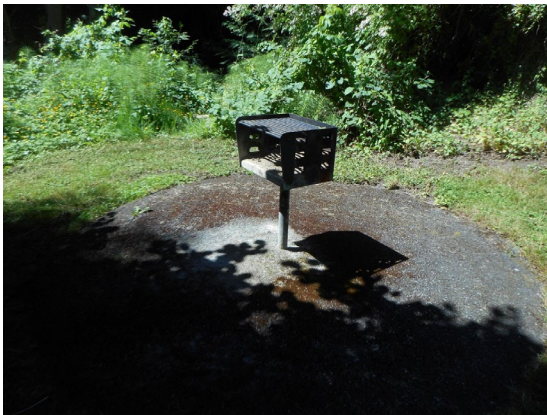
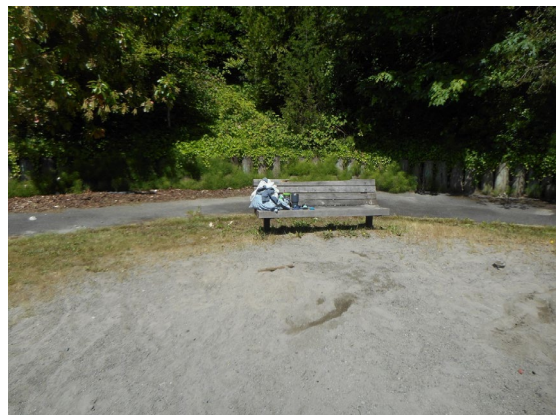
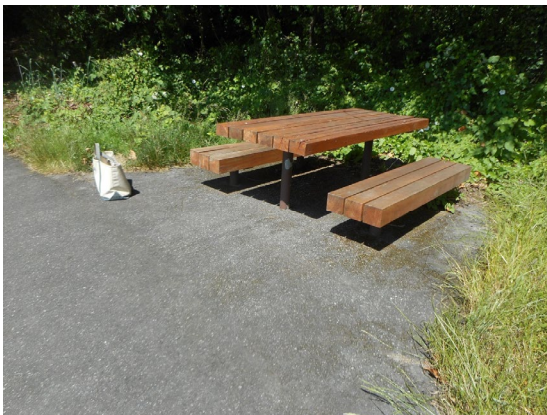
Clarke Beach Park

- Upper Left: 30"x48" clear floor space, paved and level, is required at BBQ grill closest to accessible picnic table.
- Upper Right: 30"x48" clear floor space, paved and level, is required at one end of one of the benches by the sand play area.
- Lower Left: 5% of picnic tables in each seating area require an accessible seat.

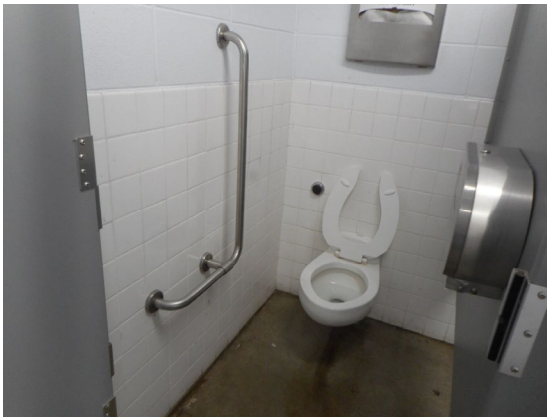
Clarke Beach Park

Upper Left: Restrooms are substantially non-accessible. Accessible stall in each restroom is non-compliant in size, grab bars are not compliant, flush control in Women's is incorrectly located, turn-around not provided in Men's restroom. Other issues were recorded.

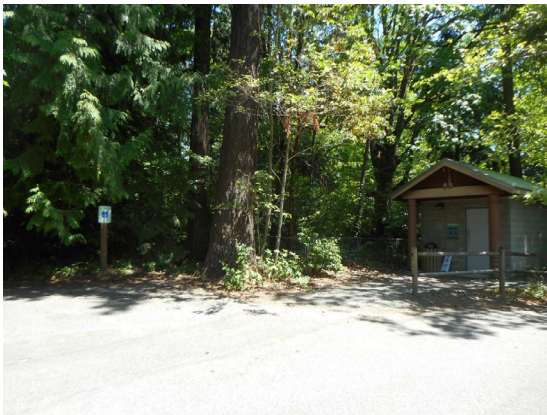
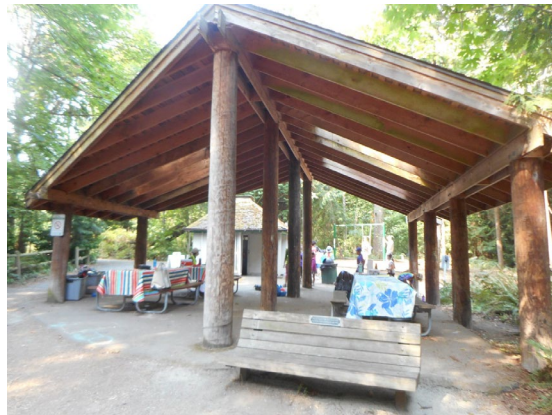
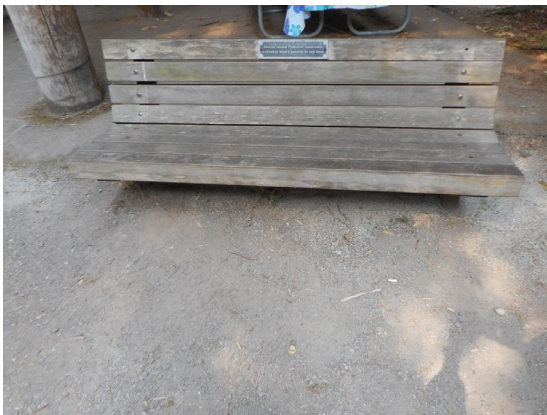
Deane's Children's Park

- Upper Left: Van accessible parking sign is mounted too low.
- Upper Right: Pavilion lacks a picnic table with an accessible seat with knee & toe clearance. 5% of picnic tables in each seating area require an accessible seat.
- Lower Left: Bench lacks a paved clear floor space at one end.

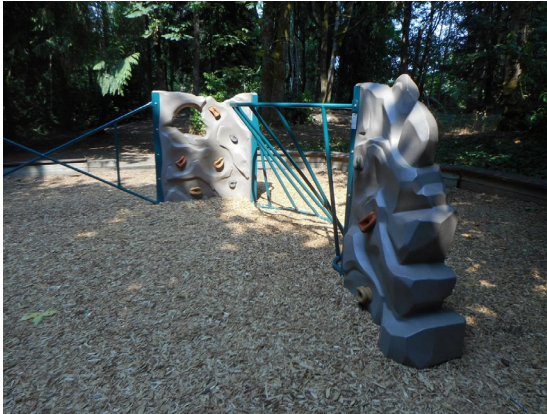
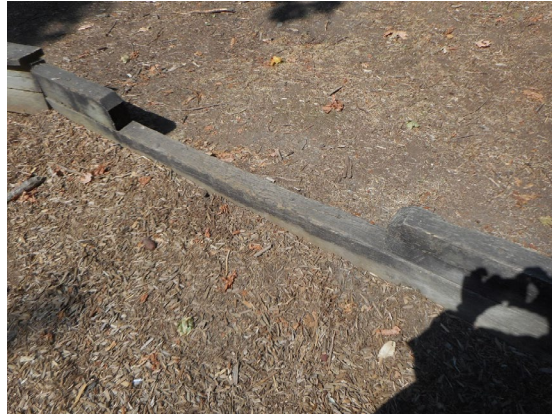
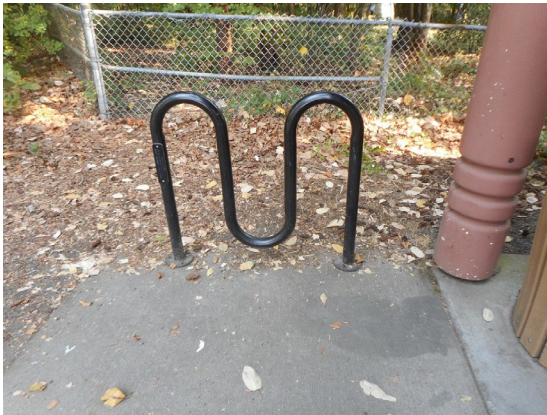
Deane's Children's Park

- Upper Left: Play area requires compliant ground surfaces, which must be periodically inspected and maintained.
- Upper Right: Wood border at play areas block accessible route. Removal of wood border and installation of ramp to play areas required.
- Lower Left: Bike rack lacks an adjacent (paved) clear floor space along one side.

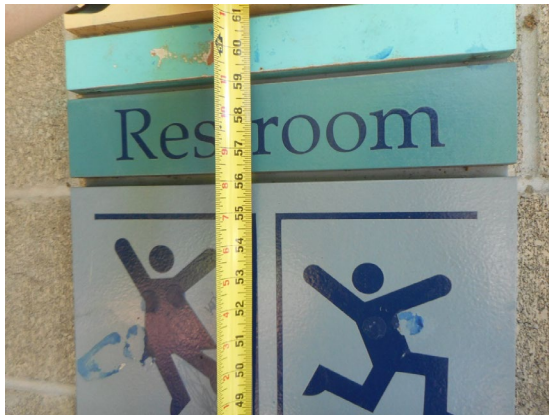
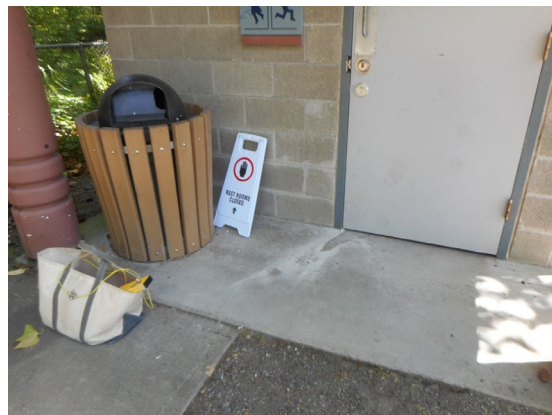
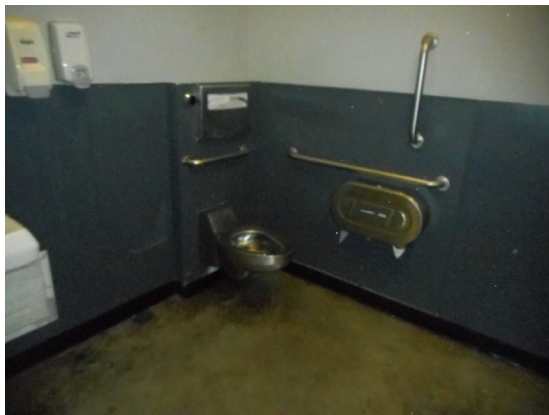
Deane's Children's Park

- Upper Left: Restroom signage lacks raised lettering, and is non-compliant in mounting height.
- Upper Right: Entry door into restroom lacks sufficient area for door maneuvering clearance. Concrete walk to be enlarged, and garbage can relocated.
- Lower Left: Grab bars at toilet are non-compliant in length & height. Wall surface behind toilet to be revised for grab bar. Seat cover dispenser lacks a forward approach. Toilet non-compliant for children's use.

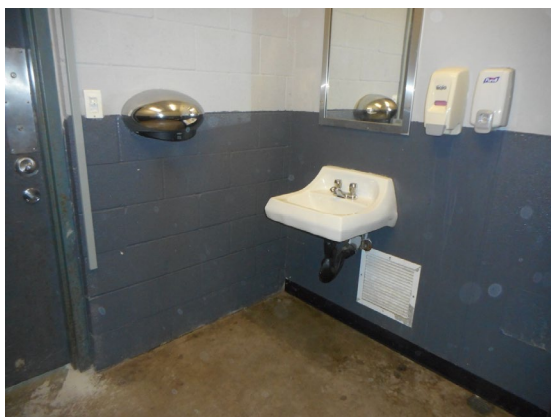
Deane's Children's Park

Upper Left: Lavatory does not provide knee & toe clearance and is mounted too high for children's use. Mirror is mounted too high.

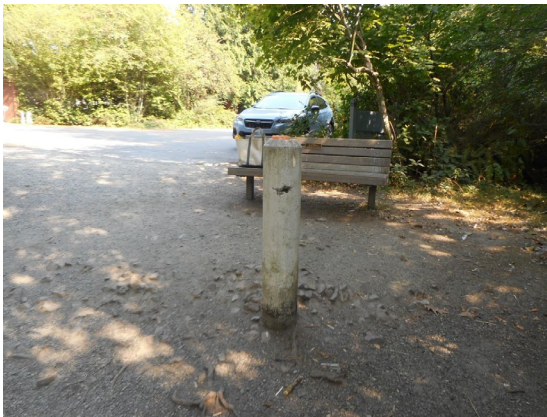
Ellis Pond

Upper Left: Park lacks a paved accessible route to bench, and one end of the bench required a paved clear floor space.

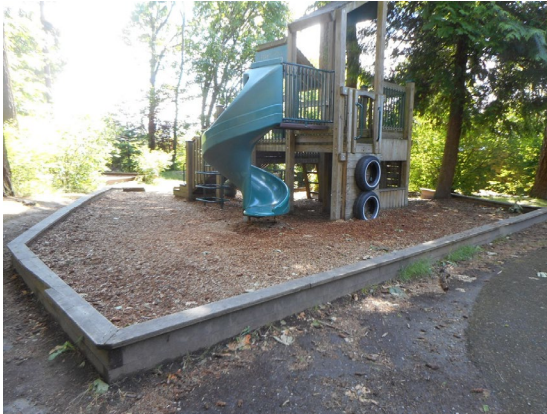
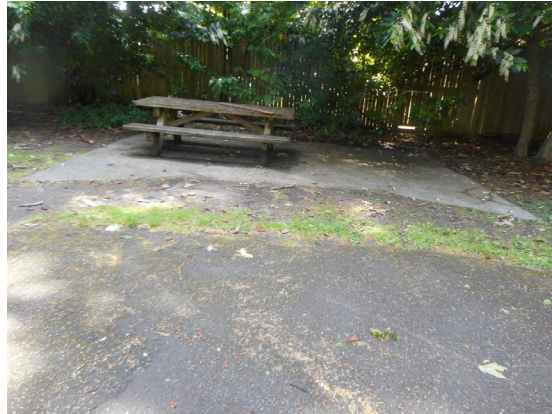
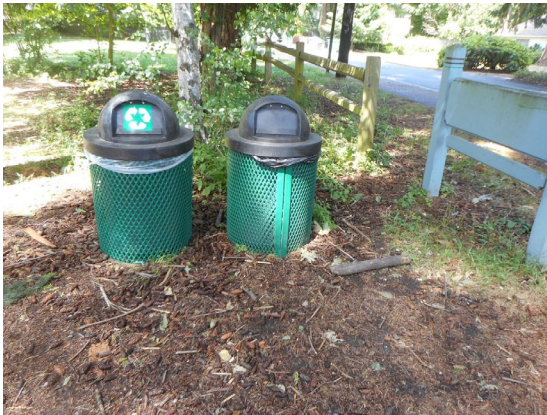
First Hill Park

Upper Left: Ground surfaces of all play areas must be compliant and require periodic inspections & maintenance. An accessible route is required into the play area.

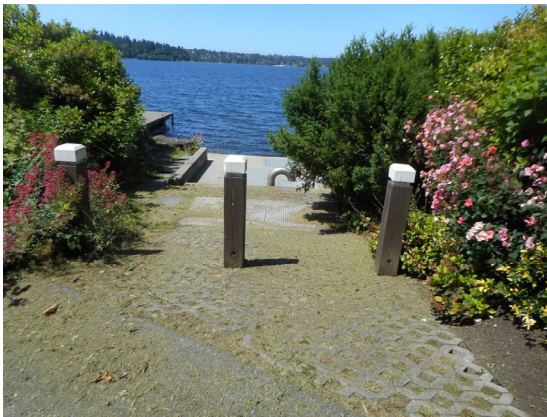
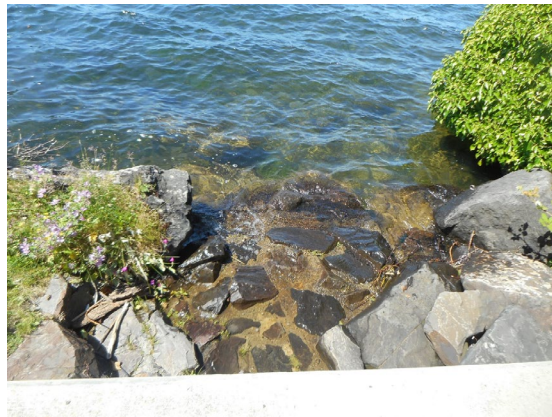
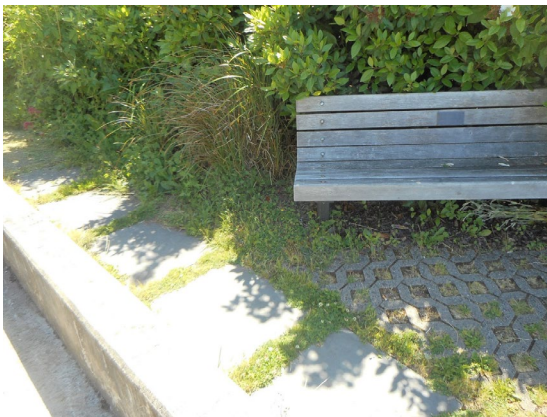
- Upper Left: Site has a path consisting of pavers and stepping stones. No accessible route is provided to site amenities.
- Upper Right: Stone steps to beach. No accessible route is provided.
- Lower Left: Bench requires an adjacent clear floor space at one end, and an accessible route.

ITEM 2: ACCESSIBLE BENCH		Recommendation: Provide level clear floor space (concrete pad) adjacent to one end of the bench.	Although not required under 2010 ADA scoping, E&A recommends for at least 5% of benches provide compliant 30"x48" clear floor space to one side of the bench. Existing condition: Bench is provided, however no adjacent clear floor space is provided.	P	O	7	2	10 SF \$250
Total for Building: Forest Landing								\$1,133
