City of Mercer Island

Americans with Disabilities Act

ADA Transition Plan

2022

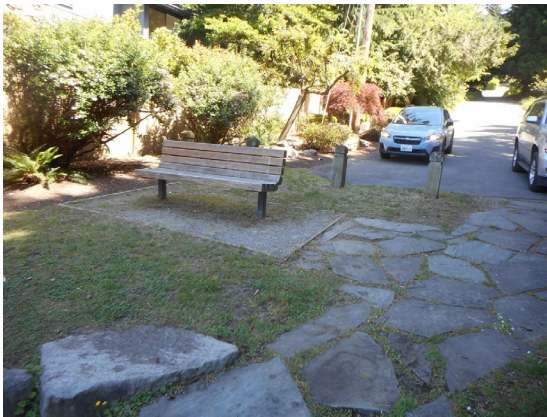
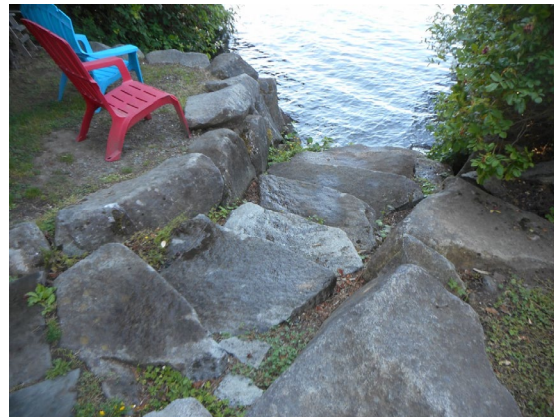
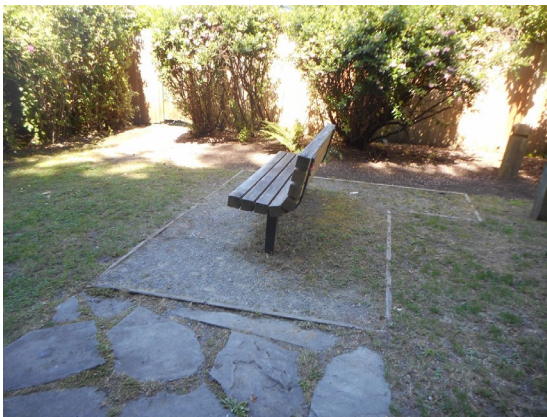
- Upper Left: A paved accessible route is lacking to the bench.
- Upper Right: A paved accessible route is lacking to the water's edge.
- Lower Left: Bench requires a paved adjacent clear floor space at one end.

ITEM 2: ACCESSIBLE BENCH	Recommendation: Provide level clear floor space (concrete pad) adjacent to one end of the bench.	Although not required under 2010 ADA scoping, E&A recommends for at least 5% of benches provide compliant 30"x48" clear floor space to one side of the bench. Existing condition: Adjacent to each side of the bench is loose gravel, and no clear floor space is provided.	P	O	7	2	10 SF	\$250
Total for Building: Franklin Landing								\$1,663

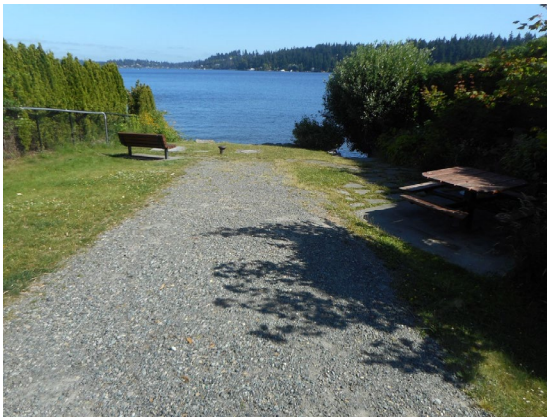
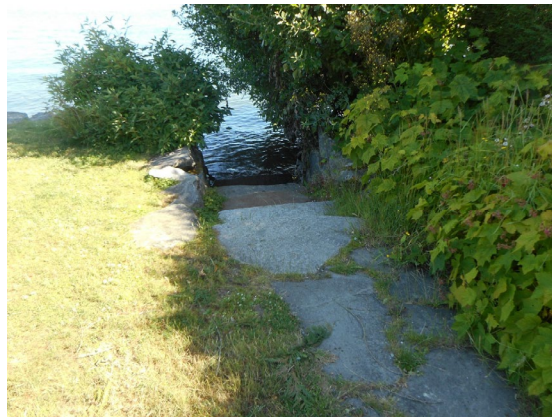
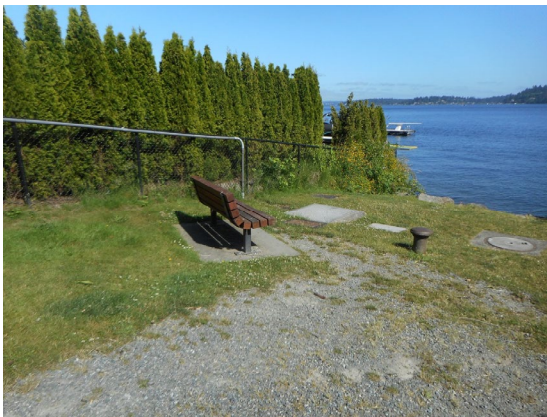
- Upper Left: A paved accessible route is lacking to the picnic table, bench, and waterfront. Picnic table does not provide an accessible seat area with a paved clear floor space below.
- Upper Right: A paved accessible route is lacking to the waterfront.
- Lower Left: Bench requires an adjacent clear floor space at one end.

ITEM 3: PICNIC TABLE		Remove and replace concrete slab with a 2% max. cross slope (1:48).	Existing concrete pad at picnic table is too small to provide required clear floor space.	P	O	1	2	3	LF	\$216
Barrier	522	Where an accessible bench is to be provided, the bench is not 42" long, 20" - 24" deep, with a 17" - 19" high seat and 18" high back (unless affixed to a wall) OR the bench lacks a 30"x48" clear floor adjacent to one end of the bench.	Citation	2010 ADA Stds. 903

ITEM 4: ACCESSIBLE BENCH		Recommendation: Provide level clear floor space (concrete pad) adjacent to one end of the bench.	Although not required under 2010 ADA scoping, E&A recommends for at least 5% of benches - provide a compliant 30"x48" clear floor space to one side of the bench. Existing condition: adjacent to each side of the bench is a lawn area, and no clear floor space is provided.	P	O	7	2	10	SF	\$250
Total for Building: Fruitland Landing									\$8,264

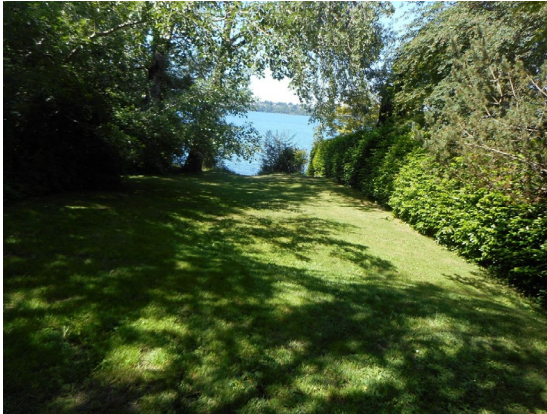
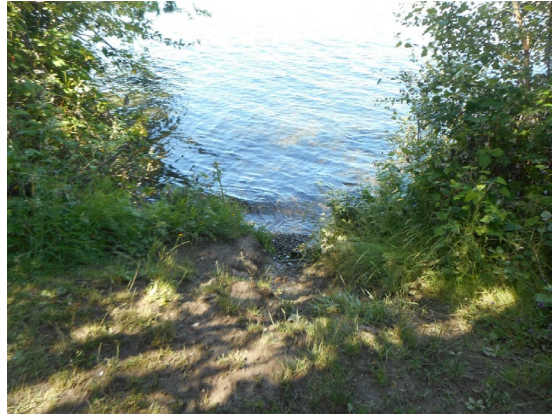
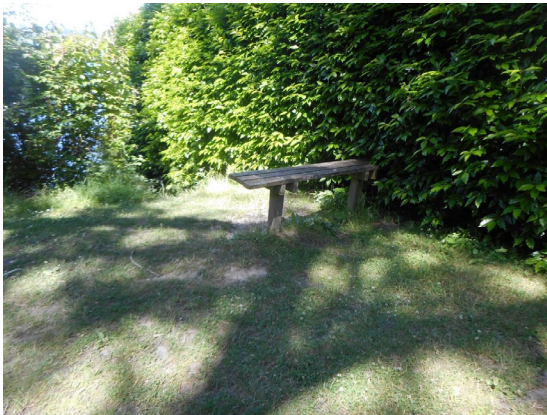
- Upper Left: The site has a lawn area only. A paved accessible route is lacking to the bench and water's edge.
- Upper Right: No accessible route is provided to the water's edge.
- Lower Left: The bench requires an adjacent clear floor space at one end.

ITEM 2: ACCESSIBLE BENCH	Recommendation: Provide level clear floor space (concrete pad) adjacent to one end of the bench.	Although not required under 2010 ADA scoping, E&A recommends for at least 5% of benches provide compliant 30"x48" clear floor space to one side of the bench. Existing condition: Bench is in a lawn area, and no clear floor space is provided.	P	O	7	2	10 SF	\$250
Total for Building: Garfield Landing								\$8,727

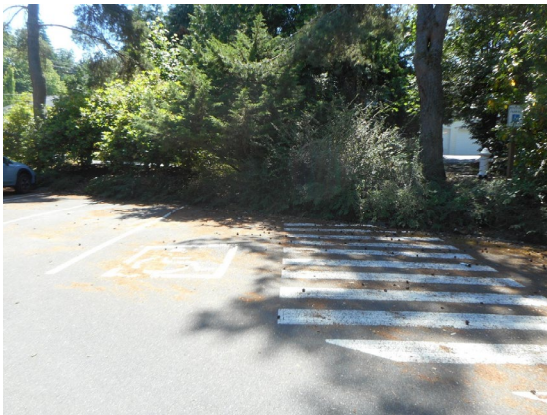
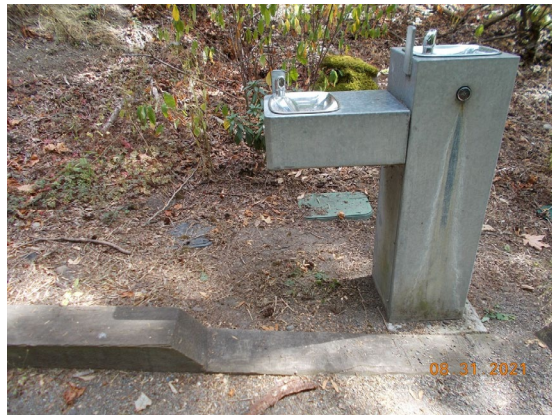
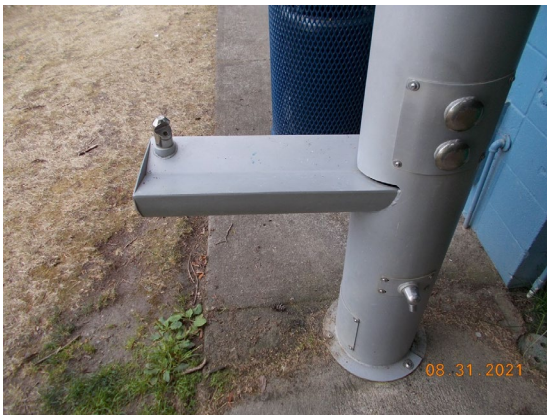
Groveland Beach Park

Upper Left: Accessible parking stall lacks signage.

LOCATION	RECOMMENDATION	COMMENTS	TYPE	RESP CODE	PRI	QTY	UNITS	BUDGET
Accessible Parking								
Barrier	540	The accessible stall lacks compliant accessible parking signage, or existing signage is not 60" min. high measured to the bottom of sign.	Citation	2010 ADA Stds. 502.6, 703.7.2.1, 216.5				
ITEM 1: PARKING LOT - ACCESSIBLE PARKING	Add new sign displaying the International Symbol of Accessibility at one existing accessible stall.	Signs shall be 60" min. AFF or ground surface, measured to bottom of the sign. Existing condition: No sign is provided at one accessible parking space (other accessible space has sign).	P	O	1	1	EA	\$290

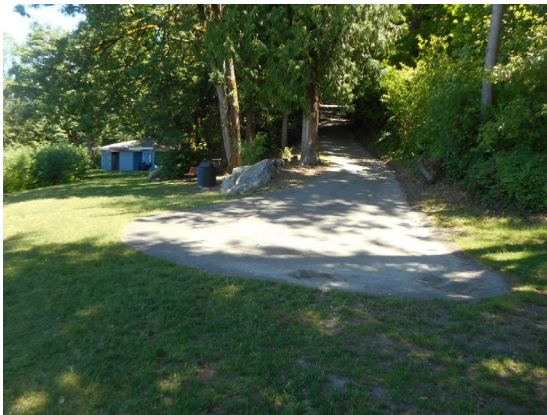
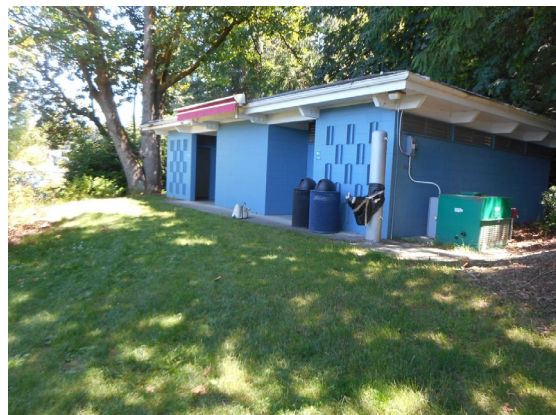
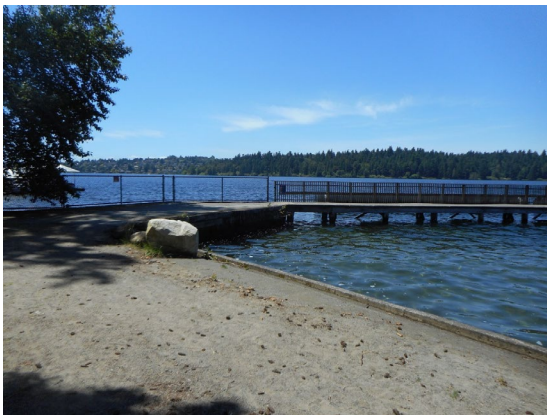
Groveland Beach Park

- Upper Left: Paved road ends. No accessible route is provided to beach, restrooms, volleyball court, or pier.
- Upper Right: No accessible route is provided through the lawn to the restrooms.
- Lower Left: No accessible route is provided to the beach or pier.

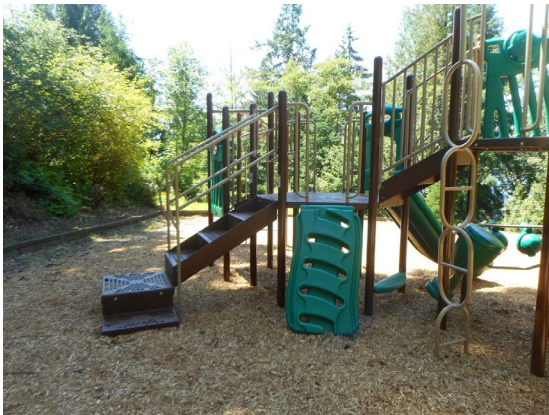
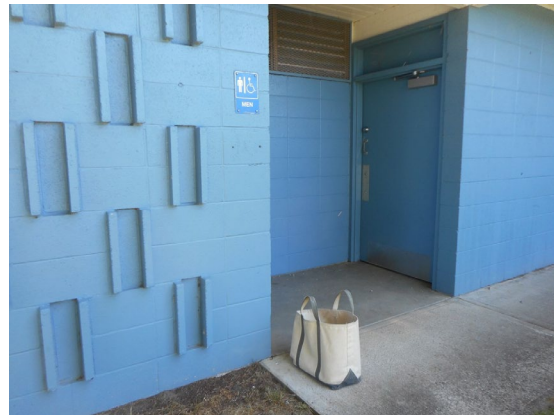
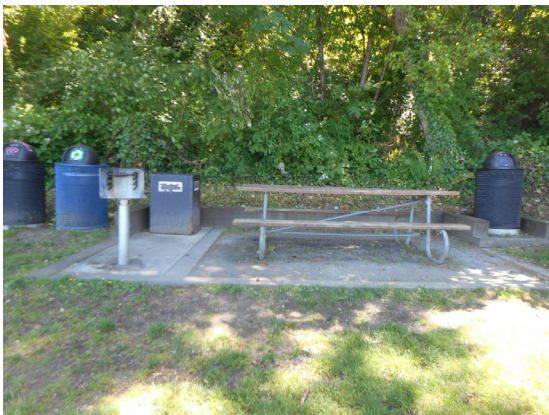
Groveland Beach Park

- Upper Left: Play area requires compliant ground surfaces, which must be periodically inspected and maintained.
- Upper Right: Restroom signage lacks an adjacent clear floor space below.
- Lower Left: The picnic table lacks an accessible seat, clear floor space, and accessible route.

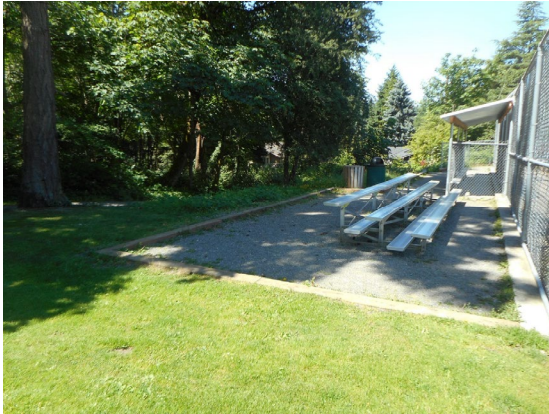
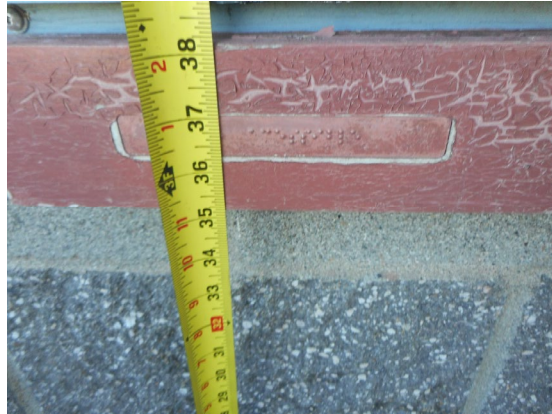
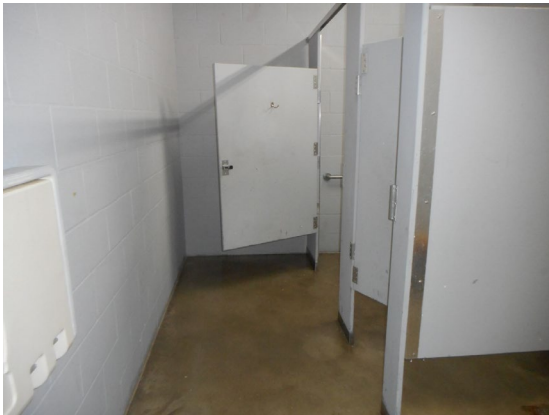
Homestead Park

- Upper Left: Ballfields lack an accessible route.
- Upper Right: Restroom signage is mounted too low.
- Lower Left: Accessible toilet stall doors are required to be self-closing, have a pull on the inside surface, and have coat hooks at 48" max. AFF.

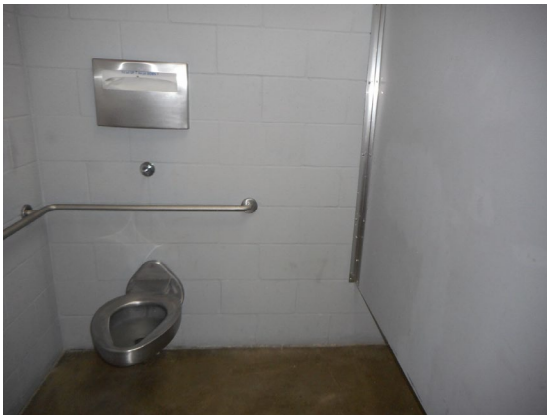
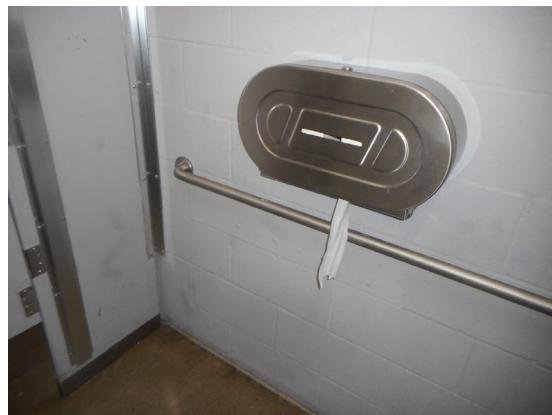
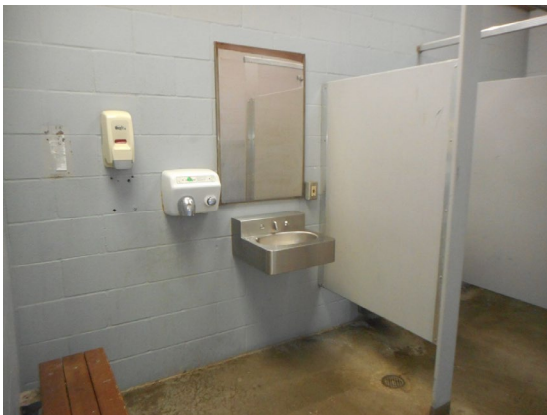
Homestead Park

- Upper Left: Grab bars in accessible toilet stalls are not compliant in length and mounting height. Seat cover dispensers mounted behind toilet are not accessible. Toilets are too far from wall (should be located 16" min. - 18" max. from side wall).
- Upper Right: Toilet paper dispensers are mounted within the required 12" clearance space above the grab bar.
- Lower Left: Men's lavatory does not provide compliant knee clearance. Soap dispenser is mounted too high.

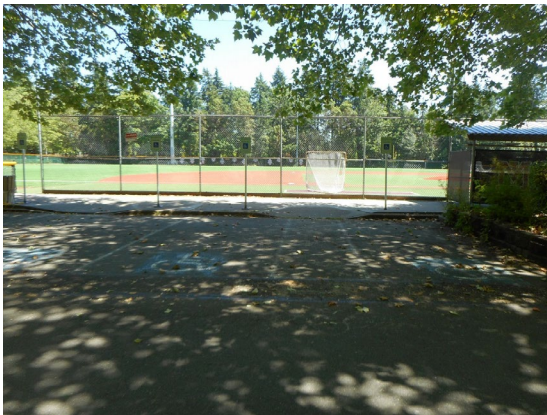
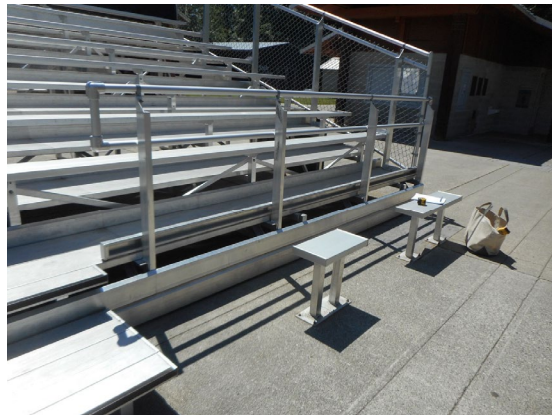
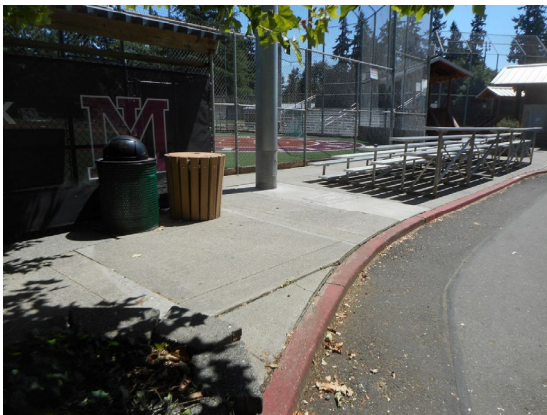
Island Crest Park

- Upper Left: Van accessible parking space is insufficient in width. Relocation of signage is required due to restriping.
- Upper Right: Ballfield #1 Home Team bleachers — companion seats do not provide the required width for adjacent wheelchair seating.
- Lower Left: Ballfield #1 Visitor Team bleachers — space is not sufficient for wheelchair seating, including accessible route.

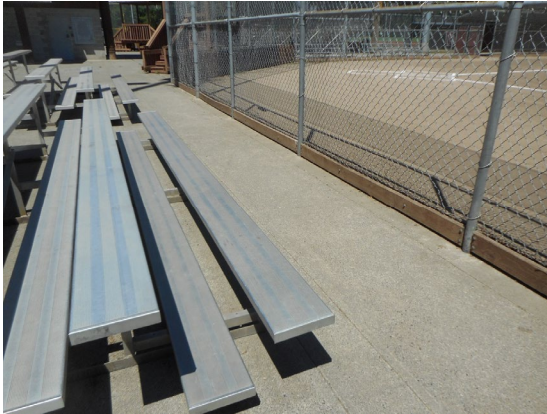
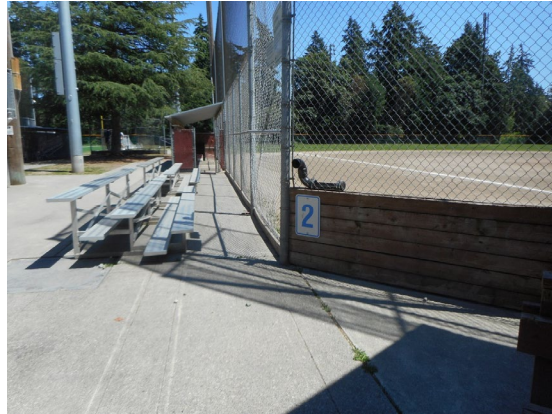
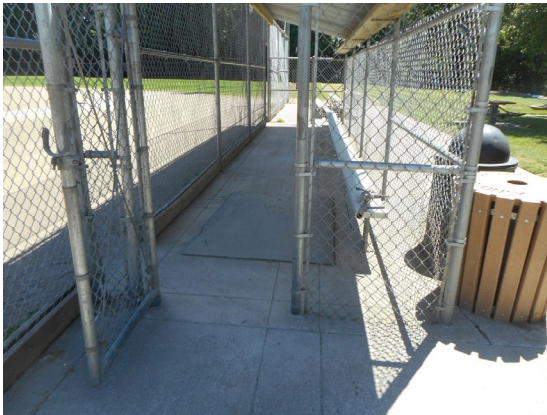
Island Crest Park

- Upper Left: Ballfield #2 Home Team bleachers are too close to fencing to provide an accessible route in front of the required wheelchair spaces.
- Upper Right: Ballfield #2 Visitor Team bleachers are too close to fencing to provide an accessible route in front of the required wheelchair spaces.
- Lower Left: Dugouts require a wheelchair space adjacent to the end of the bench. Some benches must be adjusted in length to provide wheelchair space.

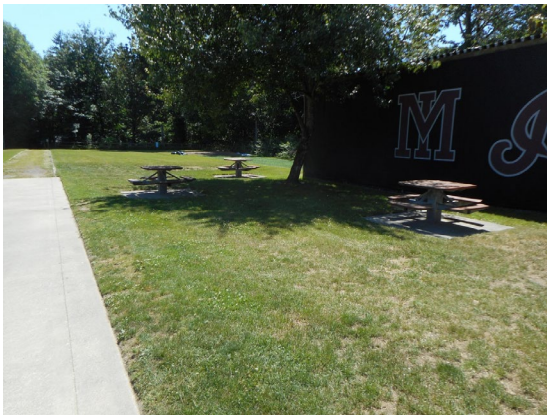
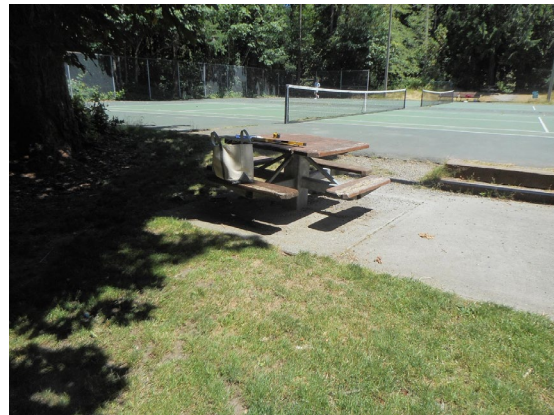
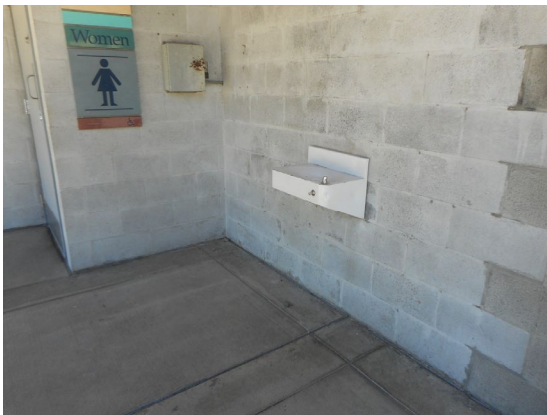
Island Crest Park

- Upper Left: 1 picnic table is required to provide an accessible seat. An accessible route is required to table.
- Upper Right: 1 picnic table is required to provide an accessible seat. An accessible route is required to table. A ramp is required to tennis courts.
- Lower Left: A single low drinking fountain is provided outside of each restroom, with insufficient knee space. Hi-low drinking fountains are required.

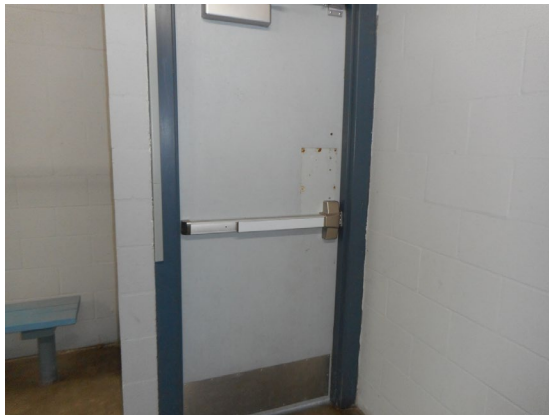
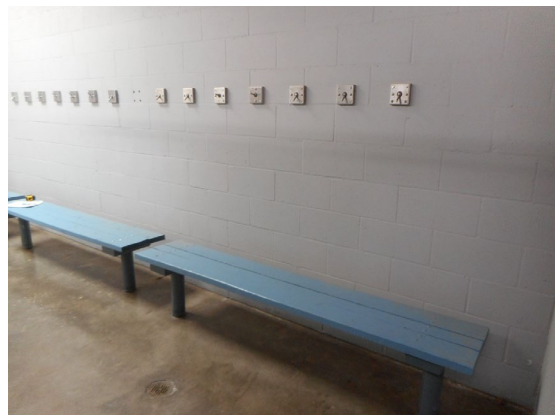
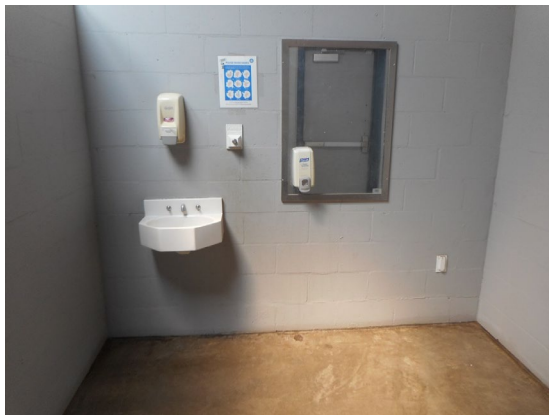
- Upper Left: Restroom doors have a latch and a closer, requiring 12" min. width on the push side.
- Upper Right: Dressing room benches are non-compliant, an additional bench is required in each dressing room. Clothes hooks are mounted too high, one in each room must be lowered or provide a new hook at 48" max. AFF.
- Lower Left: Each restroom has 2 lavatories. Neither has an accessible knee space clearance. 1 in each restroom must be compliant. Soap dispenser mounted too high.

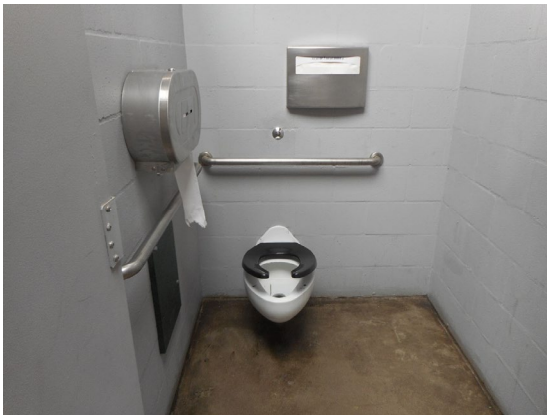
Upper Left: Accessible toilet stall in each restroom is insufficient in width. Seat heights are too low. Grab bars require relocation. Flush control in Men's accessible stall is incorrectly located. Photo is Men's restroom.

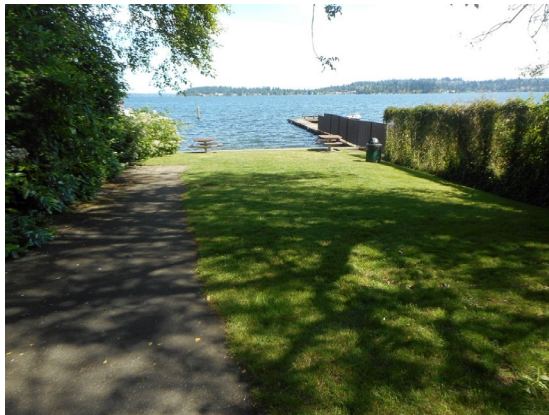
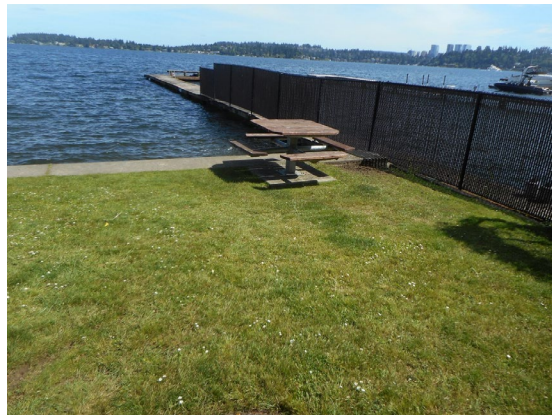
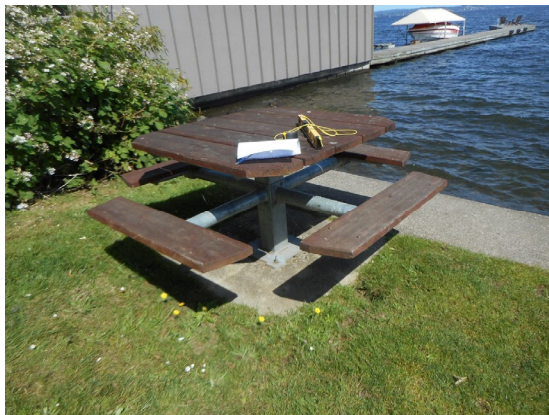
Lincoln Landing

- Upper Left: No accessible route is provided to picnic tables.
- Upper Right: Neither of the 2 picnic tables provides an accessible seat with the required knee and toe clearance. 1 accessible picnic table must be provided.
- Lower Left: The accessible picnic table requires a paved clear floor space at the accessible seat, and an accessible route to it.

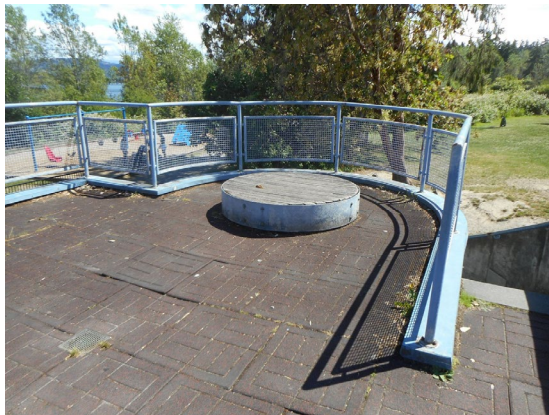
Upper Left: Rooftop viewing platform is provided above the restrooms near the tennis courts.

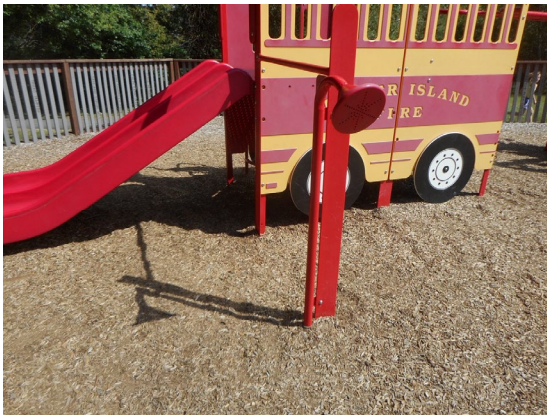
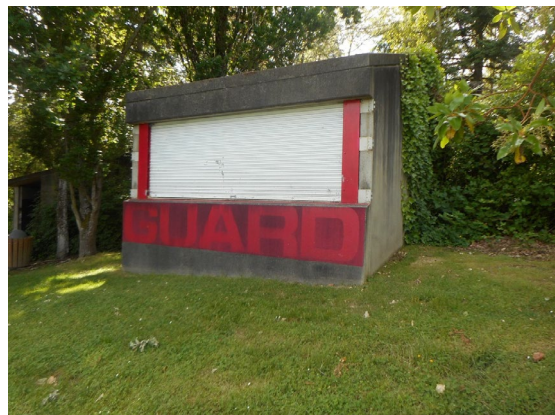
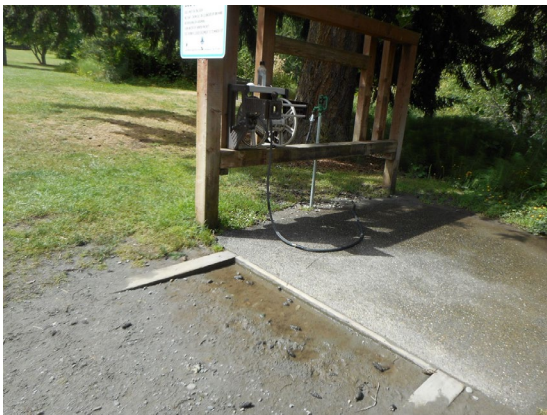
- Upper Left: Ground surfaces of all play areas must be compliant and require periodic inspections & maintenance.
- Upper Right: Service counter at Guard station lacks an accessible route and is too high. An accessible portion is required.
- Lower Left: Dog wash area lacks an accessible route, and water control is above accessible reach.

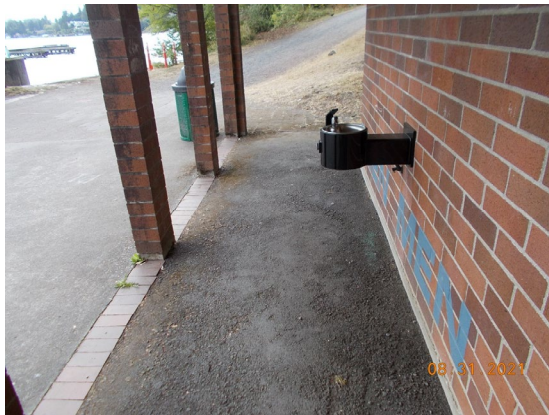
Upper Left: Only low level drinking fountain is provided near old boiler room. Hi-low drinking fountain required.

ITEM 22: RESTROOMS AT BOILER ROOM	Replace the fountain with a hi-low model.	Where provided, min. 2 water fountains are required. 1 is required to meet 602.1 - 602.6 for clear floor space, height, operable parts, and water flow, and 1 is required to meet 602.7 which is height for standing persons. If a water fountain is provided that meets both requirements, it may be substituted for 2 fountains. Spout outlets shall be 36" max. AFF or ground. Drinking fountains for standing persons: Spout outlets of drinking fountains for standing persons shall be 38" min. and 43" max. AFF. Existing condition: Only one drinking fountain is provided.	P	O	1	4	1	EA \$4,400
Barrier	753	The water fountain lacks a min. 27" high knee clearance for a front approach, OR is too high, creating a protruding object.	Citation	2010 ADA Stds. 602.2,307

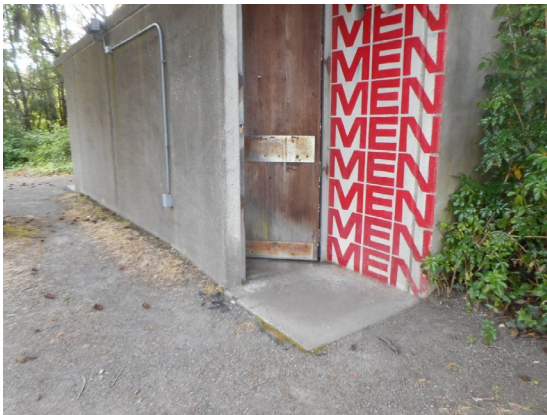
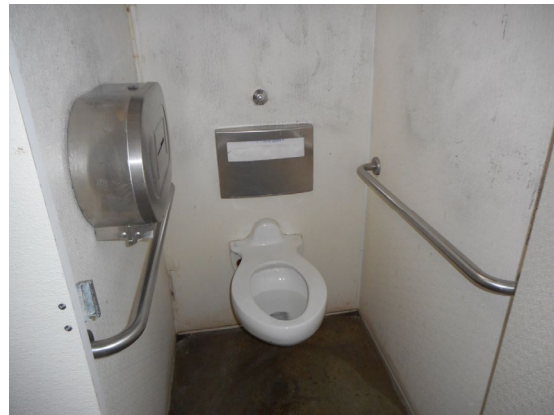
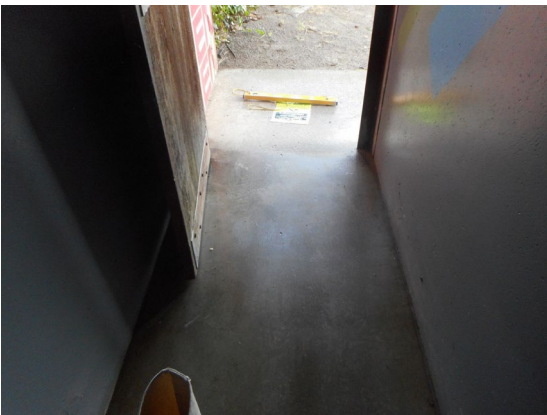
- Upper Left: Restrooms near Picnic Area C are substantially non-accessible.
- Upper Right: Designated accessible stalls are significantly too small, toilets are mounted too far from side wall, dispensers require relocation, grab bars are not compliant in location.
- Lower Left: Door maneuvering space is too narrow and shallow.

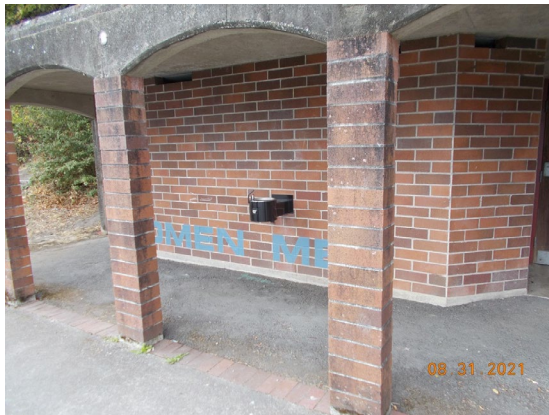
Upper Left: Restrooms near the old boiler room are substantially non-accessible.

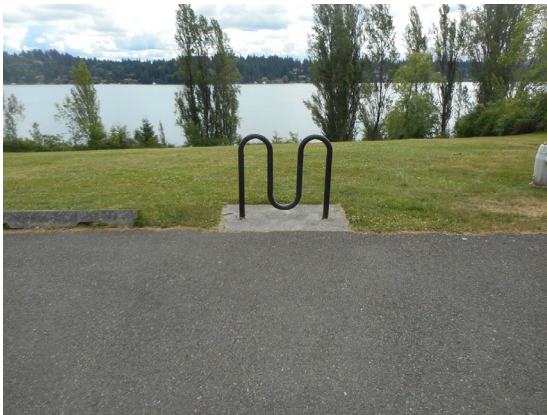
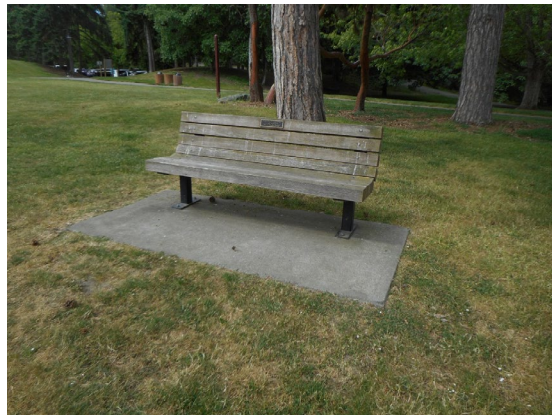
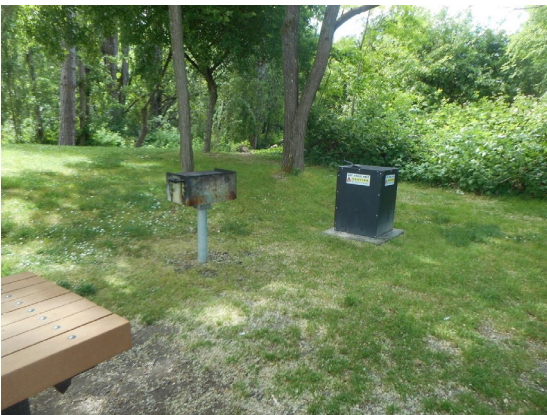
- Upper Left: Bike rack lacks a paved clear floor space at one end.
- Upper Right: Min. 1 bench in each area should have a clear floor space on one end and be on an accessible route.
- Lower Left: BBQ grill and hot coal disposal unit lack an accessible route and paved clear floor space directly adjacent.

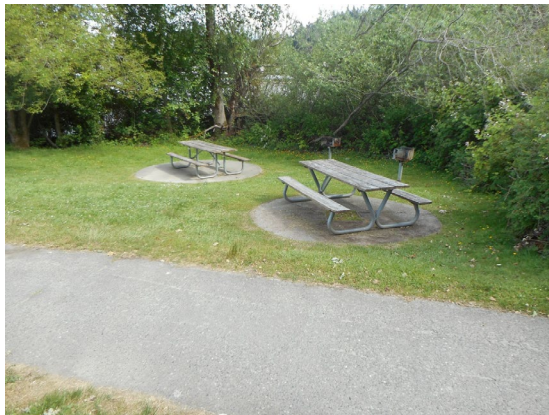
Upper Left: An accessible picnic table in each area requires a paved accessible route and an accessible seat.

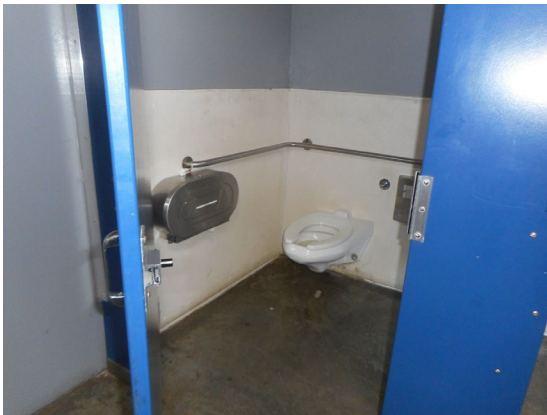
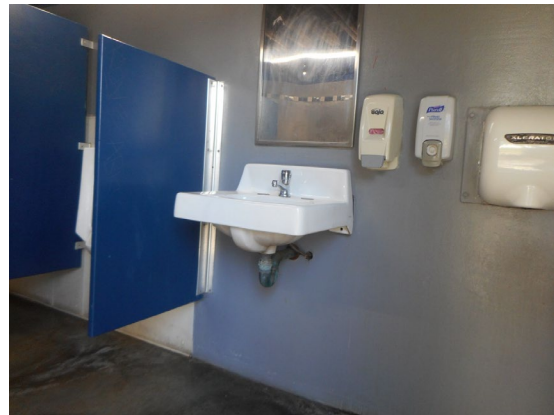
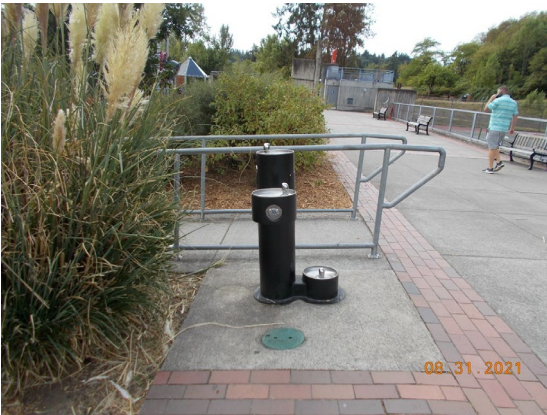
- Upper Left: Grab bars in restrooms near tennis courts are too short. Toilet paper dispenser is too close to grab bar and toilet in Men's restroom is too far from wall.
- Upper Right: Both restrooms near tennis courts have lavatories without compliant knee space clearance and pipes are not insulated.
- Lower Left: Handrails do not extend low enough to prevent a protruding object of more than 4" into accessible route.

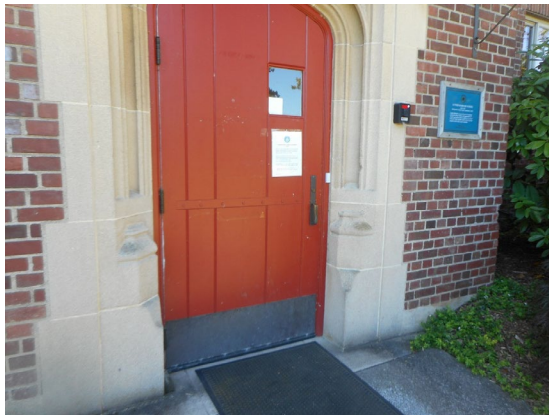
Upper Left: North entry door is recessed 12" from brick façade. To preserve historic doorway, power operator would be required.

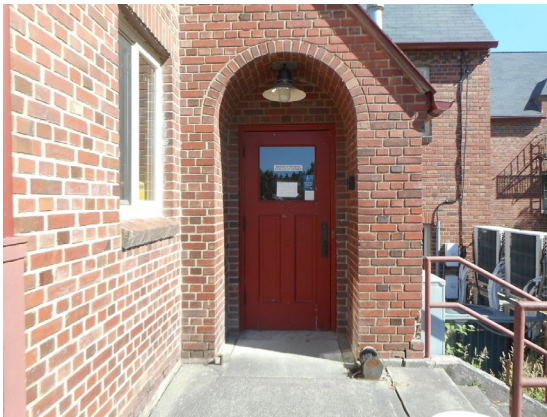
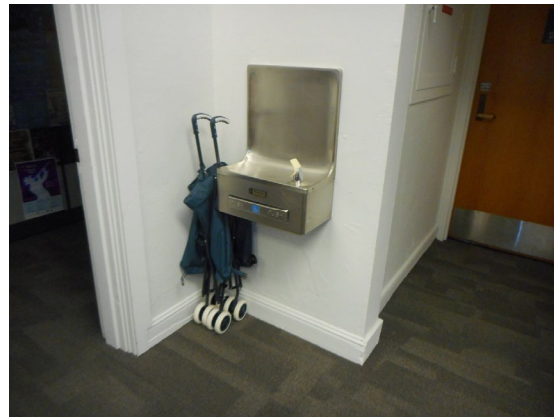
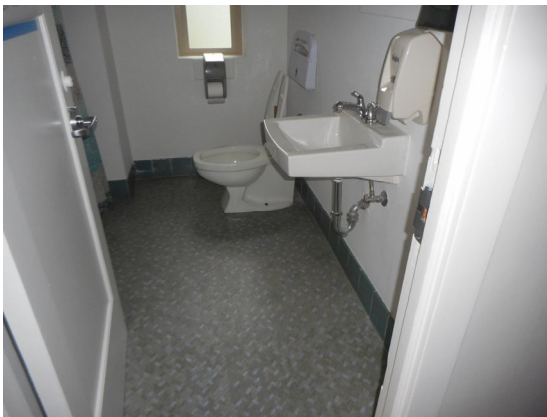
- Upper Left: South entry is designated as accessible entry, but door is recessed 34" (8" max. allowed) into required door maneuvering space. Consider abandoning entry.
- Upper Right: A hi-low drinking fountain is required.
- Lower Left: Turning space is not provided, and lavatory encroaches on door maneuvering space at second floor restroom.

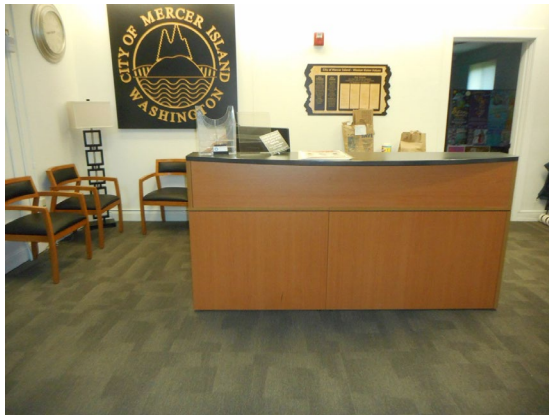
- Upper Left: First floor reception desk does not provide an accessible height counter.
- Upper Right: Office door is too narrow. Remove door and provide 32" min. wide framed opening (otherwise door opening needs to be widened).
- Lower Left: Doors have knob type hardware. Lever-type is required for accessibility.

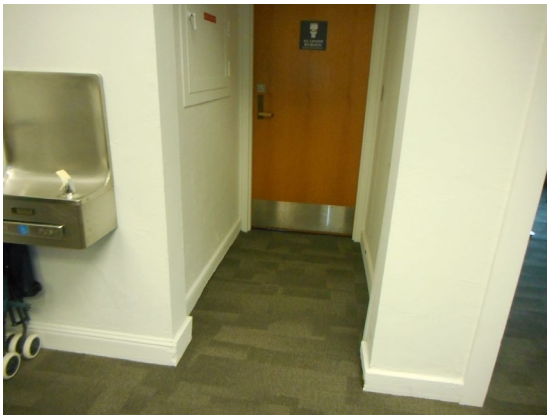
- Upper Left: Restroom signage is non-compliant. The International Symbol of Accessibility is required.
- Upper Right: Grab bar encroaches on door maneuvering space; should be 1-1/2" from the side wall behind. Revised side wall (and door opening) is required. Toilet requires seat height between 17" - 19" AFF and flush control shall be on open side of toilet.
- Lower Left: Pipes below lavatory are not insulated.

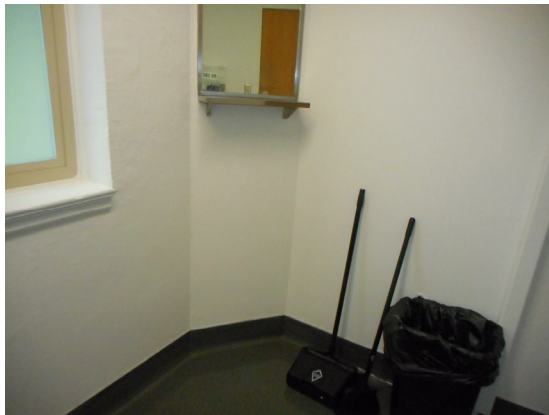
- Upper Left: Existing shelf/mirror unit is mounted too high. Shelf to be 40" - 48" AFF. An additional tall mirror is required.
- Upper Right: Coat hook is mounted above the required 48" max. height.

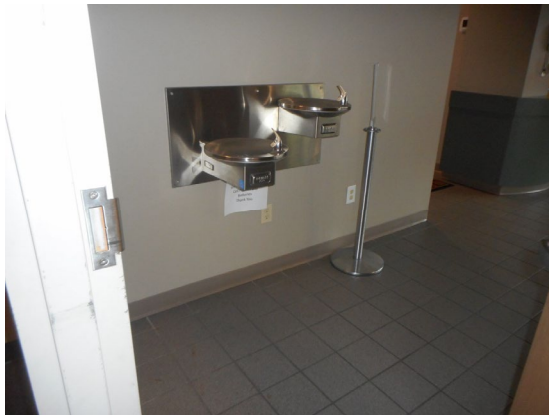
LOCATION	RECOMMENDATION	COMMENTS	TYPE	RESP CODE	PRI	QTY	UNITS	BUDGET
Drinking Fountains								
Barrier	7380	The standing persons water fountain is a protruding object.	Citation	2010 ADA Stds. 602.7				
ITEM 2: DRINKING FOUNTAINS	Provide a cane detection device less than 27" AFF.	High level drinking fountain is on the open end, near path of travel, with bottom edge at 34-1/2" AFF.	P	O	1	4	1	EA \$530

- Upper Left: The high level drinking fountain protrudes into the path of travel, with the bottom surface at 34-1/2" AFF.
- Upper Right: Lavatory is not compliant and encroaches on door maneuvering space. Restrooms require renovation.
- Lower Left: Toilets in both restrooms are too far from the side wall. Grab bars are too short. Seat cover dispenser encroaches on 12" clearance above grab bar and is not accessible.

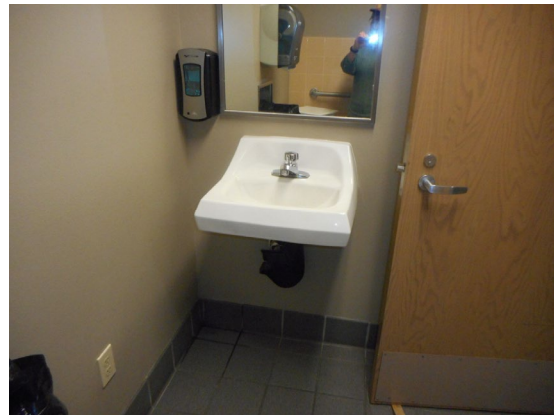
LOCATION	RECOMMENDATION	COMMENTS	TYPE	RESP CODE	PRI	QTY	UNITS	BUDGET
Restrooms / Bathrooms								
Barrier	698	The restroom is substantially inaccessible - lacks overall turning space, clear floor space at fixtures, and/or compliant fixtures and dispensers.	Citation	2010 ADA Stds. 603				
ITEM 4: PUBLIC RESTROOMS	Demolish the interior fixture layouts of both restrooms and completely renovate within its current footprint.	Restrooms are substantially non-compliant (especially in fixture encroaching on door maneuvering space). Design study is required to determine if two restrooms can be retained or if only a single compliant unisex restroom can be accommodated. Cost shown is an allowance, until further design studies are carried out.	P	O	1	3	1	EA \$35,000
Total for Building: Main Fire Station #91								\$39,730

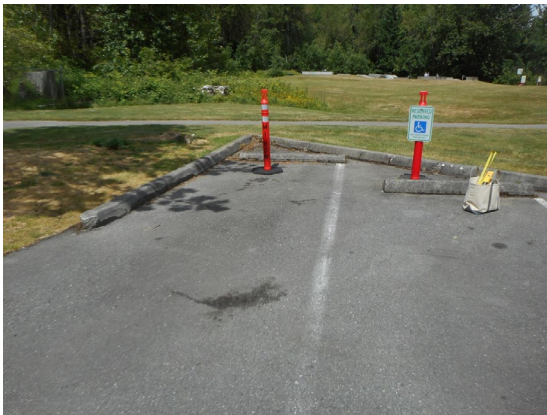
LOCATION	RECOMMENDATION	COMMENTS	TYPE	RESP CODE	PRI	QTY	UNITS	BUDGET
Accessible Parking								
Barrier	540	The accessible stall lacks compliant accessible parking signage, or existing signage is not 60" min. high measured to the bottom of sign.	Citation	2010 ADA Stds. 502.6, 703.7.2.1, 216.5				
ITEM 1: PARKING LOT NEAR THRIFT SHOP - ACCESSIBLE PARKING	Mount existing sign displaying the International Symbol of Accessibility on new permanent post at compliant height of 60" min. to bottom edge of sign.	Signs shall be 60" min. AFF or ground surface, measured to bottom of the sign. Existing condition: Compliant sign is provided at one parking space, but mounted on temporary traffic cone at height of 22" above paving.	P	O	1	1	EA	\$290

- Upper Left: Accessible parking sign is required to be 60" min. above paving to bottom of sign.
- Upper Right: Ground surfaces of fitness areas must be compliant and require periodic inspections & maintenance
- Lower Left: Ground surfaces of play area must be compliant and require periodic inspections & maintenance

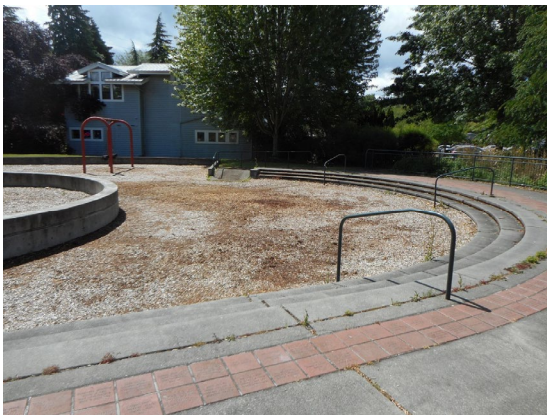
LOCATION	RECOMMENDATION	COMMENTS	TYPE	RESP CODE	PRI	QTY	UNITS	BUDGET	
Play Areas									
Barrier	843	The ground surface may not meet ASTM F 1951 or ASTM F 1292 for resilience and accessible route.	Citation	2010 ADA Stds. 1008.2.6

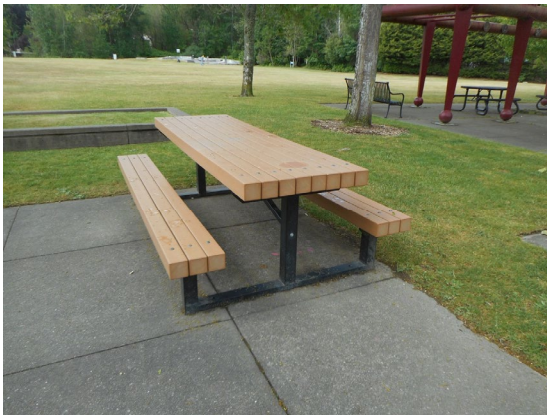
LOCATION	RECOMMENDATION	COMMENTS	TYPE	RESP CODE	PRI	QTY	UNITS	BUDGET
Built In Elements								
Barrier	482	The dining or work surface lacks 5% seating and standing spaces that are accessible, or existing tables exceed max. 34" high or lack knee clearance 27" high, 30" wide and 17" deep, or are not on an accessible route, or lack dispersion throughout seating and standing spaces.	Citation	2010 ADA Stds. 902.1, 226, 226.2

Upper Left: Picnic table does not provide an accessible seat with knee & toe space.

ITEM 2: ACCESSIBLE PICNIC TABLES - NORTHEAST PLAZA	Assuming 6 people per metal picnic table and 8 people per faux wood picnic table, replace 3 existing tables (either metal or faux wood) with accessible picnic tables with knee space 30" min. wide, 27" min. high and 17" min. deep on one end of table. Locate tables so that slab for 30"x48" clear floor space at accessible end of table has slope of 2% (1:48).	Existing metal picnic tables have elliptical table top with knee space measuring 16-1/2" deep at deepest point. Existing wood picnic tables have knee space measuring only 7" deep.	P	O	1	2	3	EA	\$7,500
---	---	---	---	---	---	---	---	----	---------

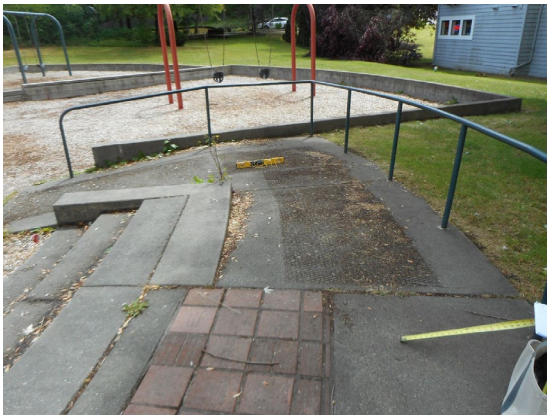
LOCATION	RECOMMENDATION	COMMENTS	TYPE	RESP CODE	PRI	QTY	UNITS	BUDGET
Exterior Accessible Routes / Entries								
Barrier	502	The ramp slope exceeds max. 1:12 (8.33%), or the ramp is less than 36" wide measured between the handrails.	Citation	2010 ADA Stds. 405.2, 405.5

- Upper Left: Ramp and top landing have excessive slopes and lacks compliant handrails on both sides.
- Upper Right: Ramp has excessive slope and lacks handrails on both sides.
- Lower Left: Fitness stations lack an accessible route thru wooden borders.

ITEM 3: PLAY AREA EAST HALF	Remove existing curb ramp and provide new compliant ramp with continuous handrails both sides with 12" min. extension at top and bottom of ramp.	Max. running slope is 1:12 (8.33%). Max. cross slope is 1:48 (2%). A slope of 1:20 (5%) is not considered a ramp. Existing condition: Change in level is greater than 6" (too high for a curb ramp) and curb ramp is provided with slope measuring 8.5% and flare with slope measuring 21%.	P	O	1	1	10	LF \$3,500

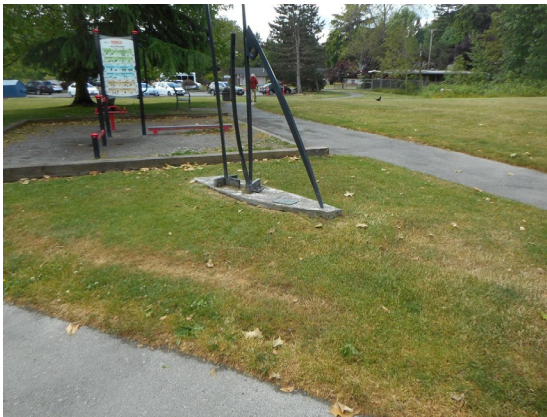
- Upper Left: Sculpture lacks a clear floor space and accessible route to the information plaque.
- Upper Right: Adjacent clear floor space at either end of bench has excessive slope.
- Lower Left: Bench requires a clear floor space at one end.

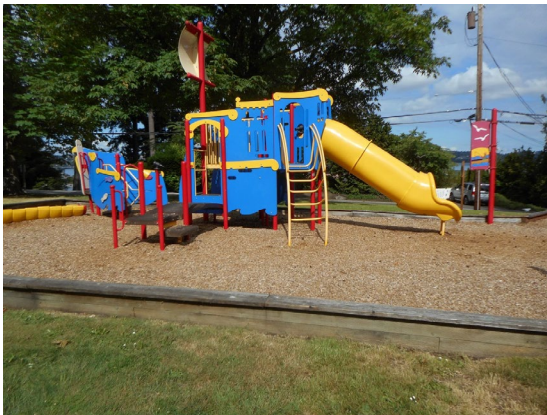
- Upper Left: Play area requires compliant ground surfaces, which must be periodically inspected and maintained
- Upper Right: Picnic table does not provide an accessible seat and clear floor space.
- Lower Left: Picnic table does not provide an accessible seat and clear floor space.

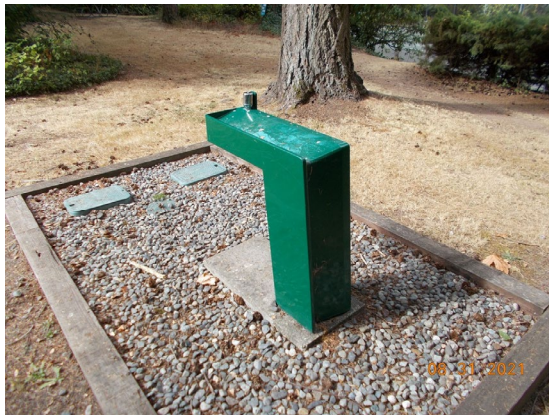
Upper Left: Low level only fountain is provided. Drinking fountain requires a hi-low model for both wheelchair users and standing persons.

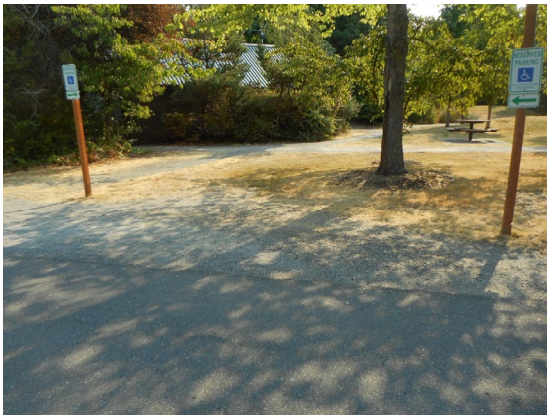
- Upper Left: Accessible parking space is not paved, and has no access aisle.
- Upper Right: There is a 2" level change from accessible parking to adjacent path.
- Lower Left: Picnic table is required to provide an accessible seat. An accessible route is required to table.

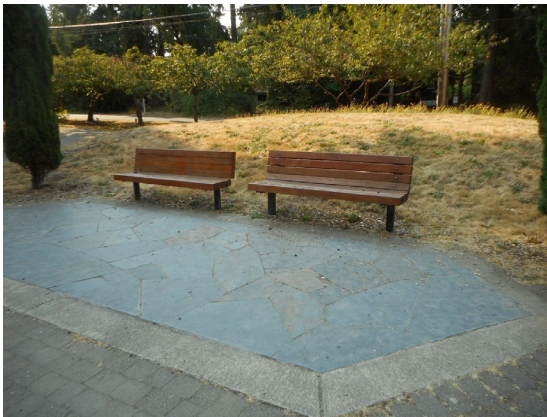
- Upper Left: Benches do not have a paved clear floor space on one end.
- Upper Right: Play area has a step, and requires an accessible ramp.
- Lower Left: Play area has lava rock for a ground surface. Ground surface must be one that complies with ASTM F 1951.

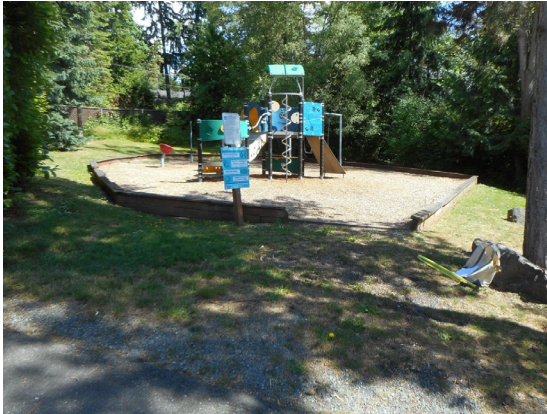
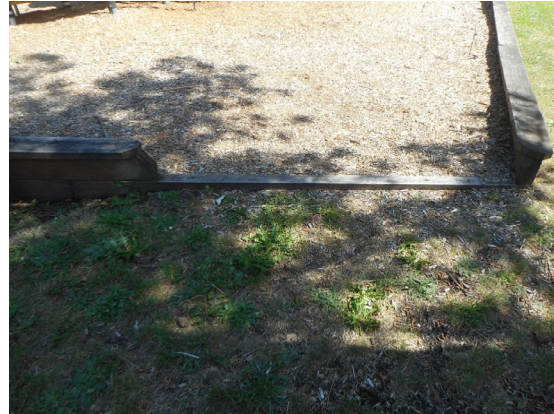
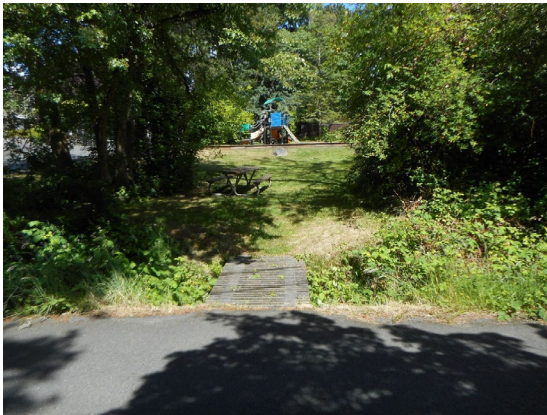
Secret Park

- Upper Left: Play area requires compliant ground surfaces, which must be periodically inspected and maintained.
- Upper Right: Play area requires an accessible route and a ramp down to play area.
- Lower Left: Picnic table does not provide an accessible seat and clear floor space. An accessible route is required to trash can, picnic table, and play area.
