City of Mercer Island

Americans with Disabilities Act

ADA Transition Plan

2022

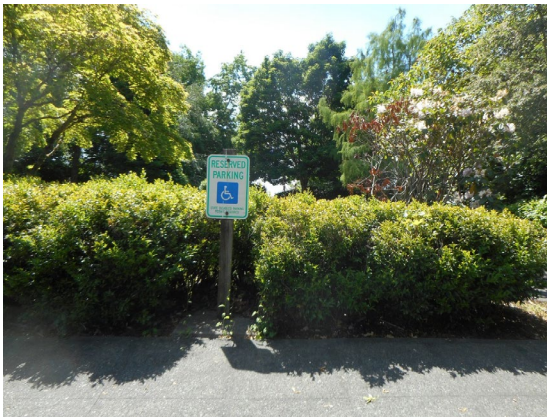
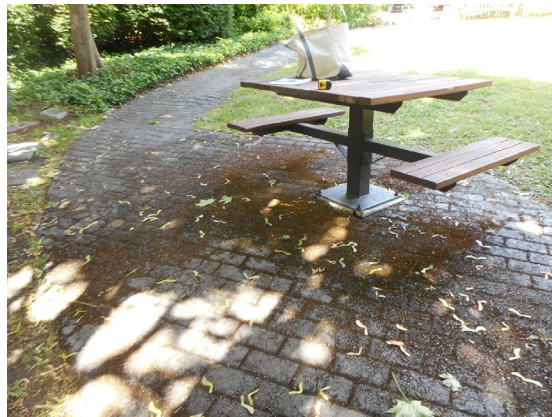
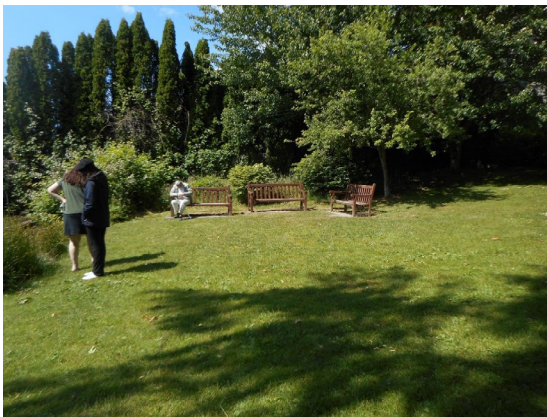
- Upper Left: Accessible parking sign is too low and should be raised to 60" min. AFF.
- Upper Right: Picnic table does not provide an accessible seat and clear floor space.
- Lower Left: Benches in various areas of the park require a clear floor space on one end and be on an accessible route.

ITEM 3: ACCESSIBLE BENCH NEAR BEACH	Recommendation: Provide level clear floor space (concrete pad) adjacent to one end of the bench and 44" wide (per Code) paved walkway from existing trail.	Although not required under 2010 ADA scoping, E&A recommends at least 5% of benches provide a compliant 30"x48" clear floor space to one side of the bench. Existing condition: bench is located in lawn, and no clear floor space is provided.	P	O	7	2	45	LF \$1,589

ITEM 4: BENCH NEAR SLOPING PATH	Recommendation: Provide level clear floor space (concrete pad) adjacent to one end of the bench.	Although not required under 2010 ADA scoping, E&A recommends at least 5% of benches provide a compliant 30"x48" clear floor space to one side of the bench. Existing condition: bench is along path but has landscaping on both ends, and no clear floor space is provided.	P	O	7	2	10	SF \$250	
Total for Building: Slater Park								\$4,629

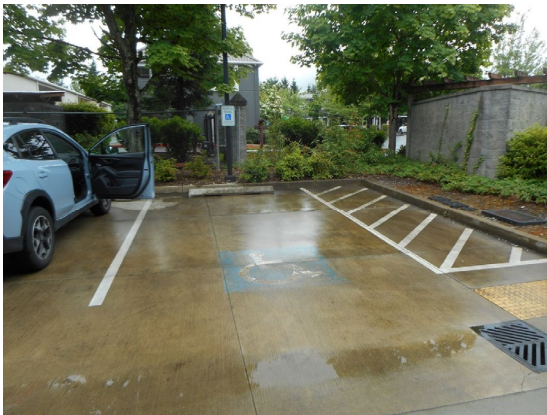
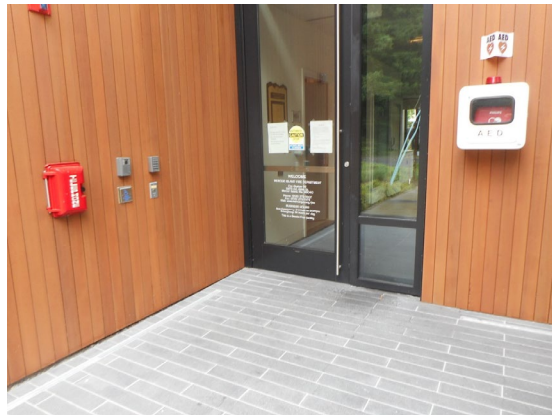
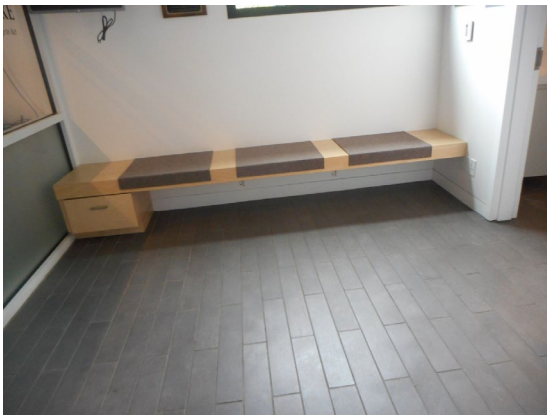
South Fire Station #92

- Upper Left: Accessible parking sign is mounted too low.
- Upper Right: AED cabinet is mounted too high and is a protruding object.
- Lower Left: Bench does not have an accessible clear floor space at one end.

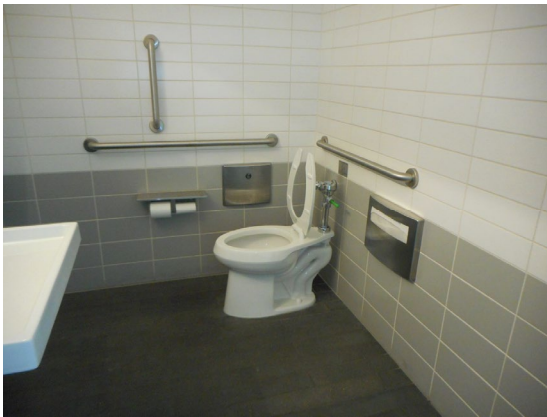
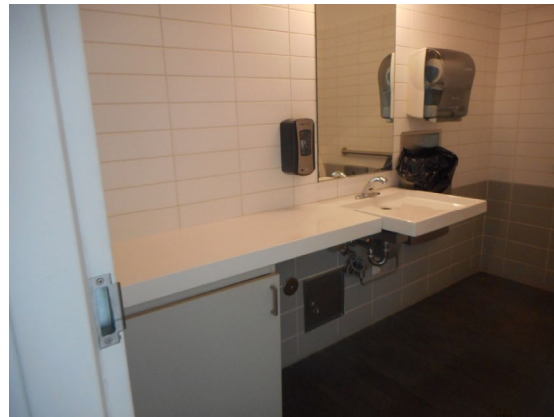
South Fire Station #92

- Upper Left: Toilet is installed at a skewed angle, and located too far from side wall. Grab bars are mounted too high.
- Upper Right: Lavatory encroaches on toilet clearance and door maneuvering space. Also, lavatory rim is too high.

ITEM 5: ALL-GENDER RESTROOM	Revise toilet to be 18" max. from the side wall to the toilet centerline.	Existing condition: toilet installation is skewed - 17-1/2" from side wall to toilet rear area and 18-1/2" at toilet front. Owner/maintenance item.	P	O	1	3	1 EA	\$0
Barrier	681	The existing grab bars are non-compliant in size, configuration, or mounting height.	Citation	2010 ADA Stds. Fig. 604.5.2, 609.2, 604.9

ITEM 6: ALL-GENDER RESTROOM	Remount the existing grab bars.	Grab bars should be 1-1/4"- 2" in diameter, 33" to 36" AFF, with 1-1/2" min. between the wall and the grab bar. 2010 Standards: Rear grab bar min. 24" long from centerline of toilet at transfer side. Existing condition: grab bars are mounted at 36-3/4" to 37" AFF to the top.	P	O	1	3	1 EA	\$410

ITEM 7: ALL-GENDER RESTROOM	Replace lavatory with an accessible more shallow (<18" - verify) model to provide the toilet clearance of 56" min. from toilet back wall. Relocate to provide required 60" deep door maneuvering space unless shallow model clears the 18" pull side for a 60" depth. Verify.	Existing condition: top of sink is mounted at 34-1/2" AFF.	P	O	1	3	1	EA	\$2,340
Barrier	689	The lavatory lacks insulation at water supply and drain pipes.	Citation	2010 ADA Stds. 606.5

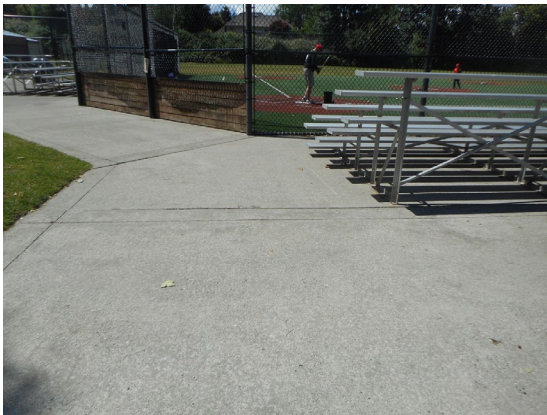
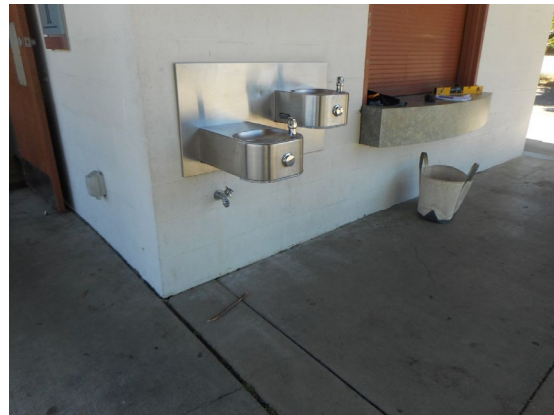
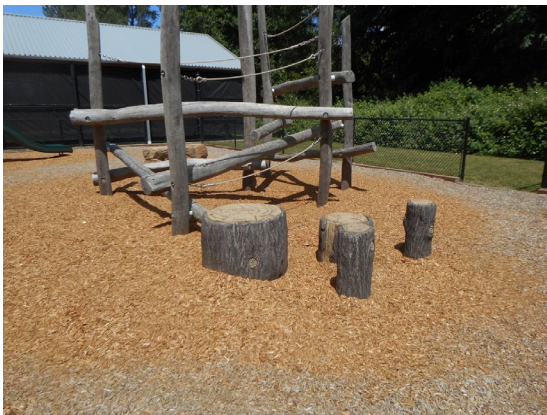
South Mercer Playfields

- Upper Left: Bleachers require wheelchair seating (with signage).
- Upper Right: Hose bib under low level drinking fountain requires relocation.
- Lower Left: Ground surfaces of all play areas must be compliant and require periodic inspections & maintenance

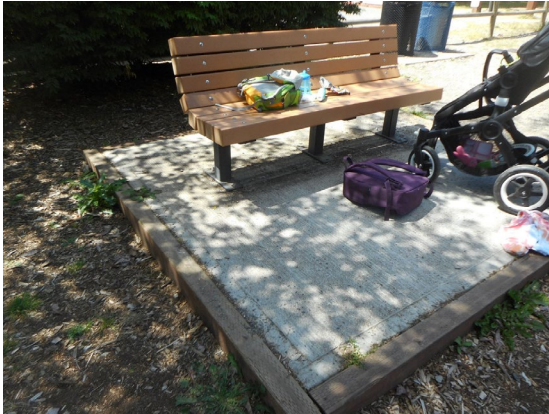
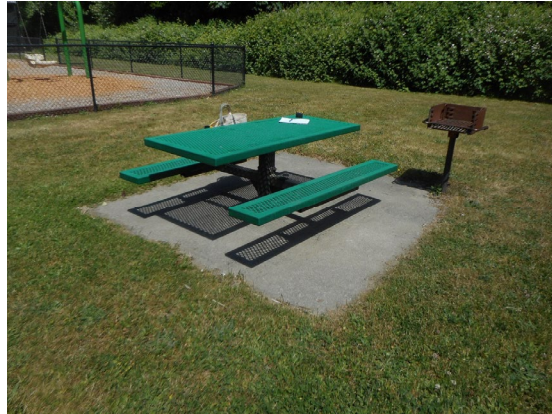
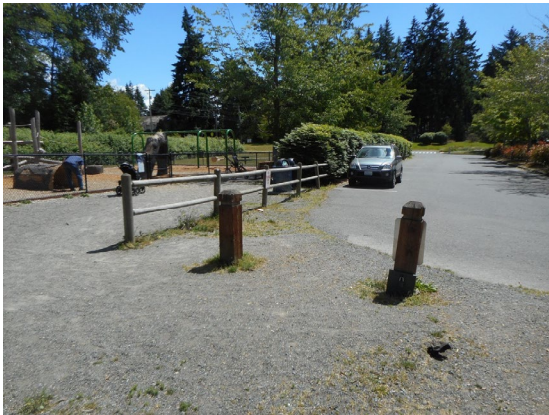
South Mercer Playfields

- Upper Left: 30"x48" clear floor space is required on one side of bench, and an accessible route to bench is required.
- Upper Right: Picnic table requires an accessible seat & accessible route.
- Lower Left: Accessible route is required to play area.

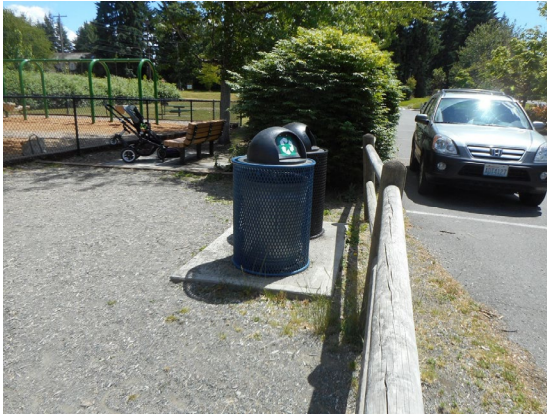
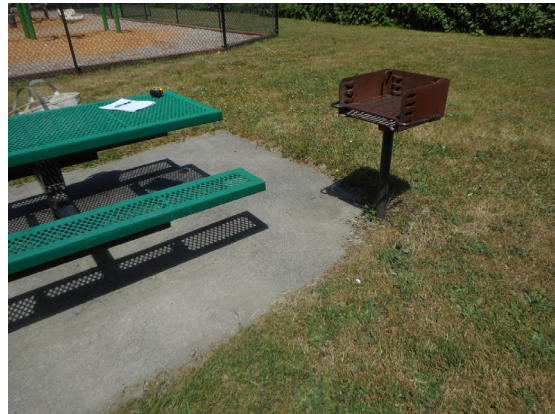
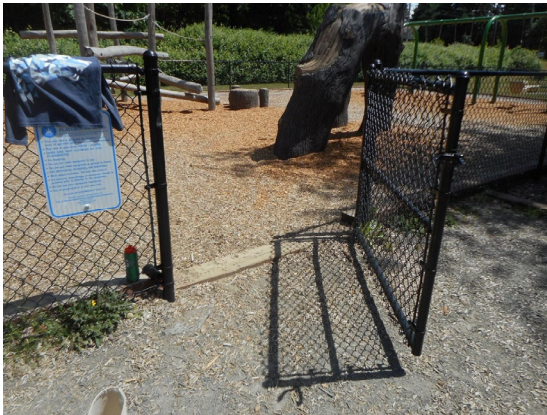
South Mercer Playfields

- Upper Left: Accessible route and clear floor space is required at trash receptacles.
- Upper Right: BBQ grill requires an adjacent clear floor space.
- Lower Left: Paved accessible route and door maneuvering space is required at play area.

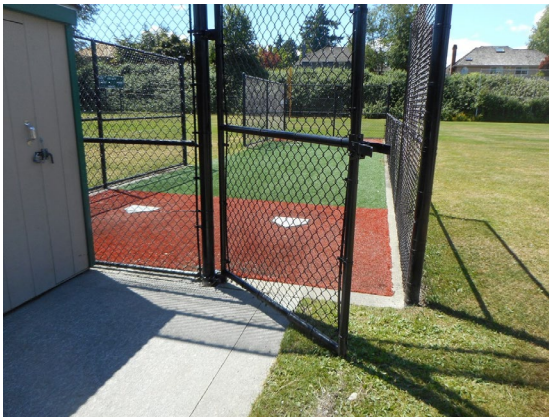
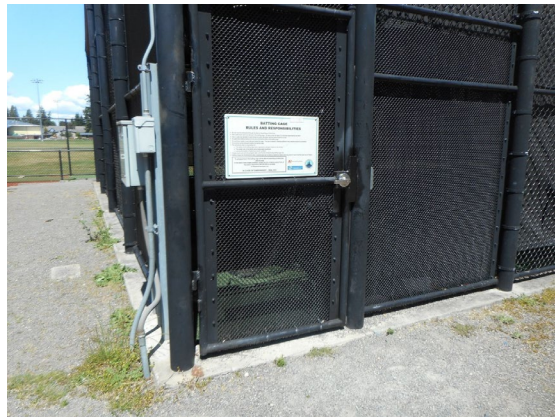
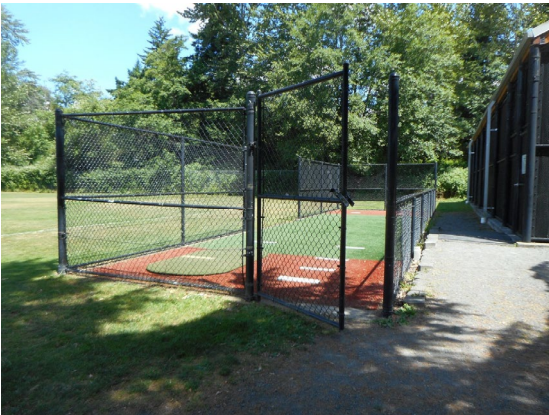
South Mercer Playfields

- Upper Left: Accessible route and door maneuvering space is required at practice area.
- Upper Right: Accessible route and door maneuvering space is required at batting cage structure.
- Lower Left: Accessible route and door maneuvering space required at practice area.

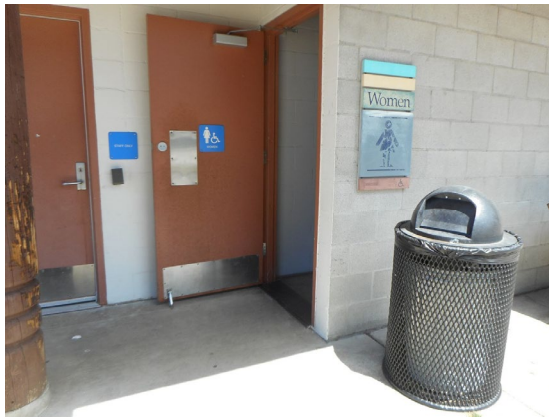
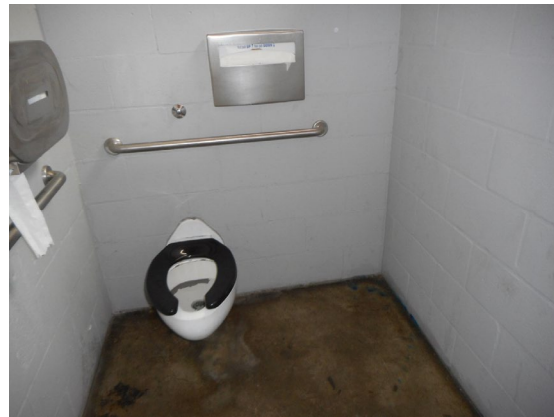
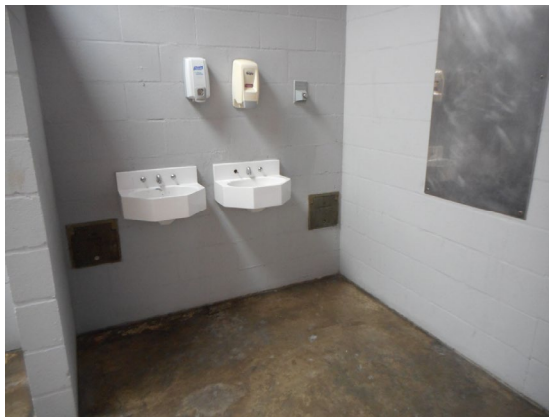
South Mercer Playfields

- Upper Left: Restroom signage should be compliant.
- Upper Right: Accessible stall size is non-compliant. Dispensers require relocation.
- Lower Left: Soap dispenser and hand drying operation button are mounted too high.

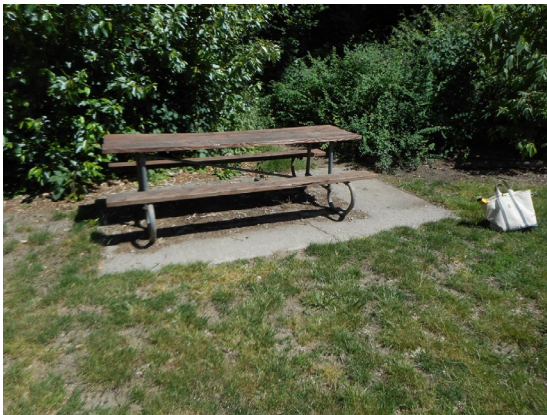
Wildwood Park

Upper Left: Picnic table does not provide an accessible seat and clear floor space.

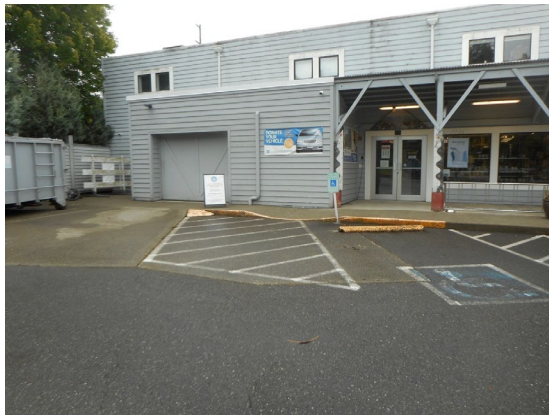
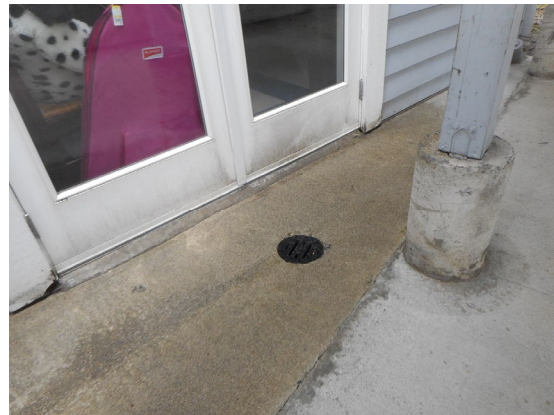
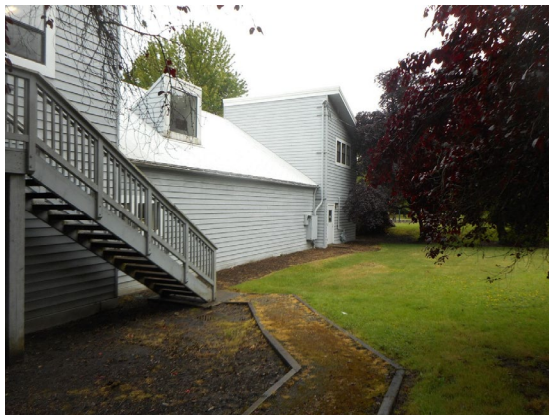
Youth and Family Services Thrift Shop

- Upper Left: Accessible parking sign is mounted too low. Bottom edge of sign to be 60" min. above pavement.
- Upper Right: Exit door has a column blocking the required door clearance and maneuvering space.
- Lower Left: Exit door from first floor lacks a paved clear floor space on exterior side.

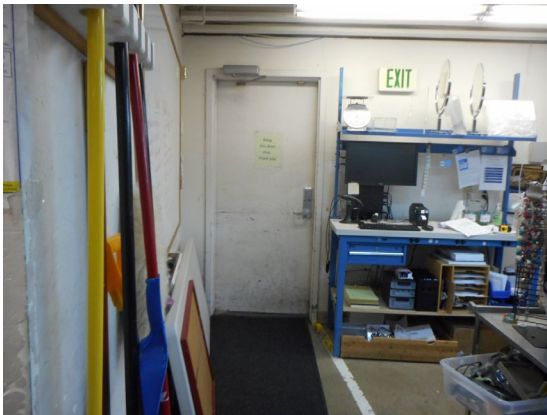
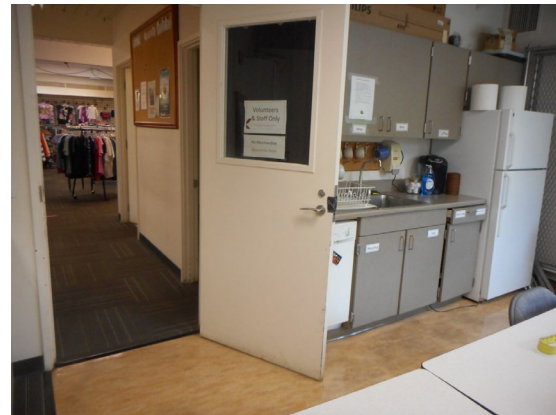
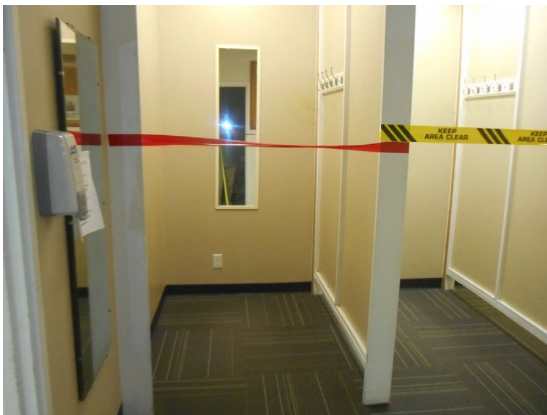
Youth and Family Services Thrift Shop

- Upper Left: Countertop blocks the 12" min. required maneuvering space on the latch/push side.
- Upper Right: The vision panel on the door is too high. To be 43" max. AFF.
- Lower Left: One accessible dressing room is required with a bench and turning space.

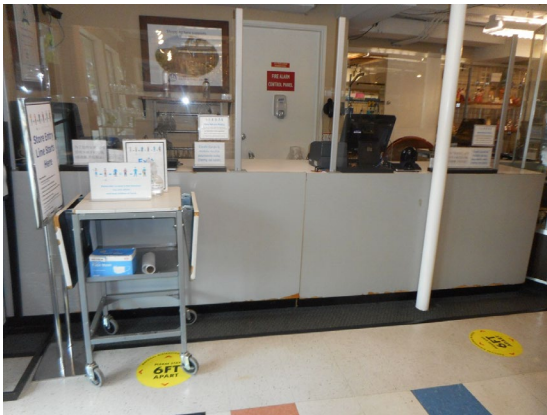
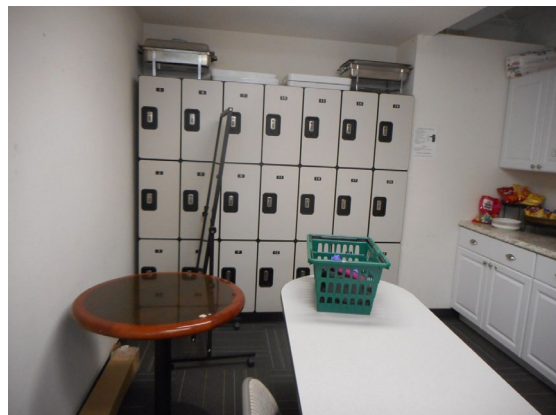
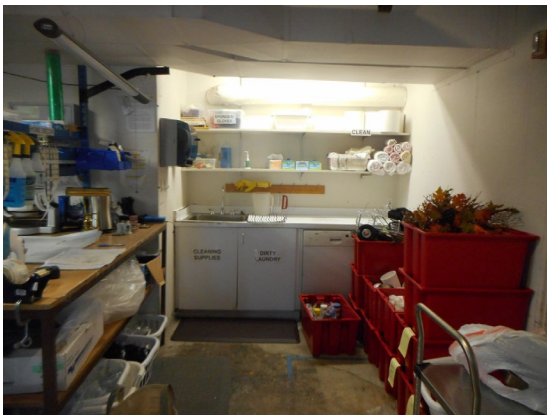
Youth and Family Services Thrift Shop

- Upper Left: Check-out counter lacks a 36" high max. x 36" min. in length accessible counterspace.
- Upper Right: Lockers do not provide the min. 5% required to be accessible, due to height of hooks & bottom shelf.
- Lower Left: Sink is 36" AFF (should be 34" max.) and lacks knee clearance for a forward approach. Above countertop outlets are out of accessible reach. Paper towel dispenser is mounted too high.

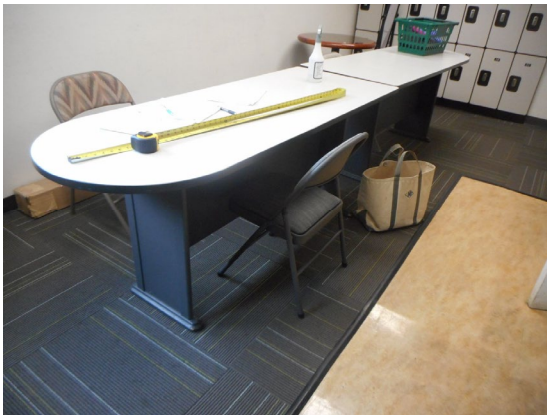
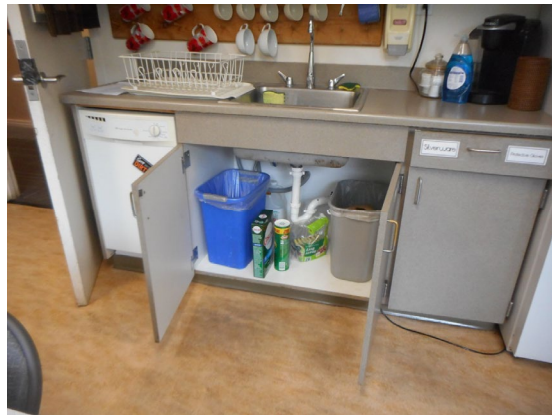
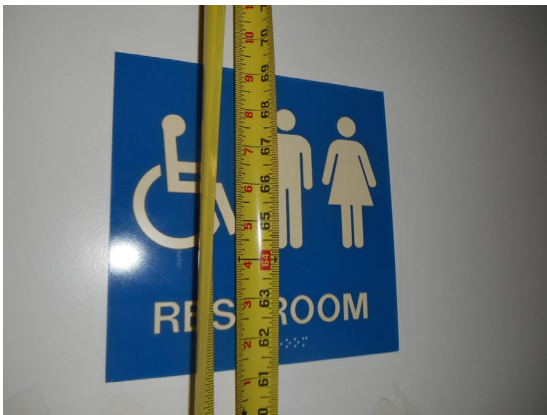
Youth and Family Services Thrift Shop

- Upper Left: Dining table does not provide the required knee clearance space.
- Upper Right: Countertop and sink are too high. Must be 34" AFF max. for sink height and for accessible reach to above countertop mounted outlets. Also, kitchen lacks 50% of storage at accessible height.
- Lower Left: Second level accessible restroom signage is mounted too high.

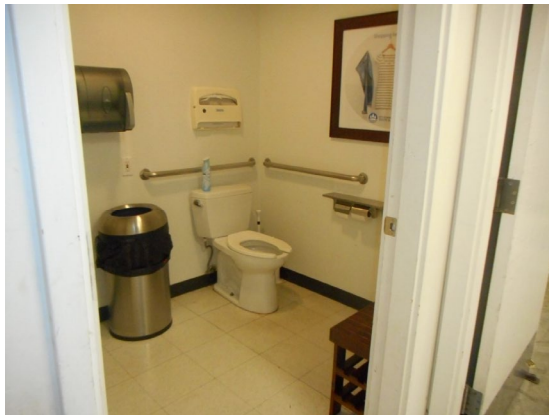
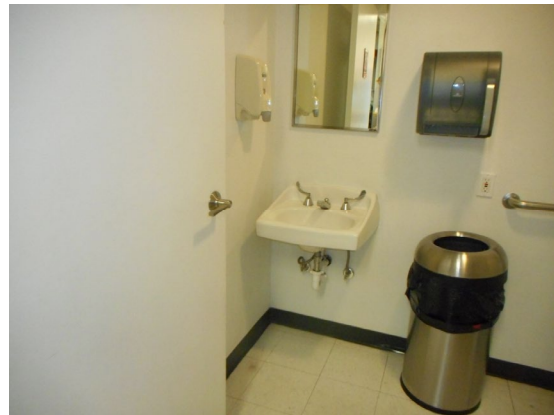
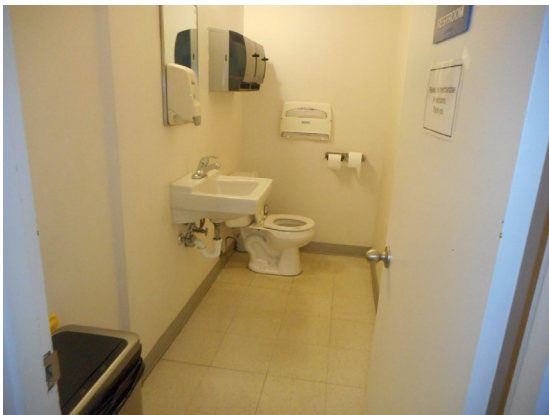
Youth and Family Services Thrift Shop

- Upper Left: Ground floor restroom grab bars are too short and incorrectly located. Seat cover dispenser is not accessible above the toilet.
- Upper Right: Ground floor restroom lavatory does not provide the required knee space clearance. Pipes require insulation. Mirror and towel dispenser are too high.
- Lower Left: 2nd floor restroom adjacent the kitchen is inaccessible. Provide directional signage to accessible restroom.

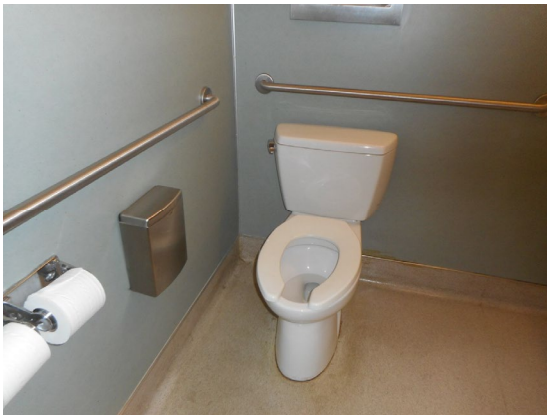
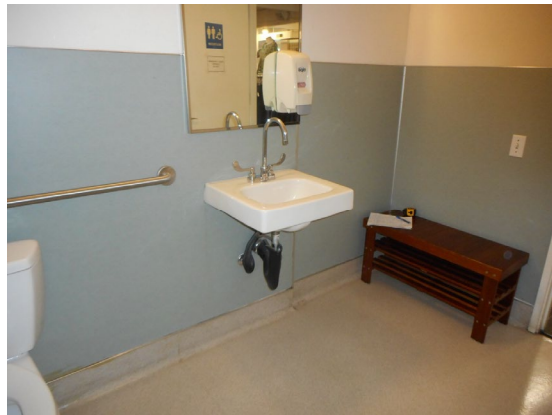
Youth and Family Services Thrift Shop

- Upper Left: Second floor accessible restroom: grab bars are mounted too high, flush control is required on the open side, seat cover dispenser is not accessible above the toilet.
- Upper Right: Second floor accessible restroom: mirror is mounted too high. The bench encroaches on door maneuvering clearance on the latch side.
