SEWER PUMP STATION CONDITION ASSESSMENT REPORT

Prepared for the City of Mercer Island

January 2024

RH2 Engineering, Inc.

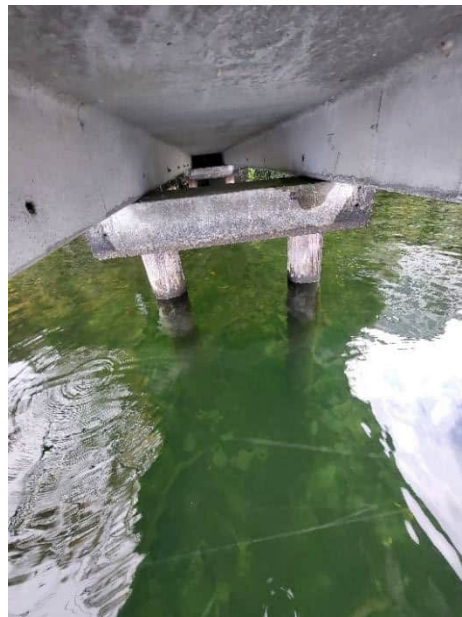
Photo of PS 19 concrete dock under decking.

concrete and prepare the concrete surface and any exposed rebar in accordance with the selected rehabilitation product's installation procedures. The rebar condition should be further evaluated. The recommended approach is to assess the condition of the rebar prior to construction to minimize change orders during construction; however, the rebar condition assessment will require temporary pumping by the City to access the existing wet well safely. If the rebar has corroded too much, it may be necessary to install new rebar to replace the missing rebar or implement similar measures.

- If new rebar needs to be installed, precautions should be taken for cathodic protection of the new rebar, such as installing anodes with the new rebar.
- Flows at this pump station will need to be bypassed for these improvements to be constructed. The bypass improvements are discussed later in the **Additional Improvements** section for this PS.
- Install a wet well vent with an in-line carbon filter on the exhaust/intake for odor control to allow better air discharge and supply for the wet well. This improvement will allow the wet well maintenance hole lid to be opened when the pumps are running and may reduce odor complaints. This improvement will also eliminate the issue of air from the wet well being displaced into the dry well through the sump pump piping. The carbon media will need to be replaced on a recurring interval when the media is expended.

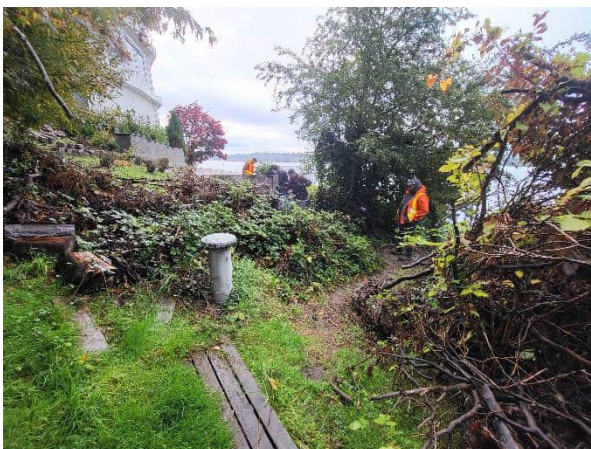
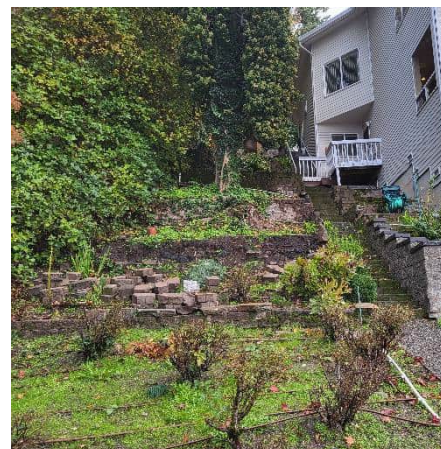
Existing PS 19 site from the north, looking south (left). PS 19 site looking east (right). PS 19 can only be accessed by foot or boat.

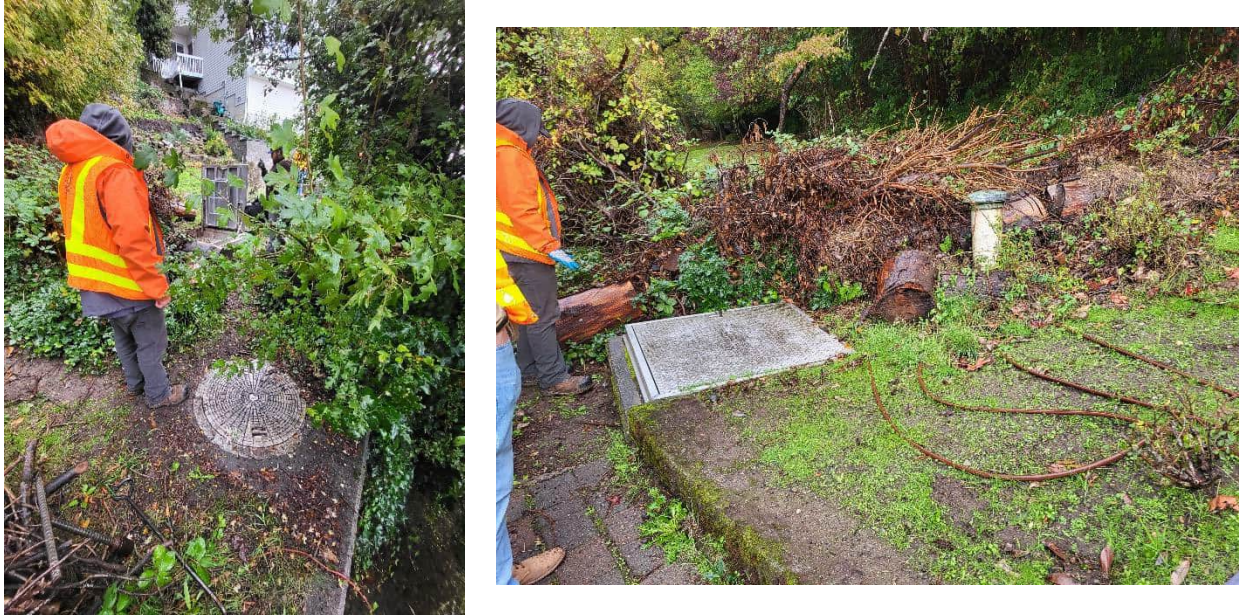
Existing PS 19 site from dock, looking towards dry well access (left). Existing PS 19 site access from the south, looking north (right).

- **Soil erosion and the lack of site drainage are increasing the maintenance needed at this PS.** This PS has no site drainage and is located downhill of a steep slope, which is contributing to soil erosion from the uphill slope to cover the PS access points. The City previously installed additional maintenance hole risers on the HGMH, but debris and soil eroding from the uphill slope continue to cover the HGMH and other PS access points.

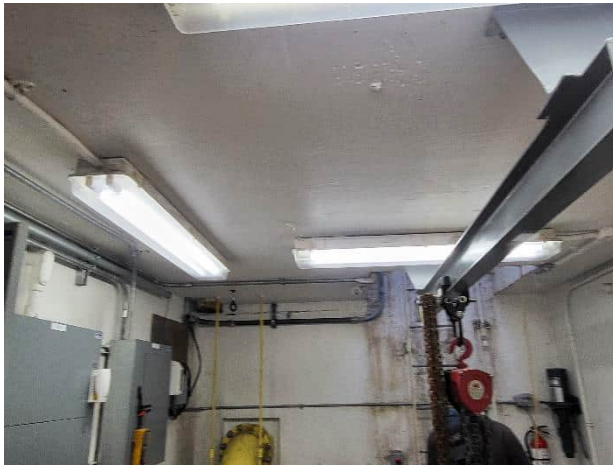
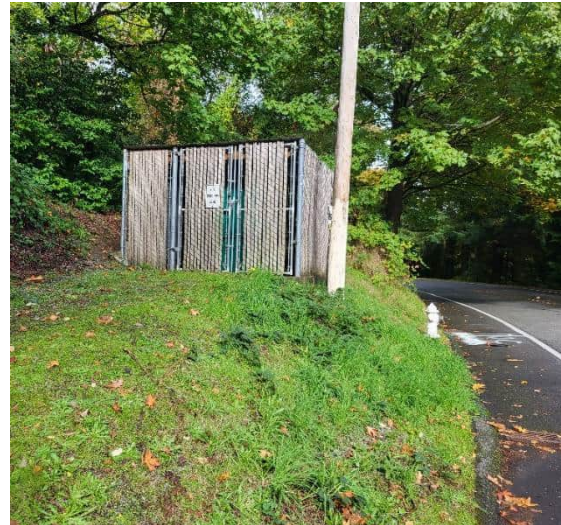
- There were no noticeable signs of cracks in the concrete with active infiltration in the dry well.
- The PS has a pile driven, pre-cast concrete dock with pre-cast concrete support beams/caps and wood decking on top.
- The existing dry well and wet well entrance hatches, flooring, lighting, ventilation, and fire/safety detectors appear to be in good condition.

*Existing lighting in PS 19 dry well (right).
Location of existing PS 19 generator (right).*

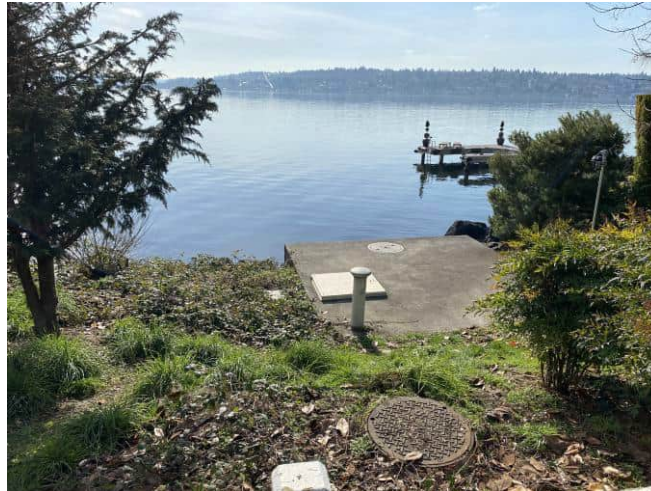
PS 20 site and wet well and dry well access (left).

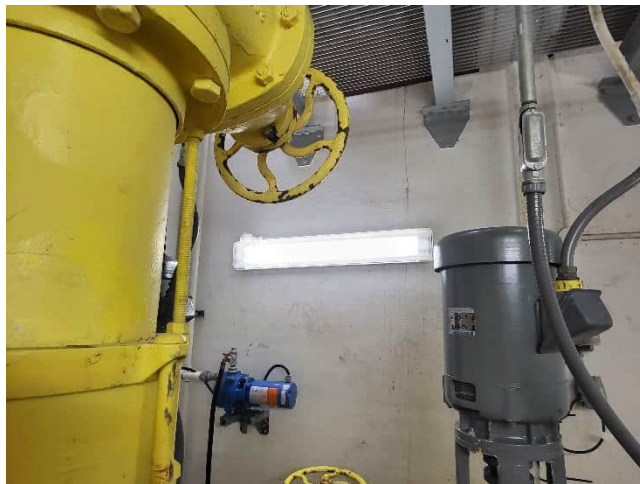
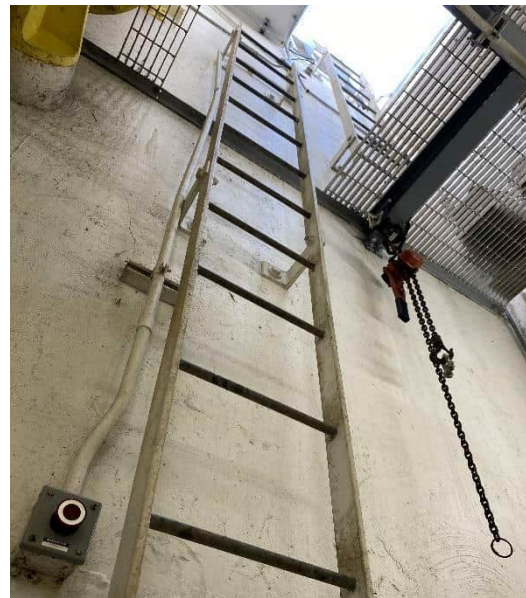
- There were no noticeable signs of active infiltration in the dry well due to cracks in the concrete.
- The pump station’s lighting, flooring, ventilation, and fire/safety detectors all appear to be in good condition.
- The dry well’s access hatch and ladder appear to be in good condition.

Existing PS 20 lighting (left). Existing condition of PS 20 dry well access ladder (right).

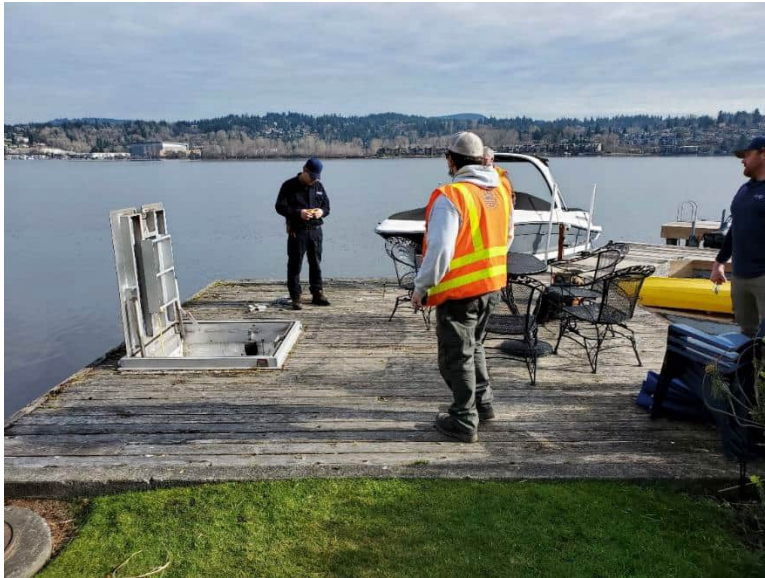
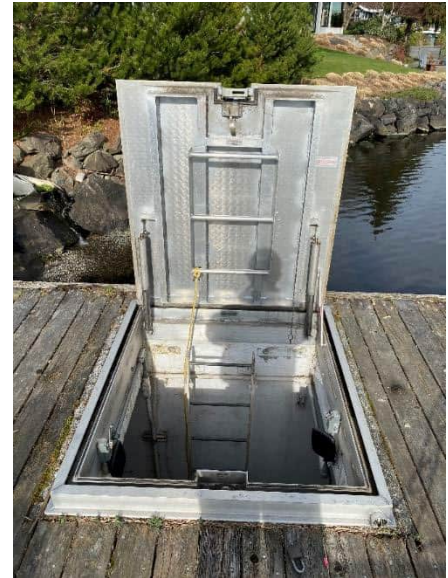
- The existing entry hatches, dry well ladder, flooring, lighting, ventilation, and fire/safety detectors for the pump station appear to be in good condition.

PS 21 dock access from 8002 Avalon Place (left). PS 21 dry well access hatch (right).

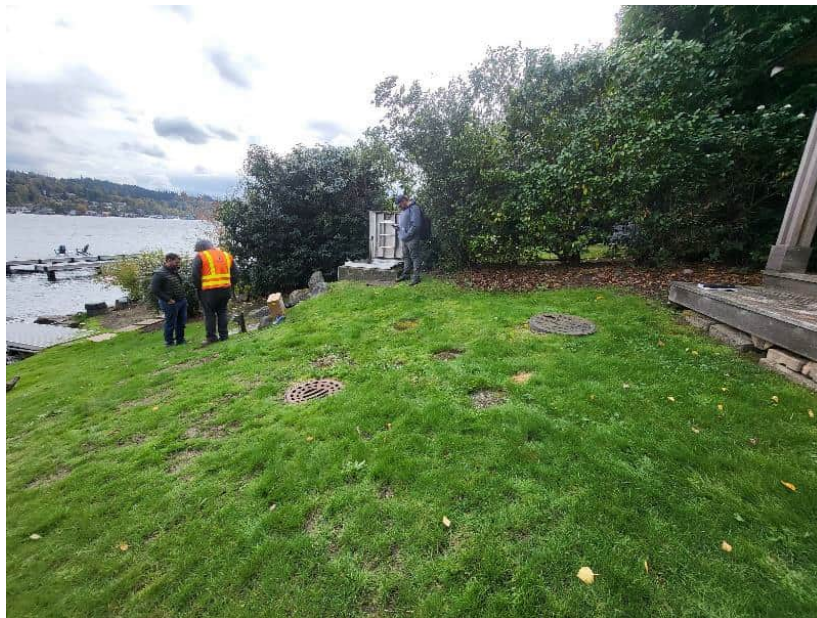
PS 22 site on grassy slope.

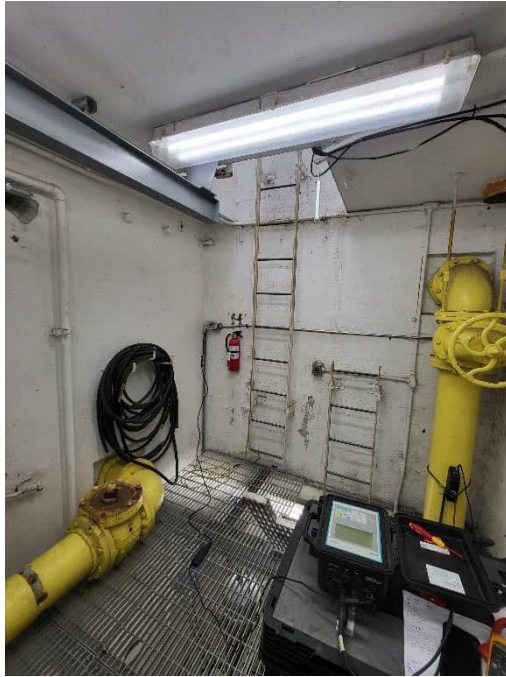
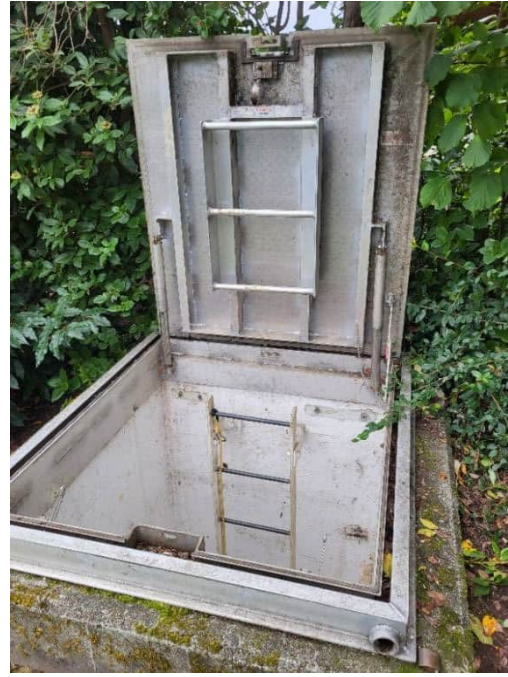
- There were no noticeable signs of active infiltration in the dry well due to cracks in the concrete.
- The wet well and dry well entrances, dry well ladder, lighting, flooring, ventilation, and fire/safety detectors all appear to be in good condition.

PS 22 lighting and existing dry well grating (left). PS 22 dry well access hatch (right).

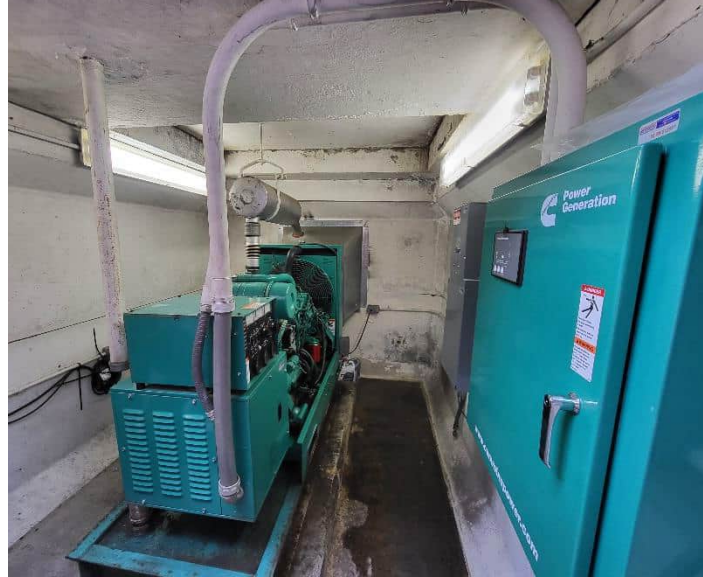
Existing PS 23 below-grade generator room.

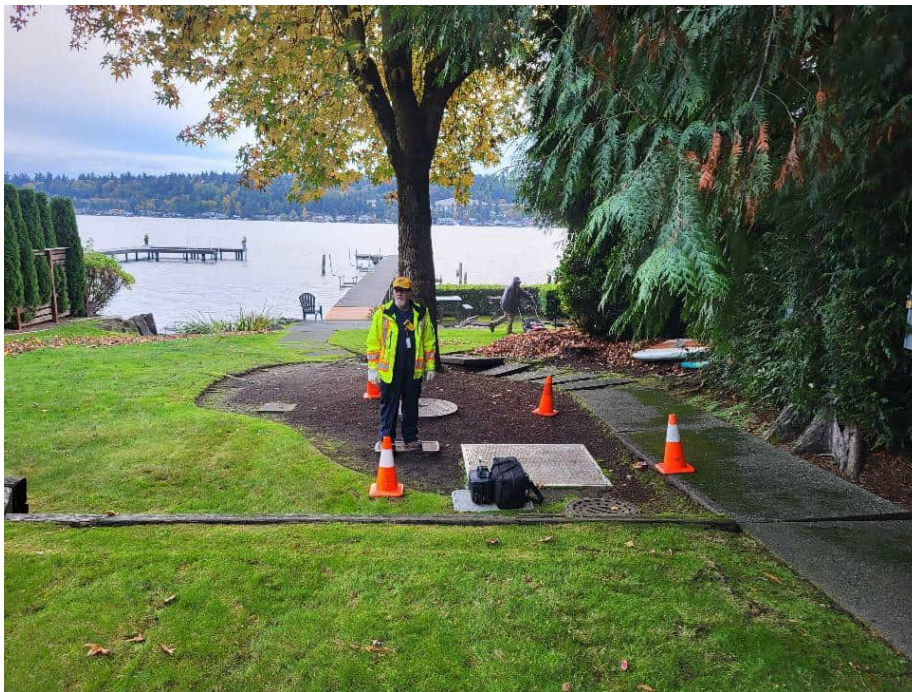
PS 23 wet well and dry well site and access.

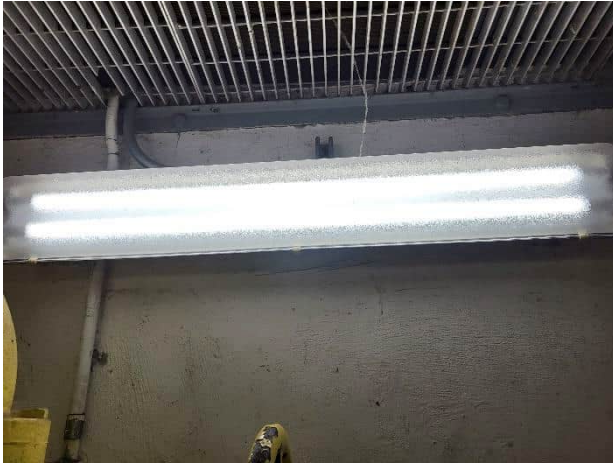
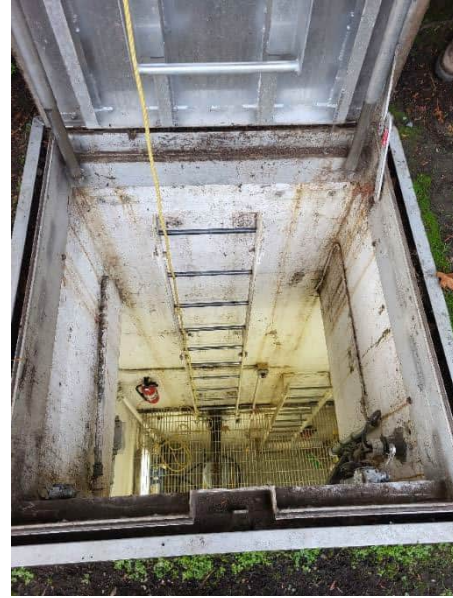
- There are grass and trees at the PS site, but none of the nearby vegetation notably limit site access.
- The PS is approximately 25 feet from nearest residence based on available GIS data.
- The exterior concrete that was visible appears to be in acceptable condition.
- There were no noticeable signs of active infiltration in the wet well. The wet well should be further evaluated during construction, once the temporary bypass is in place and the wet well has been drained. Then a more accurate evaluation of the wet well infiltration can be made.
- There were no noticeable signs of active infiltration in the dry well due to cracks in the concrete.
- PS 23's existing entry hatches, dry well ladder, flooring, lighting, ventilation, and fire/safety detectors appear to be in good condition.

PS 23 lighting in dry well (left). PS 23 dry well access hatch (left).

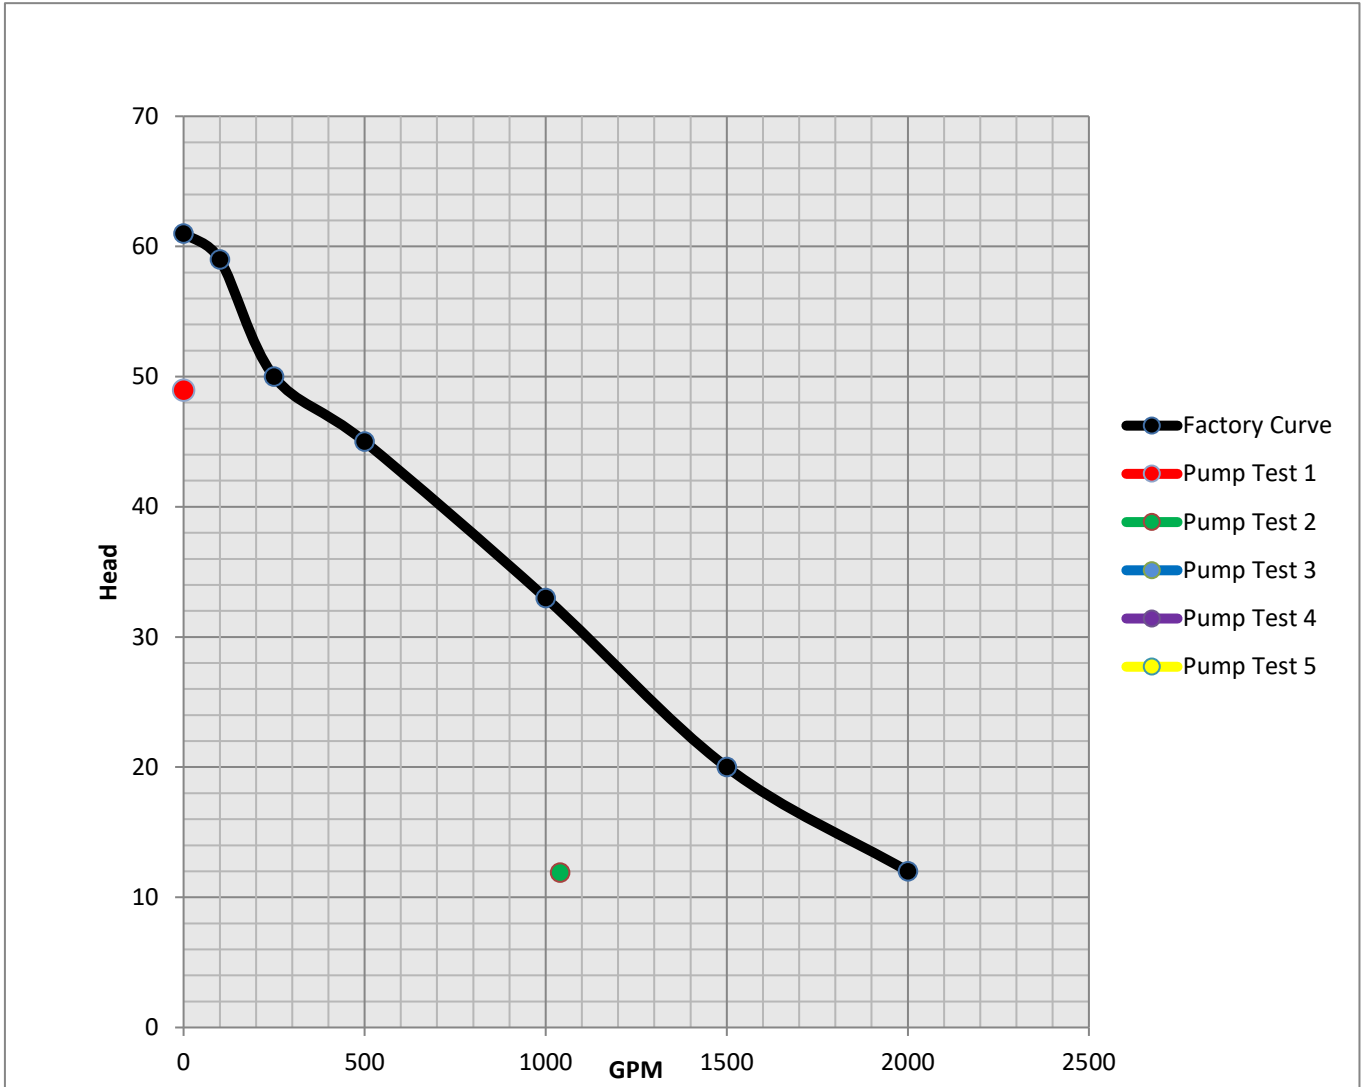
3. Pump RSP 202
 - a. Pump has a minor seal leak
 - b. Pump has excessive vibration
 - c. Pump down rate is noticeably slower than Pump 3
 - d. Check valve has a leak on the stem

The results of the test indicate there are several issues. The cause of the high vibration readings needs to be identified. It is doubtful the imbalance is from the motor and more likely from the pump. A partial blockage could cause the low flow, higher than expected amps, and an unbalance condition. The bearing fault seen in the spectrum indicates there may be a bearing failing in the motor.

Failure to achieve the shutoff head could be contributed to impeller and casing wear and/or due to the discharge valve not closing fully.

1. Finding and correcting the source of the excessive vibration is critical. The present vibration levels will quickly lead to damage throughout the pump.
2. Open and inspect the pump. Check for clogs and measure wear ring clearances.
3. Uncouple and run the motor alone, measure unloaded amps and check vibration
4. Schedule to have motor serviced (clean, dip and bake) and bearings replaced. Or replace with new premium efficient model.
5. Due to the age of the equipment, the pump bearing housing should be disassembled, bearing lands and bores measured for proper clearances. Pump and motor should have a detailed inspection to determine if replacement is more viable to repair.
6. Higher level of vibration analysis may be required if source of vibration cannot be determined through visual inspections

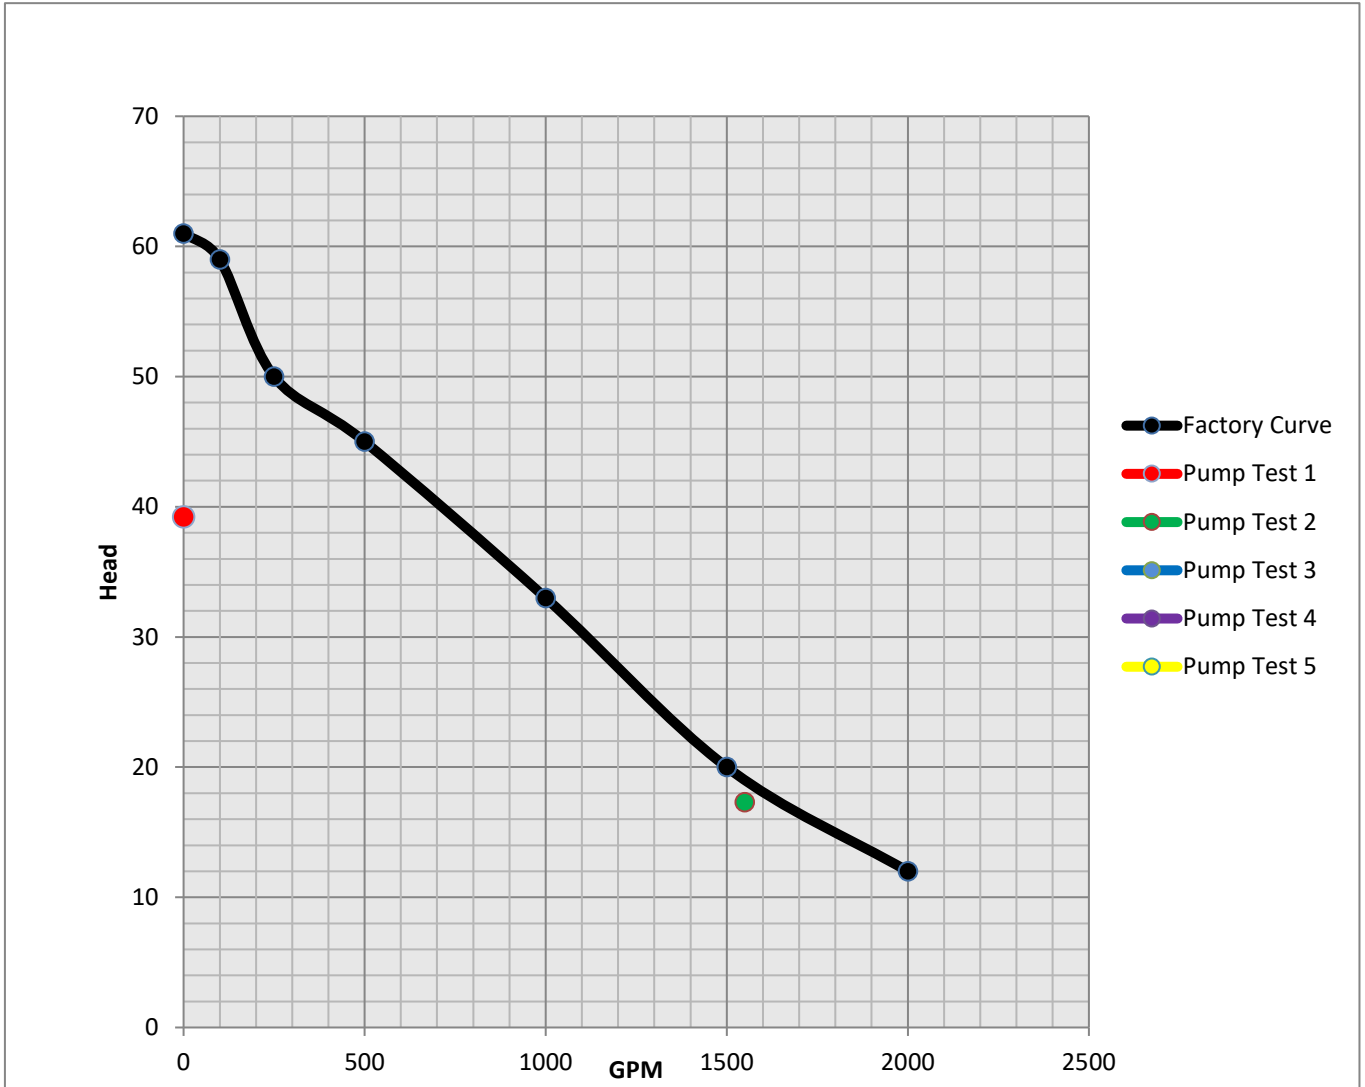
- e. See attached documents for details
4. Pump RSP 203
 - a. Check valve chatters during operation. May be signs that valve components are loosening.
 - b. Discharge valve has a significant leak at the stem

The tests and observations show this pump to be performing OK when pumping to the system. Failure to reach proper shutoff head should be investigated to find the cause. One of the test results is likely incorrect as the test points do not follow a curve similar to the factory curve.

1. Vibration should be addressed and lowered
2. Open and inspect the pump and measure wear ring clearances
3. Uncouple and run the motor alone, measure unloaded amps and check vibration
4. Schedule to have motor serviced and bearings replaced. Or replace with new premium efficient model.
5. Due to the age of the equipment, the pump bearing housing should be disassembled, bearing lands and bores measured for proper clearances. Pump and motor should have a detailed inspection to determine if replacement is more viable than repair.
6. Higher level of vibration analysis may be required if source of vibration cannot be determined through visual inspections

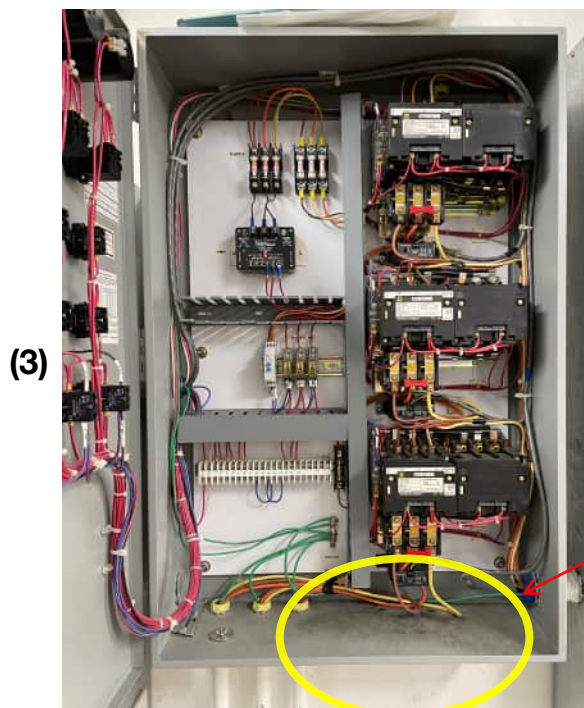
1. Incoming power is 480v, 3 phase with high leg to ground
2. Unloaded voltage is balanced
3. The gray dust below the contacts is usually from arcing contacts indicating wear.
4. Arcing reduces the performance of the contact and increases circuit resistance
5. This may explain higher than expected motor current
6. Parts for older contacts are getting harder to find. Would recommend considering replacing them with current models or upgrading the entire panel to increase reliability.

Control Panel
Interior of the pump control panel

Dust below
contactors

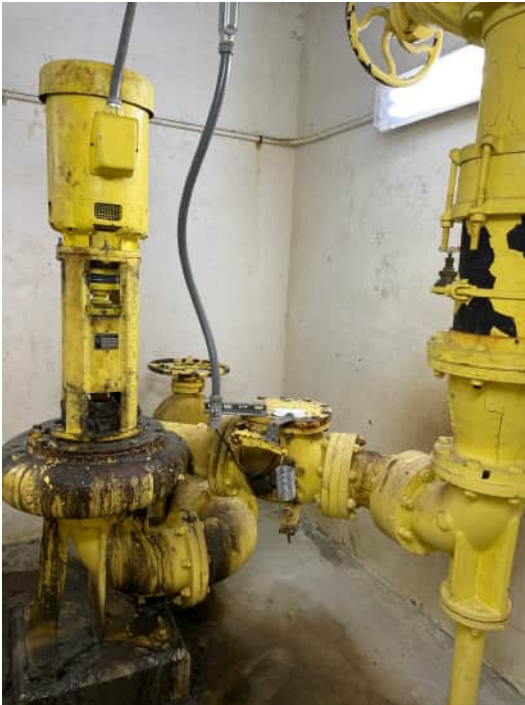
1. Pump Control Panel
 - a. Looks to be original equipment
 - b. Panel is clean and dry.
 - c. Gray powder below contactors.
2. Pump RSP 201
 - a. Pump had a leaking mechanical seal and was removed at the time of testing.

Pump 1

Pump was taken out of service at the time of testing due to a mechanical seal leak.

- Winding resistance: 1.5 ohms
 - c. Motor should be taken in for service (Clean, dip, bake, replace bearings) or replaced with a new higher efficiency model. The lower insulation readings are indicators of windings that are dirty and /or failing.

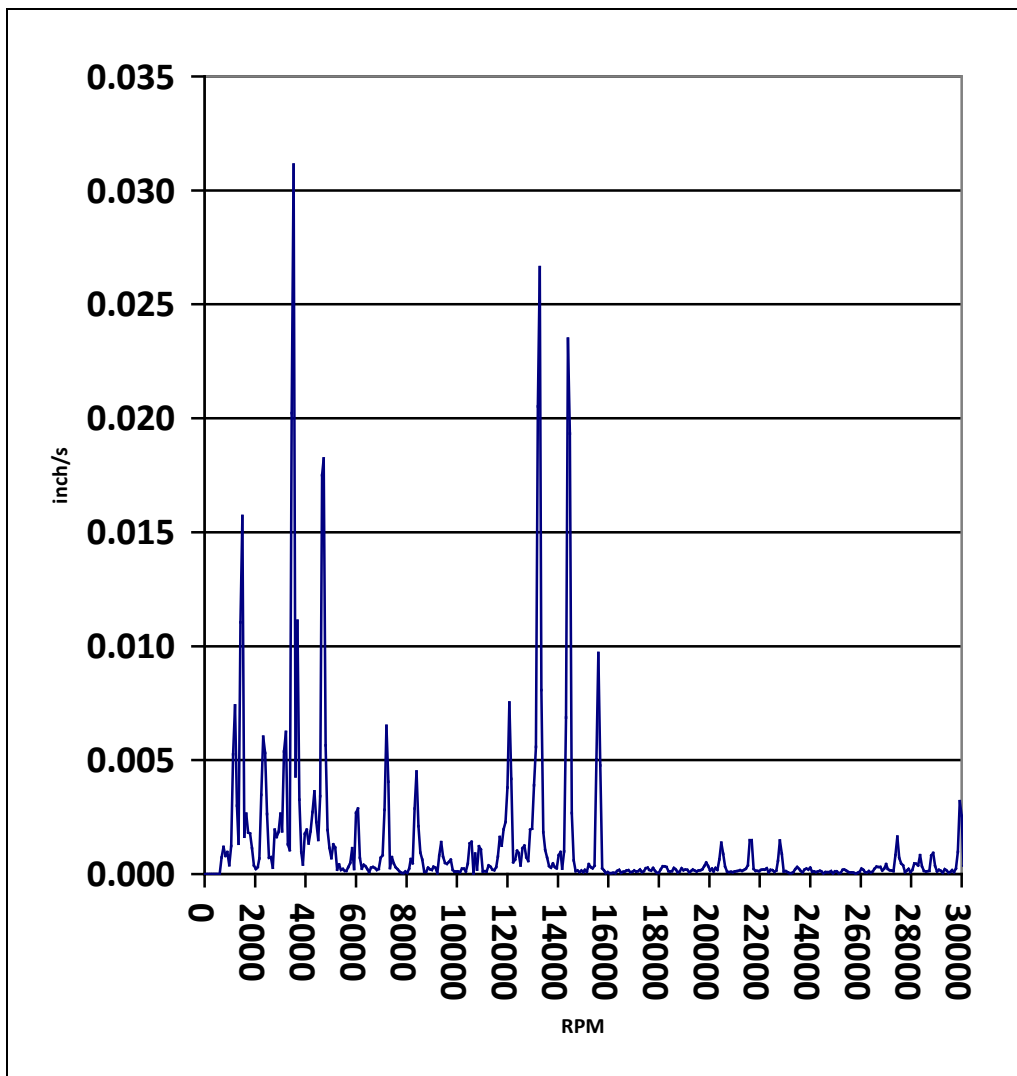
Mercer Island, City of : Lift Station 21 : LS21-Pump 212

The elevated bearing fault signatures seen in the spectrum (Motor Top X) shows that a bearing or bearings are damaged.

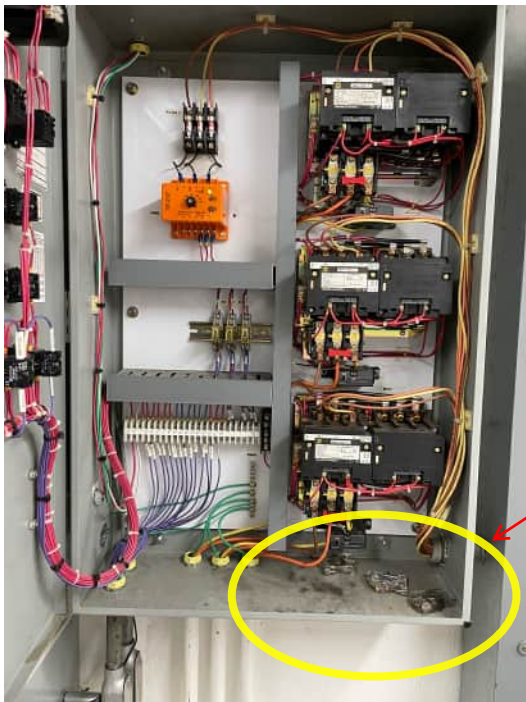
Control Panel
Panel interior

Dust below
contacts
