PS 10 VEGETATION MANAGEMENT - SITE PLAN

PS 19 VEGETATION MANAGEMENT - SITE PLAN

SUBJECT: Capital Improvement Project
PS 10, PS 19 Tree Evaluation
9042 N. Mercer Way, 7697 W. Mercer Way

PURPOSE: A) Management recommendations for trees and vegetation obstructing pump station access, and
B) Risk assessment of trees within striking range of pump station

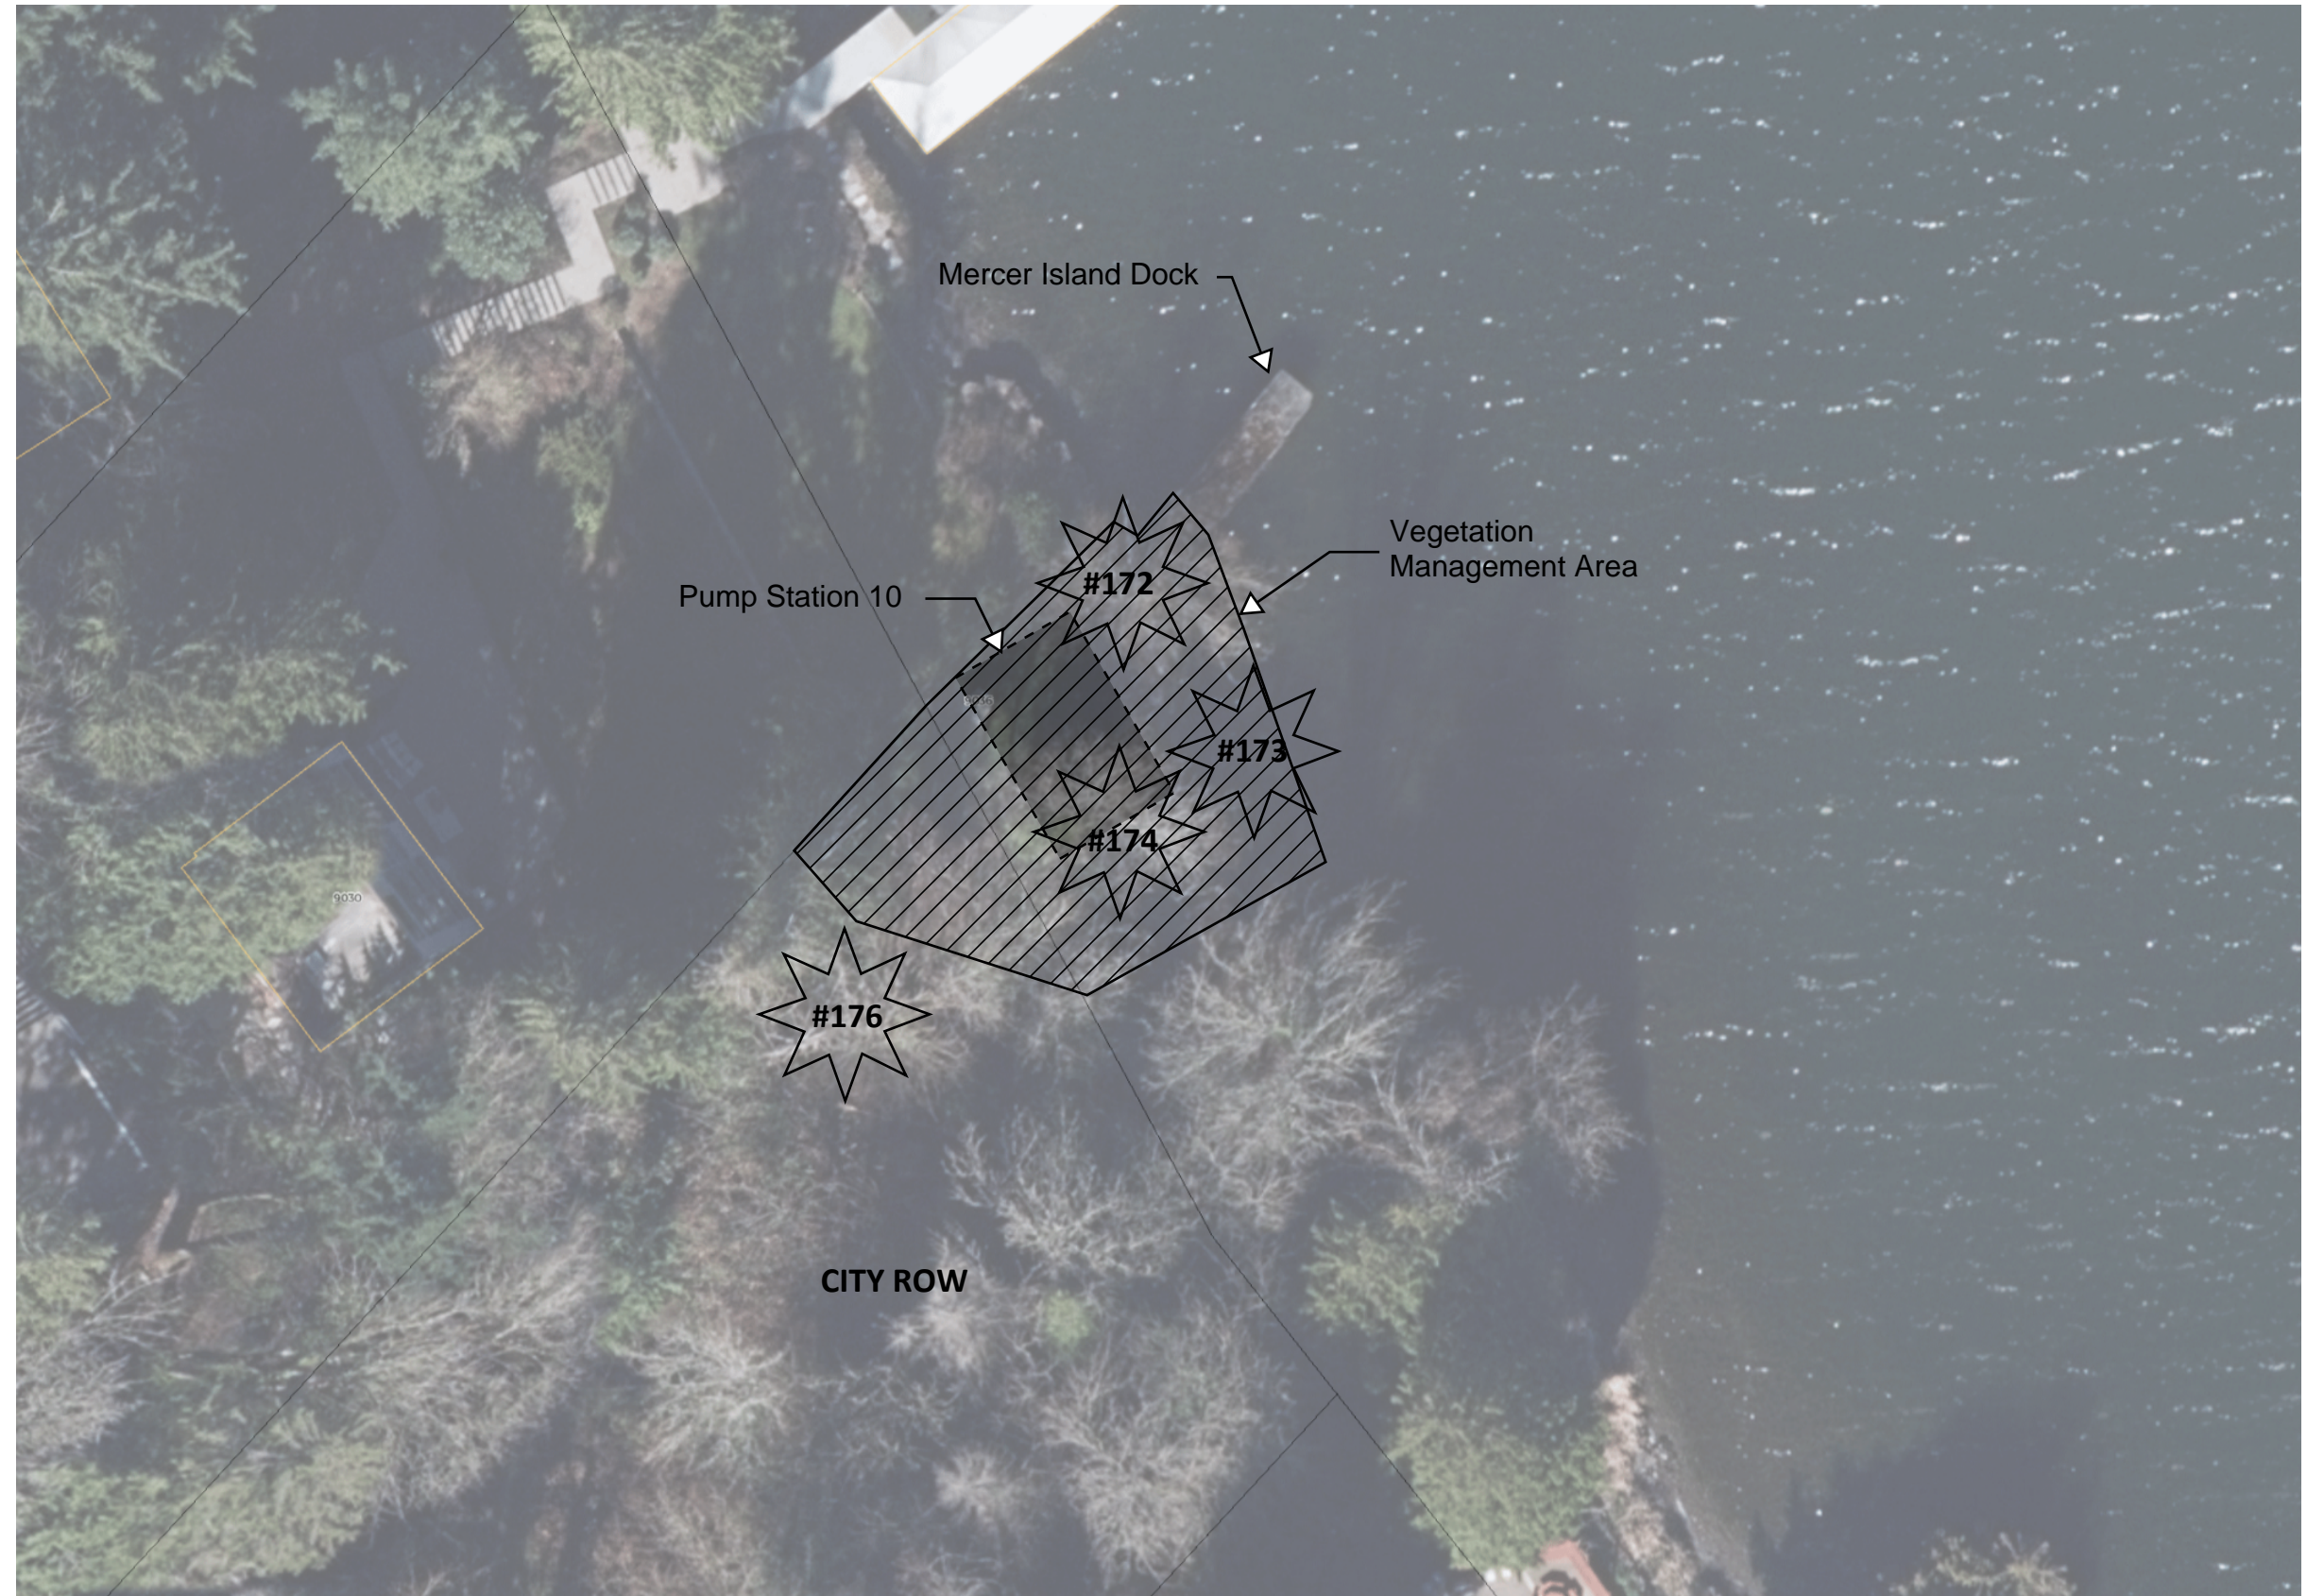
TREE INVENTORY

REMOVE:

- #172 - SCOULER'S WILLOW, 14"DBH
- #173 - BIG LEAF MAPLE, 11"DBH

CUT_CREATE 10'TALL WILDLIFE SNAG:

- #176 - WESTERN RED CEDARY, 22"DBH

TRIM/PRUNE:

- #174 - RED ALDER, 12"DBH

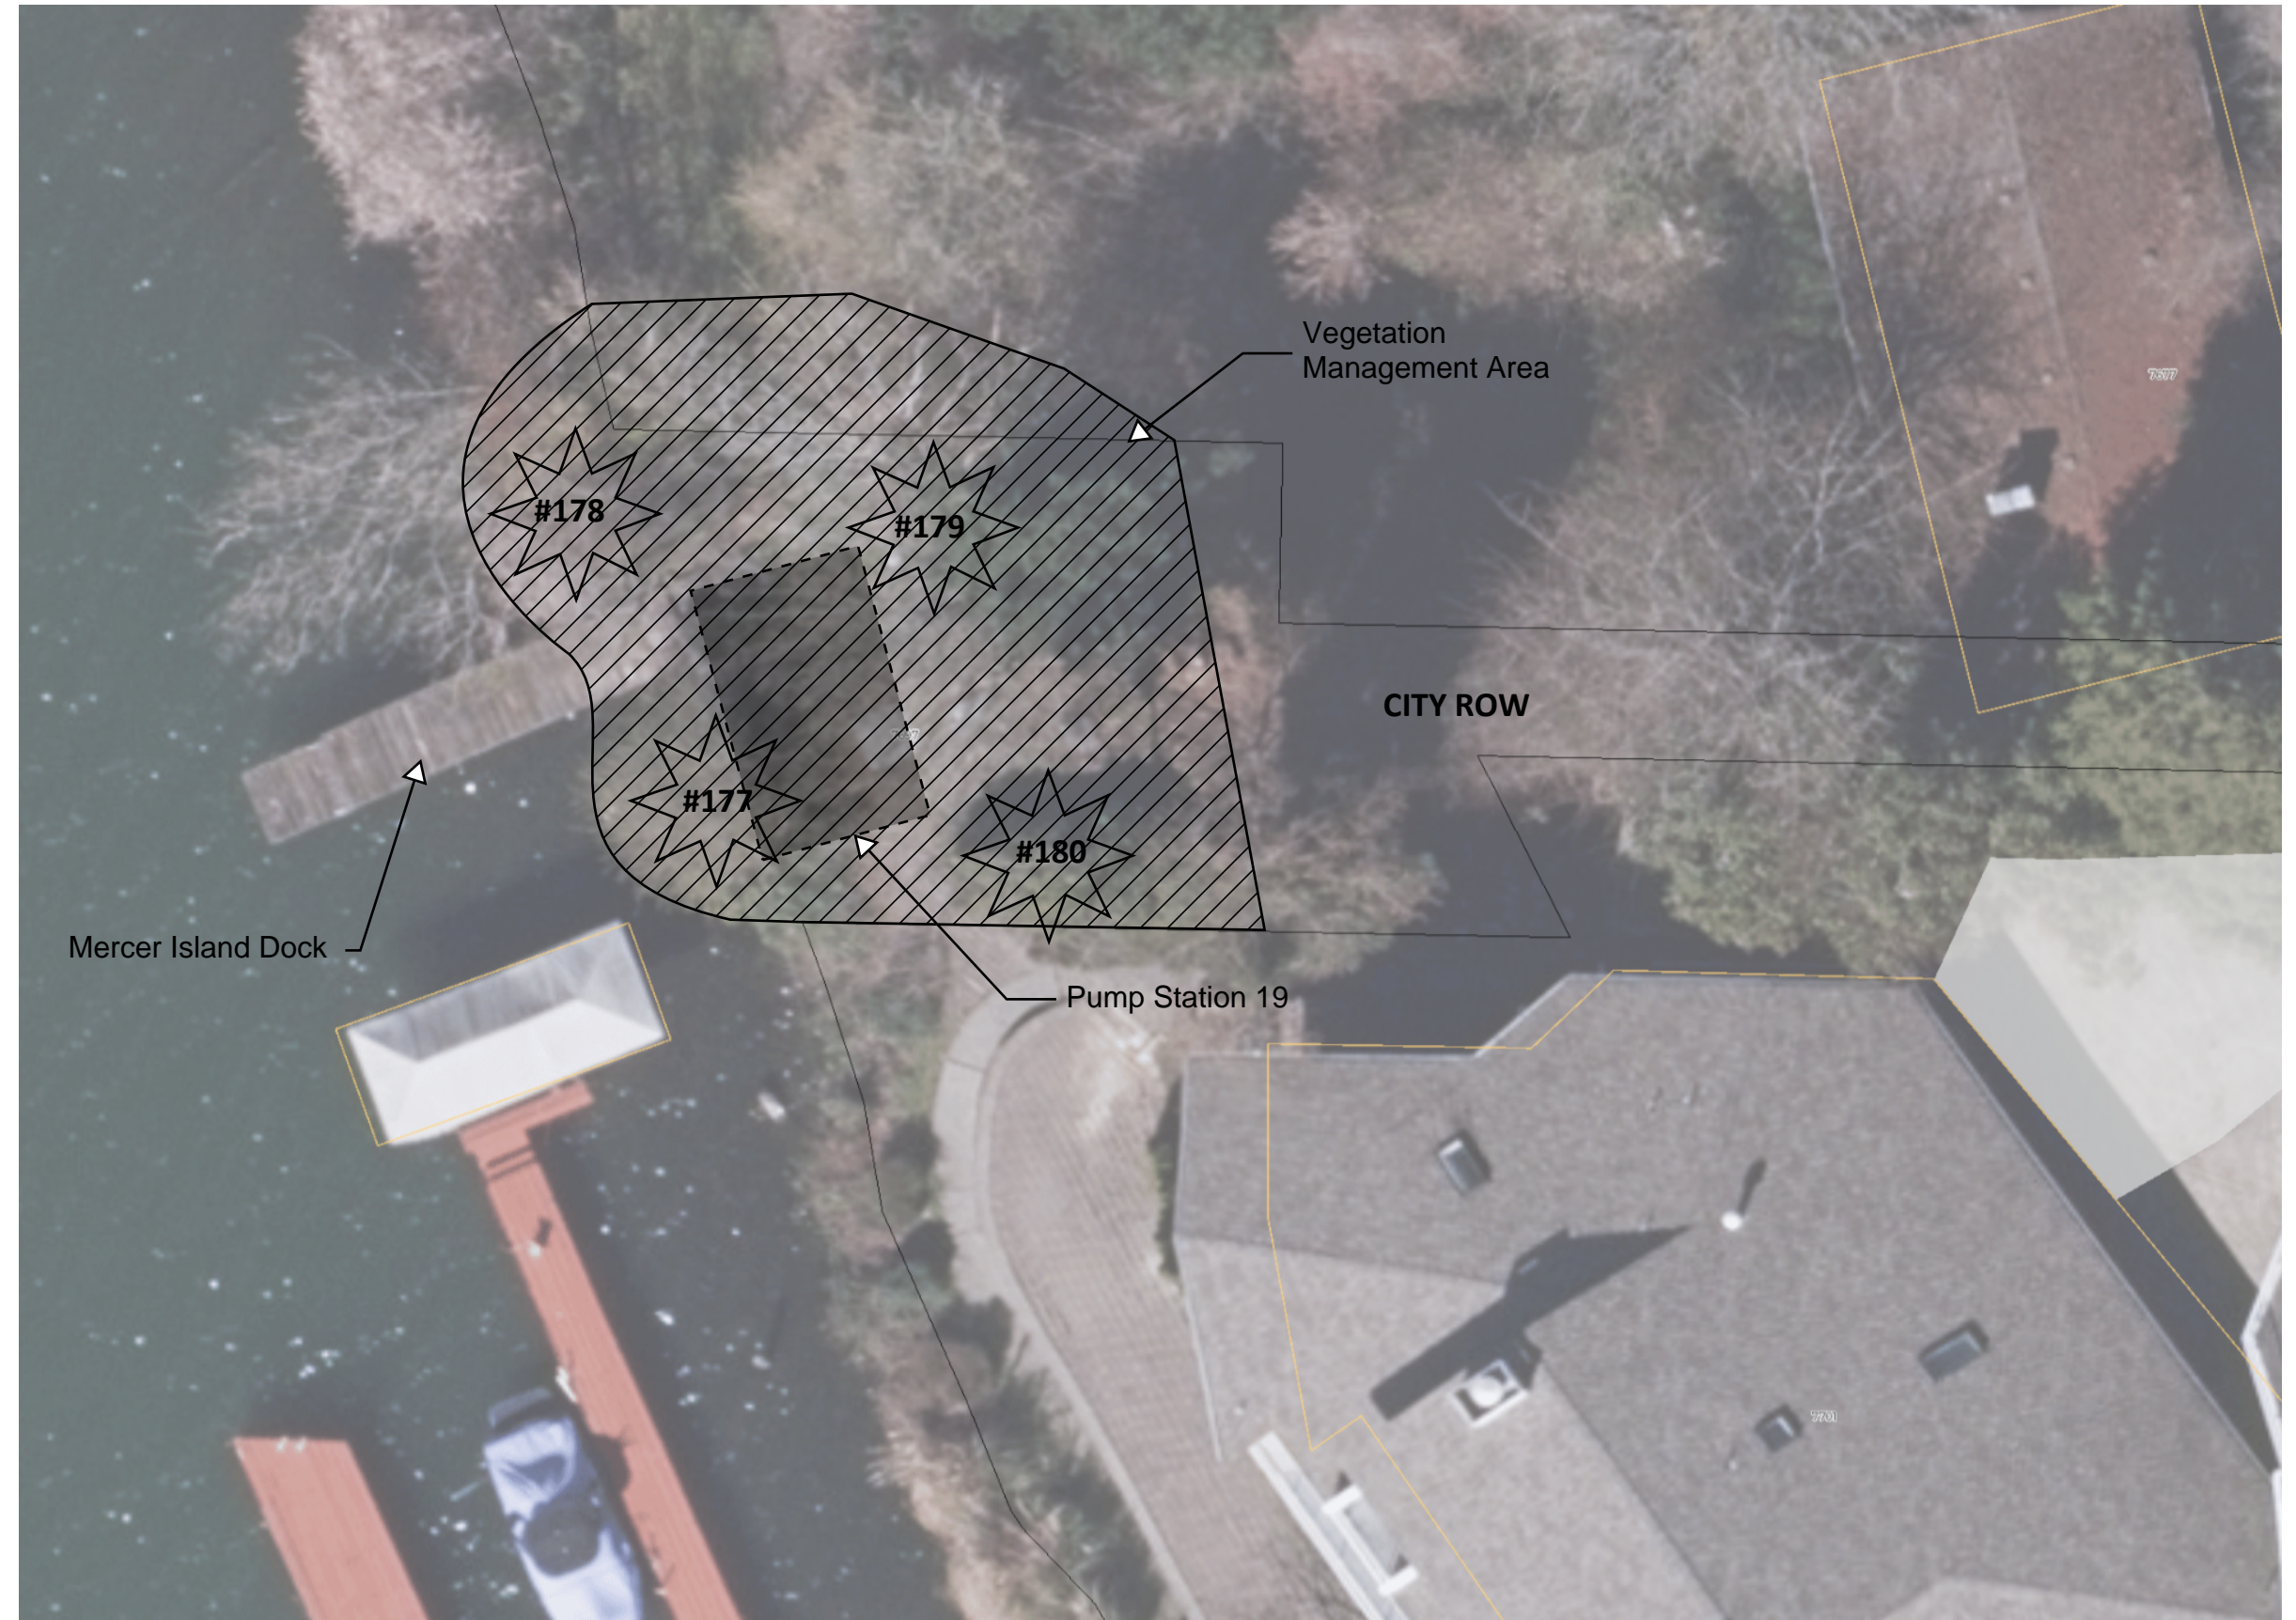
TREE INVENTORY

TRIM/PRUNE:

- #177 - HAWTHORNE, 2-5"DBH
- #178 - ASH, 10"DBH
- #179 - NORWAY MAPLE, 24.5"DBH

PROTECT IN PLACE:

- #180 - RED ALDER, 20"DBH

PS 19: Tree #177, the hawthorn next to the dock, can be retained but about half its crown should be removed to allow dock access. Given the size of the tree and number of stems, I expect it will maintain its health with that amount of crown loss. **Tree #178**, the ash over the water, can be retained. Pruning the one scaffolding branch over the dock should be sufficient management to allow site access. **Tree #180**, the Norway maple, can be retained. The hanging failed branch, dead top, and any other dead branches over 2 inches in diameter should be cleaned from the crown to mitigate risk. The tree should be re-assessed for risk after the brush pile at the base of the tree is gone. **Tree #181** can be retained. The ivy on the tree should be removed to reduce the likelihood of failure and increase its health.
