### ADDENDUM NO. 1

### City of Mercer Island, Washington Public Works Facility Retrofit PROJECT NUMBER 24-41

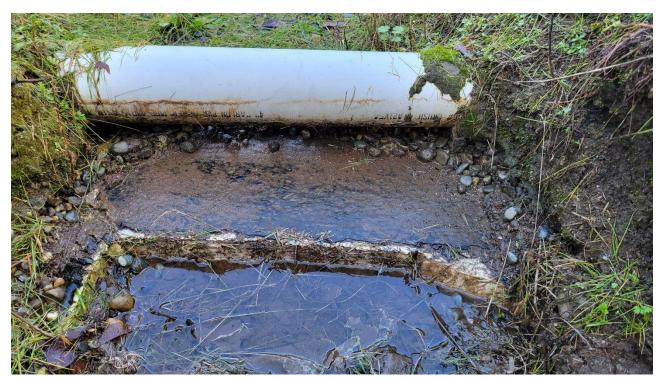
Suspect Material on Foam Board, Edge of Roof

On November 15<sup>th</sup>, 2024, Asbestos Northwest LLC conducted a targeting sampling of building materials City of Mercer Island Public Works facility located at 9601 SE 36<sup>th</sup> St in Mercer Island WA. Asbestos Northwest was represented by AHERA certified inspector Sean Butler. The sampling of suspect material was carried out at the request of the client prior to the removal and replacement of a green roofing system. As-built drawings by the client had an unclear notation indicating the possible presence of a 1/4in concrete panel material within the layering of the green roof. This material was shown as being directly above 2in foam insulation, and below the gravel fill. During excavation no obvious cement board material was found, but a layer of a brittle, asphaltic material was present. Samples of this material were taken from each of the two excavations near the south edge of the roof, photos are attached below.

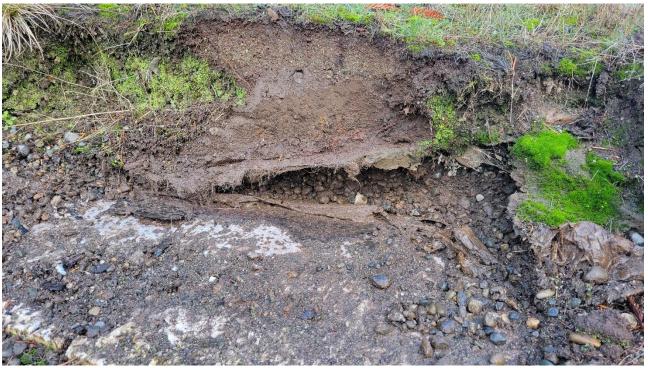
Exposed Asphaltic Material on Foam Under Gravel

**None of the materials sampled contained asbestos.** Only the above described materials were sampled, no other samples were taken from any other building materials at this time. No cement paneling was seen, under analysis the black brittle material was found to be asphaltic in composition.

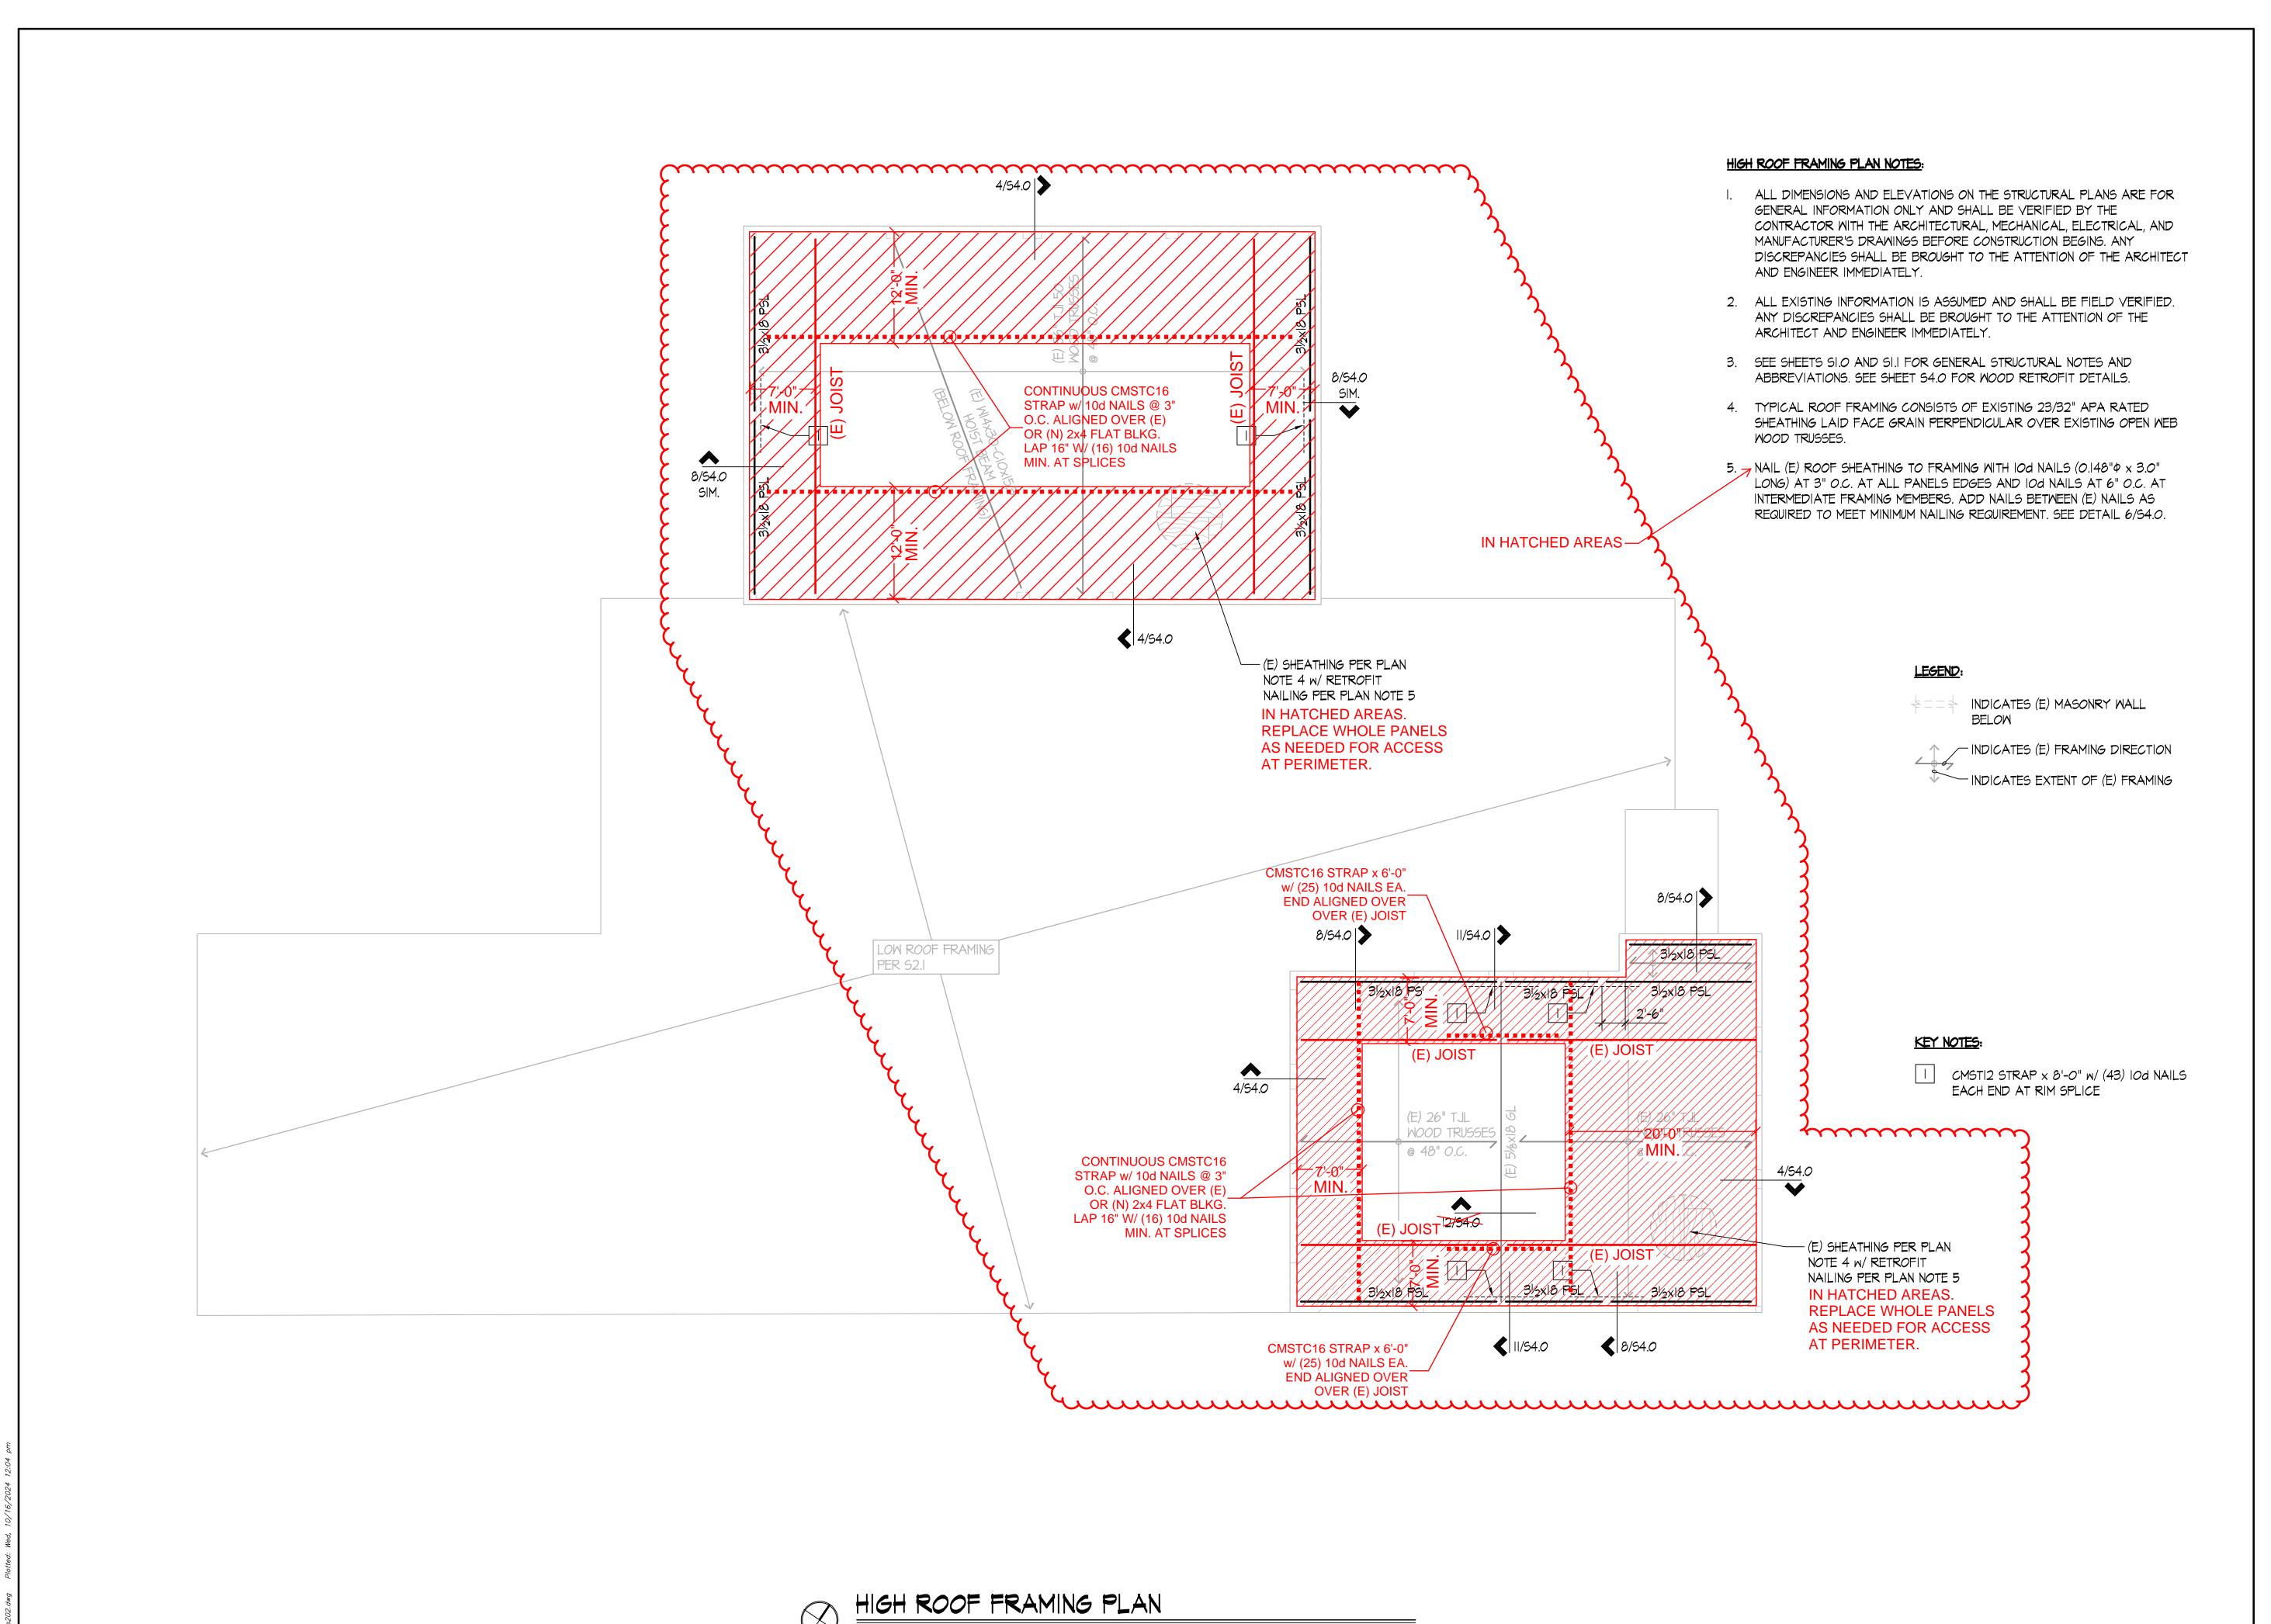
S2.2

HIGH ROOF FRAMING PLAN ALT 1

Sheets A2.2 Alt 1 and S4.0 Alt 1 are attached in response to question 4 and provide additional direction for the area of roofing removal and structural requirements that allow the noted middle portion of the roof to be left untouched. Bidders shall indicate which of the following options listed below are made part of the submitted bid. Bidders shall indicate selection on the Bid Form, in the space provided for acknowledgement of the Addendum Number by indicating Addendum No.1 and either Option A or Option B:
