# Mercer Island Seismic Hazard Assessment

by Kathy G. Troost & Aaron P. Wisler  
April 2009

## SEISMIC HAZARD AREAS (MICC 19.16.010)

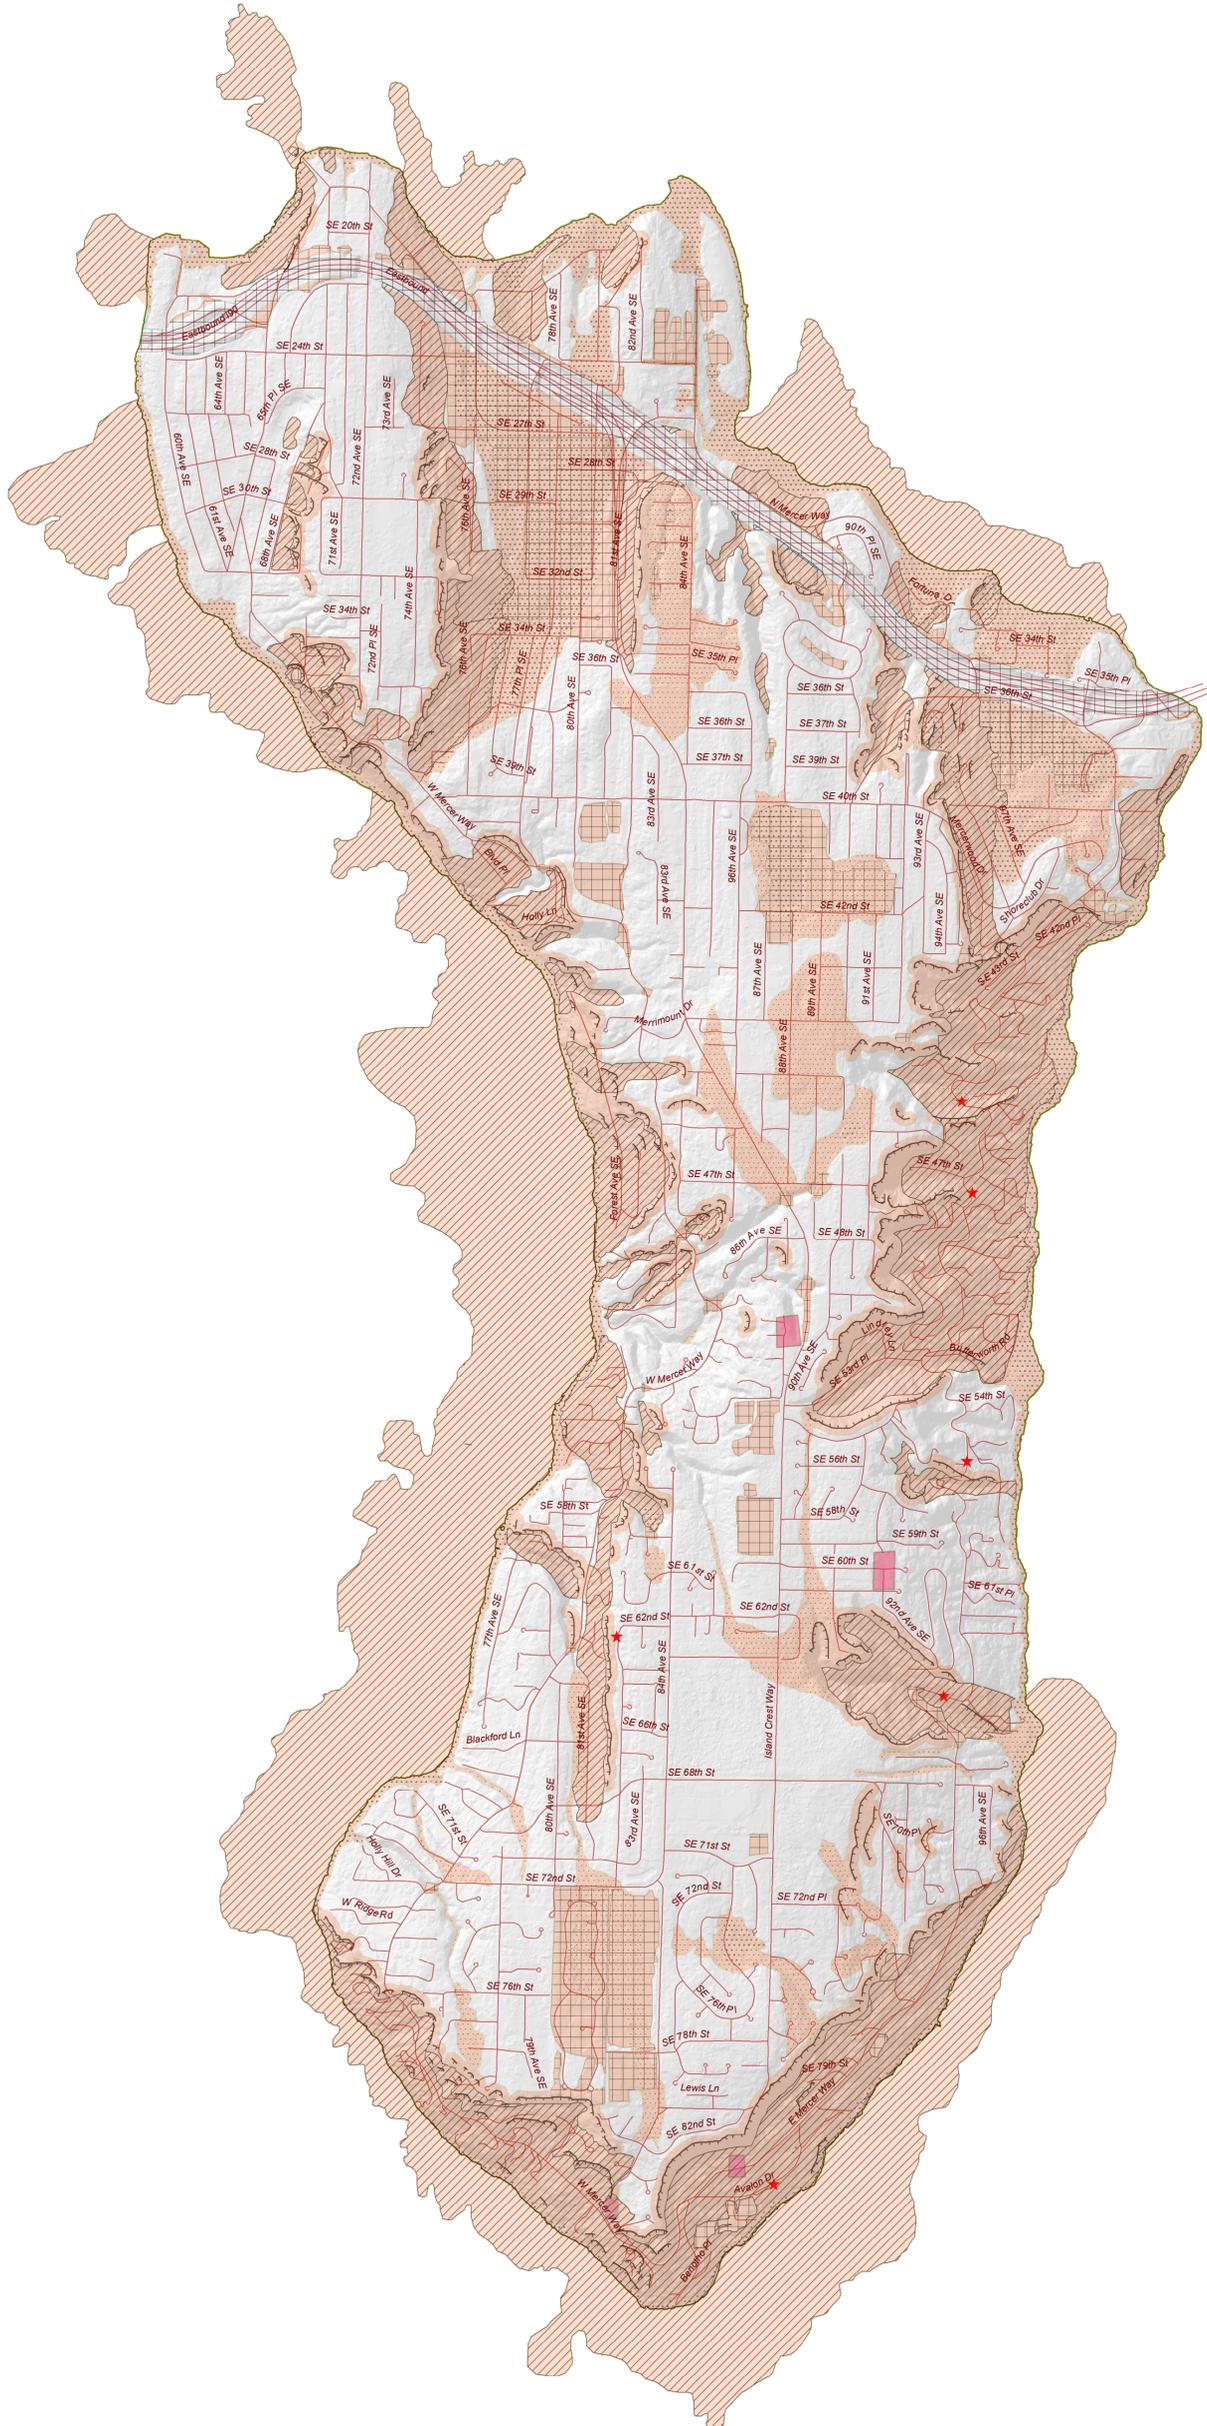
Seismic Hazard areas are those areas subject to severe risk of damage as a result of earthquake-induced ground shaking, slope failure, settlement, soil liquefaction or surface faulting.

**Seismic Hazard** Seismic Hazard Area (Known or Suspect)

**For all other areas risk is unknown or limited to ground shaking**

Potential for seismically induced ground failures including settlement, cracking, lateral spreading, liquefaction due to ground shaking. Seismically hazardous areas include the following:

- High Potential for seismically induced ground failures (Poorly consolidated, see note below)
- Moderate Potential for seismically induced ground failures (Moderately consolidated, see note below)
- Scarp
- Landslide and Mass Wastage Deposits (subaerial & subaqueous)
- Modified land

- Miscellaneous Ground Effects of the 2001 Nisqually Earthquake (Approx. Area)
- Ground Settlement from the 1965 Earthquake (Approx. Area)
- Miscellaneous Ground Effects of the 1949 Earthquake (Approx. Area)

Geologic materials were assessed then classified as either strongly, moderately, or poorly consolidated. Degree of consolidation is a direct translation of geologic unit based on geologic history and predominant lithology. Because considerable variability exists within each geologic unit, more detailed analysis is needed for site-specific evaluations or to evaluate the degree of consolidation at a larger scale than provided. Slope and degree of saturation also affect the degree of consolidation, but have not been factored into this map. This qualitative assessment should be used to evaluate and understand the character of the island as a whole. These data should not be used for purposes of site-specific land-use planning or site-specific geologic evaluations. The classification shown on the map does not account for the built environment and impervious surfaces.

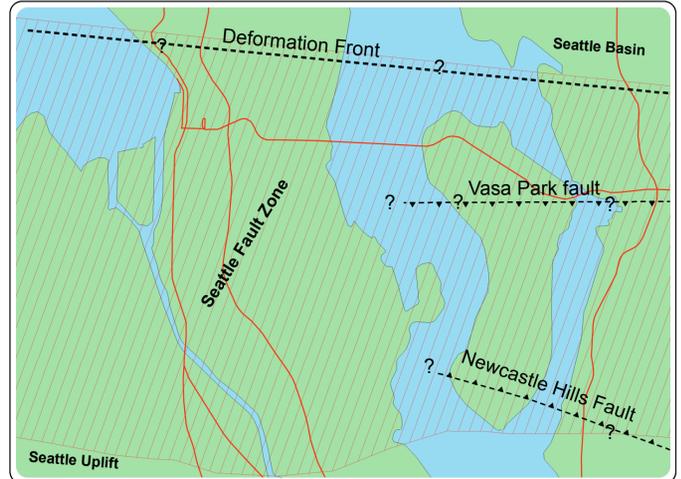
## ACTIVE FAULTS

Mercer Island falls within the Seattle fault zone and at least two strands of the Seattle fault cross the island. No direct evidence of surface fault rupture has yet been documented for Mercer Island (Troost and Wisler, 2006).

The Seattle Fault Zone is the area where several parallel strands of the Seattle fault have either broken the ground surface or caused deformation of geologic materials. Earthquakes of magnitude M7 or greater have occurred on some of these fault strands within the Holocene (last 10,000 years) and will likely occur again (Blakely, et al., 2002; Sherrod 2002, 2005). The Seattle Fault Zone is one of several active crustal faults zones in the Puget Lowland currently undergoing research.

On Mercer Island, evidence for movement along these fault strands consists of exposures of deformed sedimentary strata and geophysical images of folded and faulted strata (Troost and Wisler, 2006; Stephenson et al., 2007). Elsewhere in the Puget Sound lowland, evidence for movement on the fault strands consists of uplifted beach deposits, down-dropped tidal marshes, offset strata, fault scarps, and deformation such as sheared and tightly folded strata. Evidence of the Seattle fault zone in the subsurface consists of aeromagnetic, gravitational, and seismic reflection anomalies (Liberty and Pratt, 2008).

East of Mercer Island, the Vasa Park fault and Newcastle Hills fault each have surface expression in the form of fault scarps and subsurface expression in the form of magnetic and seismic linear anomalies (Liberty and Pratt, 2008; Sherrod, 2002). The magnetic and seismic anomalies may be continuous with similar features to the west of Lake Washington, but those continuities are not firmly established (Liberty and Pratt, 2008). The locations of these faults are not well defined on Mercer Island (Pratt, 2009, pers. comm.)

The Deformation Front is an east-west-trending, convex-upward fold in geologic strata, where those strata drape over the northern-most thrust fault in the Seattle Fault Zone. North of the Deformation Front is the Seattle Basin, where strata lie nearly flat; south of the Deformation Front the strata dip down toward the north beneath the Seattle Uplift (Pratt, 2009). The location of the Deformation Front was moved northward from previous interpretations (Brocher, et al, 2004) following detailed evaluation of seismic lines by Pratt (2009).
