Figure 1 Guy Michaelsen October 5, 2005

Luther Burbank Park Wetland Reconnaissance Map Mercer Island, Washington

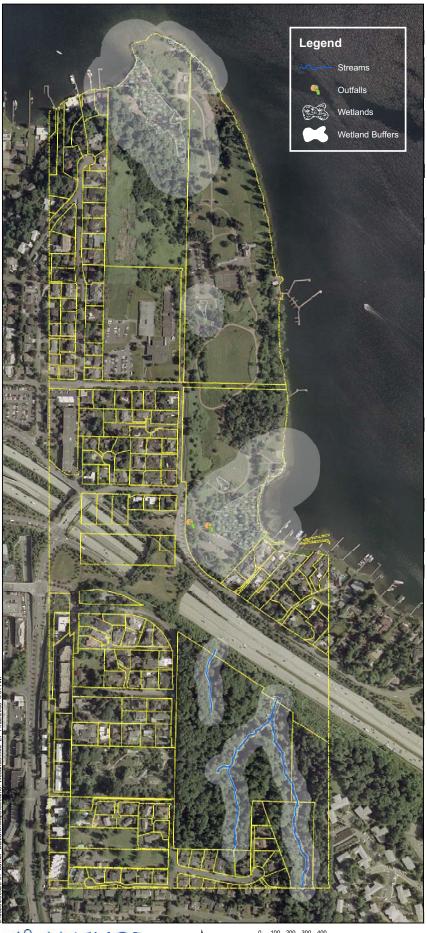
Notes: Potential wetland habitat conditions were evaluated based on a reconnaissance-level site visit performed on September 30, 2005. Wetland delineations or surveys were not Wetland delineations or surveys were not performed as part of this analysis. To confirm the presence, absence, boundaries, functions, and values of wetland systems, wetland delineations should be conducted according to the methods defined in the 1987 U.S. Army Corps of Engineers Wetland Delineation Manual and the 1997 Washington State Department of Ecology Wetland Identification and Delineation Manual.
