MERCER ISLAND PARKS
OVERWATER STRUCTURES ASSESSMENT

DRAFT REPORT

May 30, 2014

Re: **Mercer Island Parks – Overwater Structures Assessment**

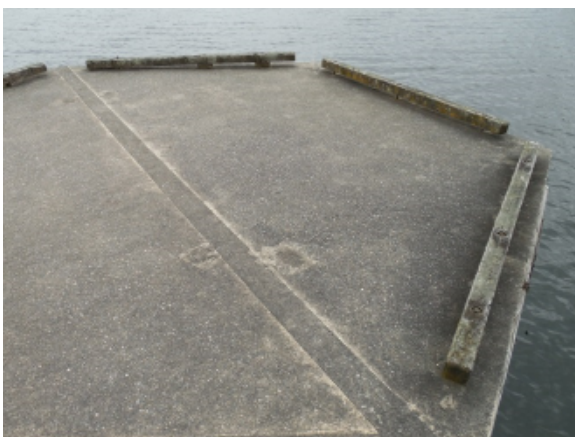
Photo 23A – Platform at end of small pier

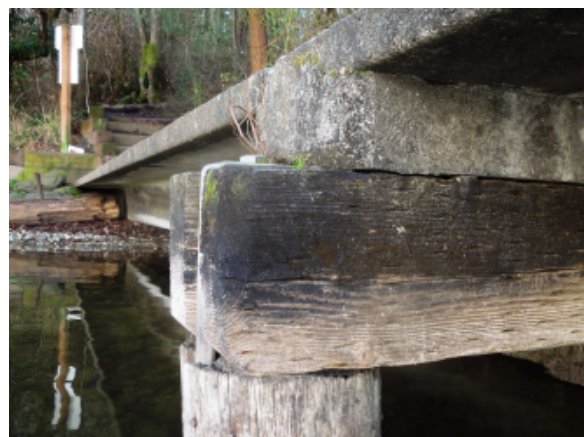
Photo 24A – Pile cap to pile connection (small pier)

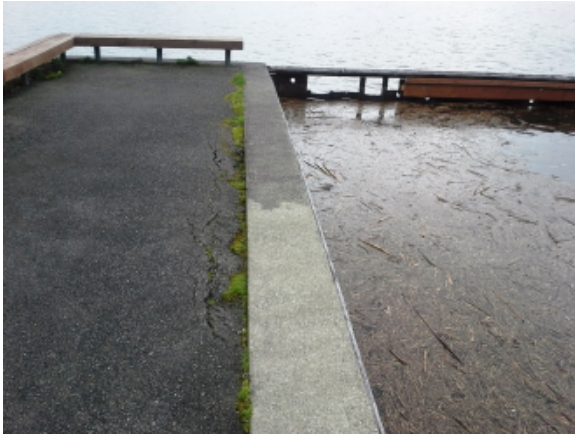
Photo 1B – Kid's swim area / bulkhead

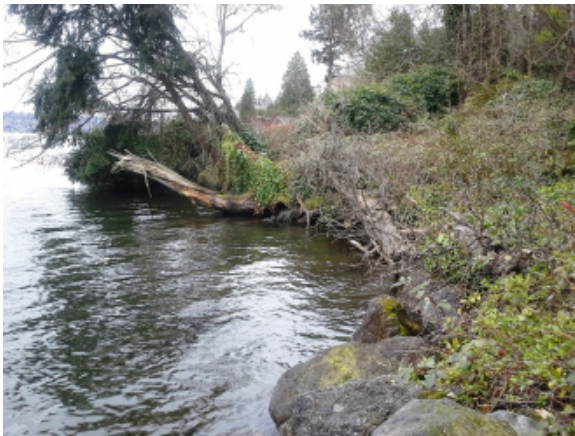
Photo 9B – Natural shoreline

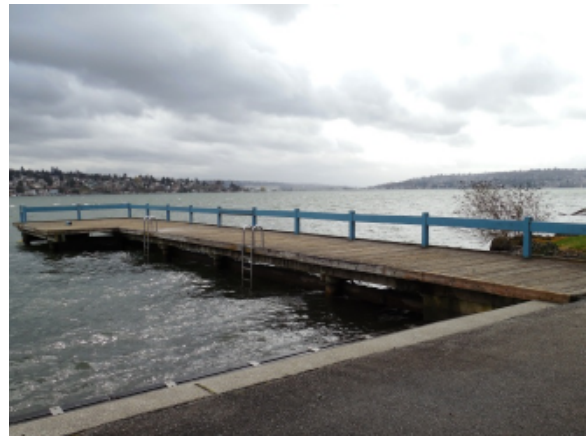
Photo 10B – Small pier

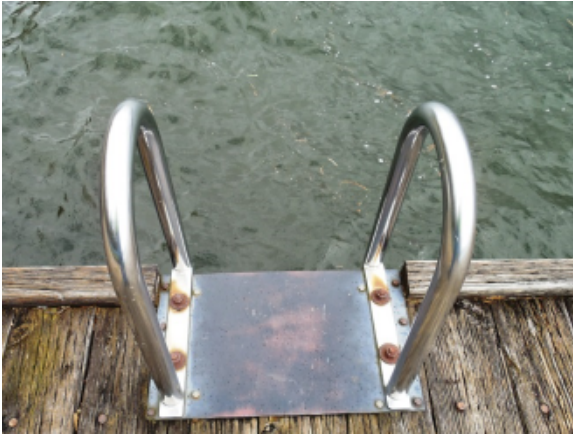
Photo 13B – Swim ladder

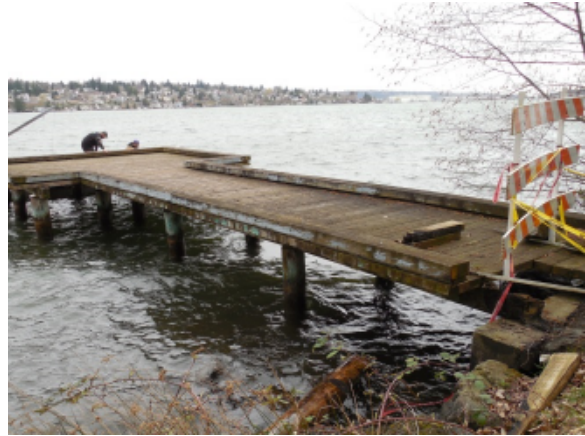
Photo 20B – Small pier

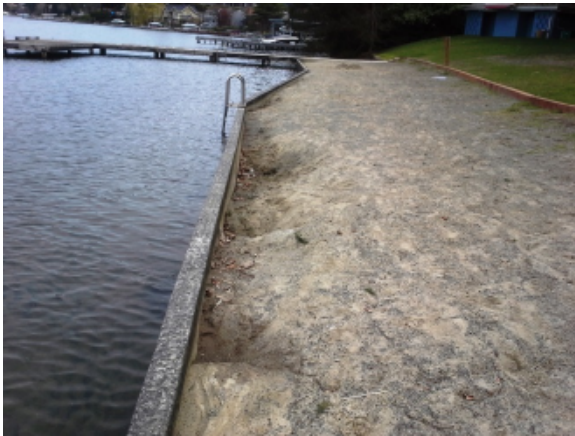
Photo 1C – Groveland Beach 1

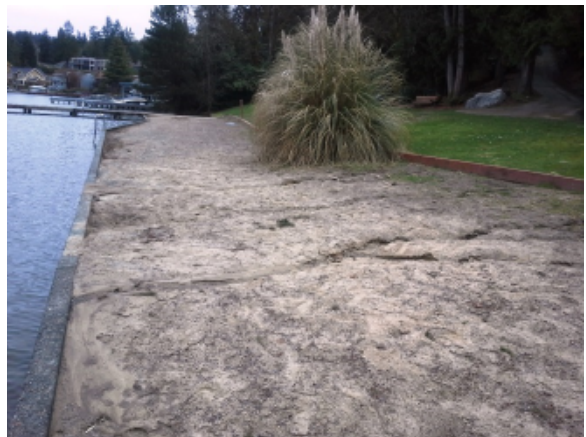
Photo 2C – Rilled sand, Beach 1

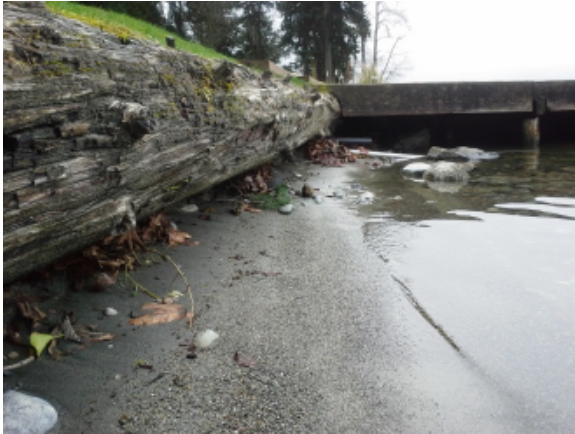
Photo **7C** – Log bulkhead

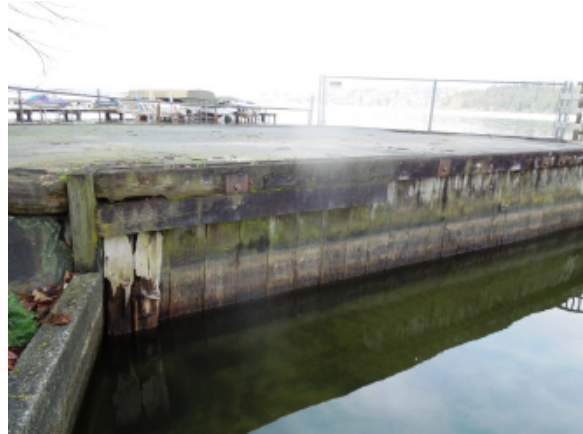
Photo **8C** – Large pier, south return

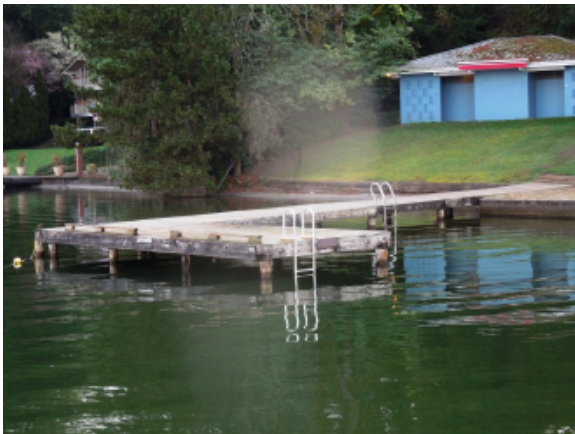
Photo 29C – Small pier
